COLORADO CULTURAL RESOURCE SURVEY

Architectural Inventory Form

1. Resource number: **5PE.5588**
2. Temporary resource number: **001**
3. County: **Pueblo**
4. City: **Pueblo**
5. Historic building name: **White, Asbury, House**
6. Current building name: **Williams, Lawrence L. and Gloria J., House**
7. Building address: **419 W 11th Street**
8. Owner name: **Lawrence L. and Gloria J. Williams**
- Owner organization:
- Owner address: **2121 N Greenwood Ave**
Pueblo, CO 81003

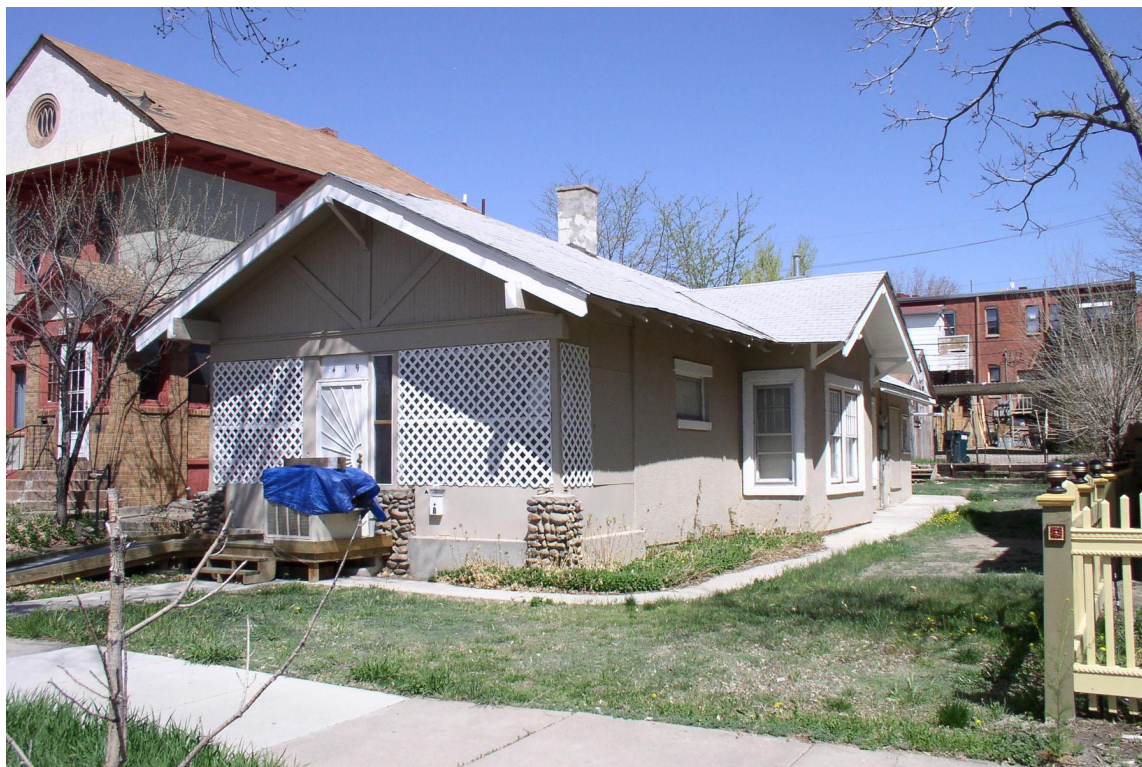
19. Primary external roof material: **Asphalt Roof/Composition Roof**
Other roof materials:
20. Special features:
Fence
Chimney
Porch
21. General architectural description:
Oriented to the south, this house rests on a tan-colored, stucco-covered foundation. Tan-painted stucco covers the exterior walls. Windows are generally 6-over-1-light, double-hung sash, with cream-painted wood frames and stucco-covered surrounds. The east elevation features a protruding, front-gabled, rectangular bay. Just south of it is a single-light awning window, with an aluminum-frame storm window. North of the bay is a 2 (horizontal)-over-2 (horizontal) light, double-hung sash window. The north end of the west elevation has a pair of 1-over-1, double-hung sash windows. A larger window opening to the south has been enclosed with tan-painted plywood and now hosts a 1-beside-1-light, sliding-sash window. The east end of the rear (north) elevation features a pair of single-light casement windows, with white-painted wood frames. At the west end is a single-light, fixed-frame window. A front-gabled porch extends across the entire front (south) elevation. Plywood and latticework enclose the porch. While the porch's original piers appear to have been removed, the cobblestone pedestals remain. False half-timbering, with vertically oriented readboard, fills the porch's gable. Approaching the porch at center is a concrete walk. A wood ramp rises from the west. The porch is entered at the center via a white, steel security storm door. A 2-light, plexiglass sidelight appears to the east of the door. Two shed-roof additions protrude from either side of the rear (north) elevation. The east addition is wood-framed, covered in stucco. The west addition is constructed of tan-painted concrete blocks. A shed-roof porch extends from the center of the rear (north) elevation. It is enclosed with a combination of aluminum-frame storm windows and plexiglass. Gray asphalt singles cover the cross-gabled roof. The rafter and perlin ends are exposed

and shaped. Simple knee brackets appear under the eaves of the porch and the side bay. Stucco covered chimneys emerge at the center of the house and from the north end of the roof's east-facing slope.
