COLORADO CULTURAL RESOURCE SURVEY

Architectural Inventory Form

- 1. Resource number: **5PE.5589** Parcel number(s):
- 2. Temporary resource number: **003** **525425009**
- 3. County: **Pueblo**
- 4. City: **Pueblo**
- 5. Historic building name: **McClung, James S., House**
- 6. Current building name: **423 West Eleventh Street**
- 7. Building address: **423 W 11th Street**
- 8. Owner name: **Eleventh Street Properties, LLC**
- Owner organization:
- Owner address: **421 W 11th St**
Pueblo, CO 81003

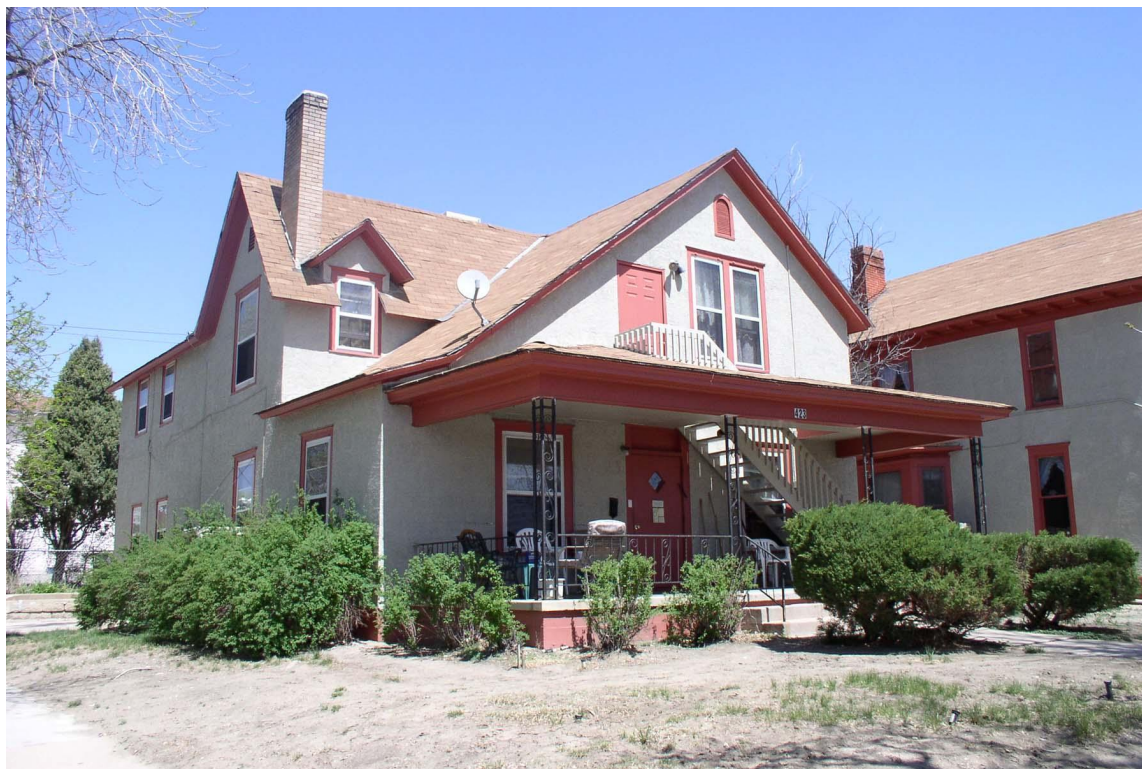
21. General architectural description:
Oriented to the south, this dwelling rests on a combination of stone, concrete, and concrete-block foundations, largely covered in tan-painted stucco. Tan-painted stucco also clads the exterior walls. Windows are generally 1-over-1-light, double-hung sash, with salmon-painted wood frames; white, aluminum-frame storm windows; and broad, salmon-painted surrounds with protruding cornices. A 1-beside-1-light, sliding-sash window, with an aluminum frame, opens on the north end of the east elevation's first story. A wall dormer emerges behind the asymmetrical, front-gable structure extending across the front (south) façade. A hipped-roof porch spans the entire front (south) façade. It features a concrete floor and black-painted, wrought-iron railings and supports. It provides access to a salmon-painted, wood slab door, with a single, diamond-shaped light, opening west of center in the façade. A steel staircase ascends from the east end of the porch, through the porch roof, to a slab door on the west end of the front (south) façade's second story. Salmon-painted, wood slab doors also open on the east end of the rear (north) elevation and in the rear (north) elevation of a side-gabled structure connecting this house to the dwelling immediately east at 421 West 11th Street. Brown asphalt shingles cover the cross-gabled roof, and salmon-painted wood fascia and soffit box the eaves. Chimneys protrude from near the southwest and northeast corners of the house.

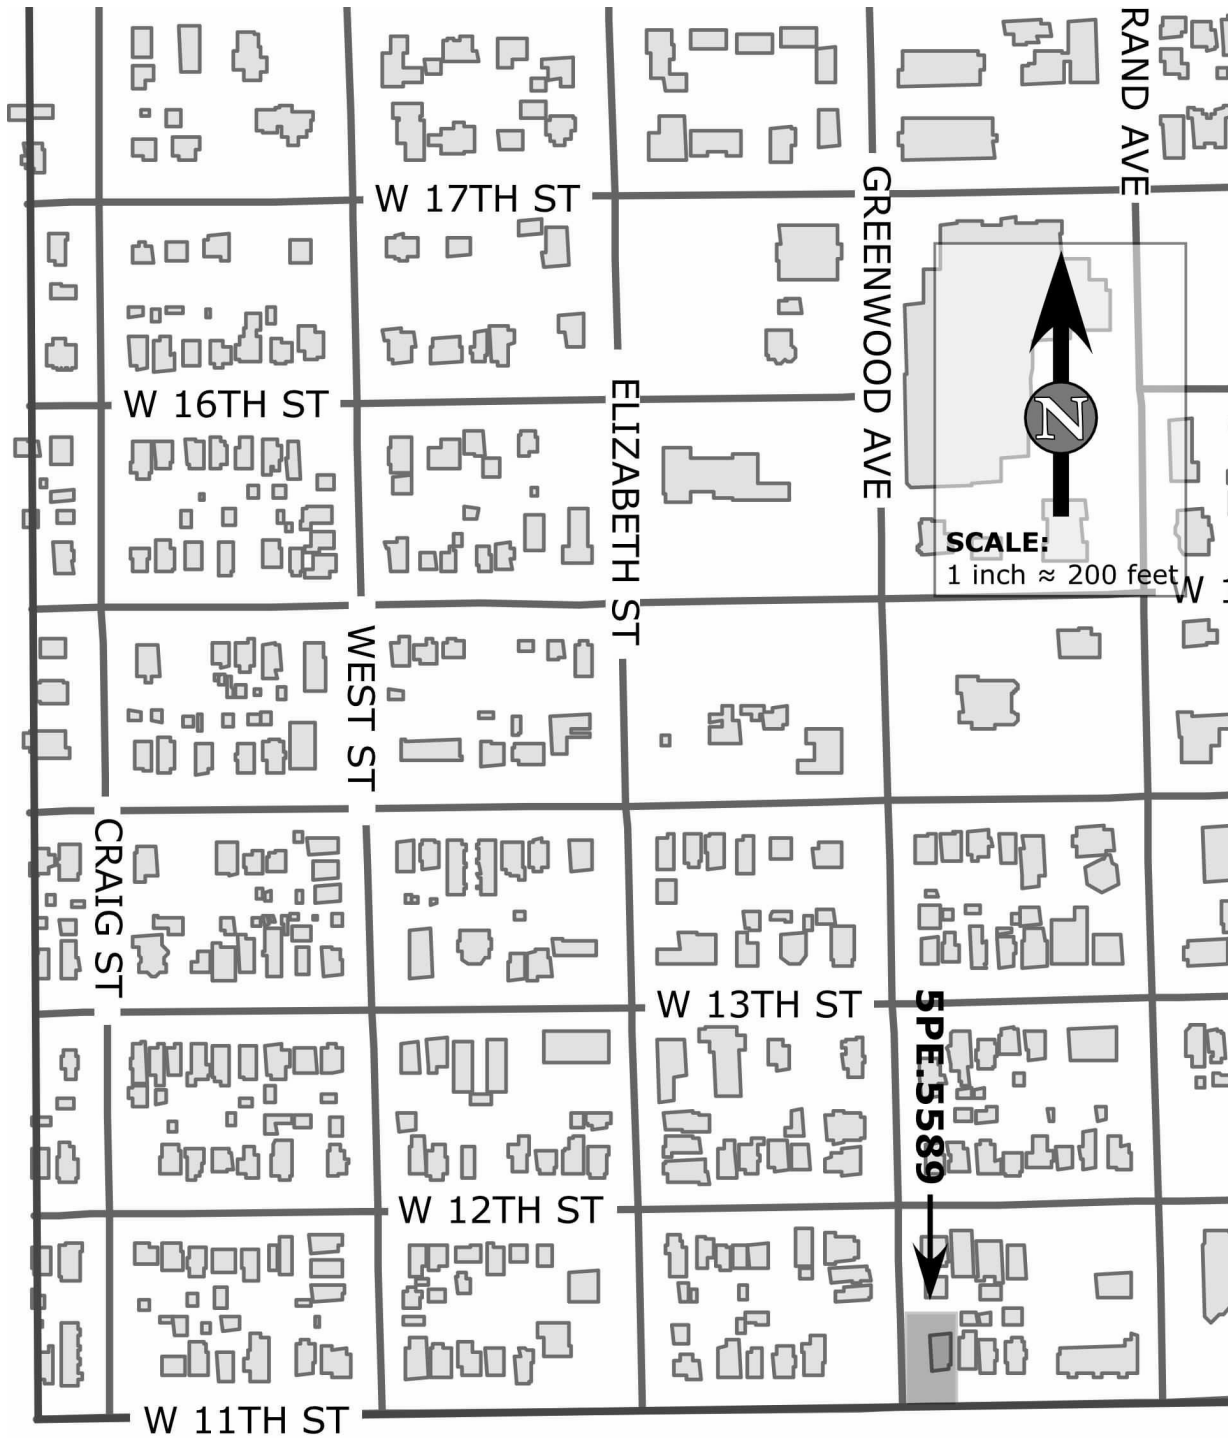
SITE SKETCH MAP

This property is located on terrain gently sloping downward from north to south, with an elevation of around 4,700 feet above mean sea level. The neighborhood features modest, one- and two-story houses. A grass strip, generally planted with large cottonwood or elm trees, separates the sidewalk from the street. This property is located on the northeast corner of West 11th Street and Greenwood Street. A chain-link fence surrounds most of the backyard. A single-car, concrete parking area is located adjacent to the house's northwest corner, approached from Greenwood Street. A larger, crushed-gravel parking area is located behind (north of) the house, accessed from the alley. A planted grass yard, with mature landscaping, surrounds the dwelling.
