COLORADO CULTURAL RESOURCE SURVEY

Architectural Inventory Form

I. IDENTIFICATION

- 1. Resource number: **5PE.5592**
- 2. Temporary resource number: **007**
- 3. County: **Pueblo**
- 4. City: **Pueblo**
- 5. Historic building name: **Liddy, P.M., House**
- 6. Current building name: **Deshon-Crispell Apartments**
- 7. Building address: **515 W 11th Street**
- 8. Owner name: **David A. and Glenda K. Deshon; and Yvonne Crispell**

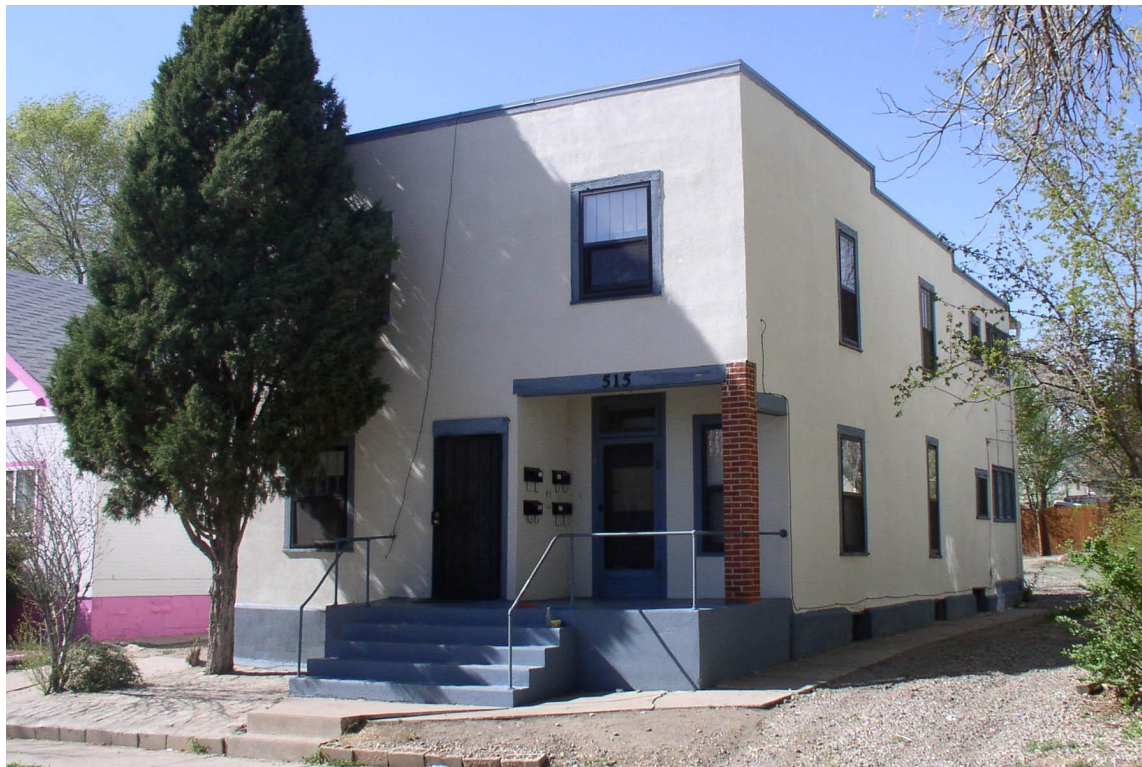
19. Primary external roof material: **Asphalt Roof/Composition Roof**
Other roof materials:
20. Special features: **Porch**
21. General architectural description:
Oriented to the west, this building rests on a blue-painted concrete foundation with three-light, wood-frame, hopper basement windows. Cream-painted stucco clads most of the exterior walls; however, two-story additions to the rear (north) elevation are covered in cream-painted, vertical, flush-set, wood siding. Windows are generally 5 (vertical)-over-1, double-hung sash, with blue-painted wood frames, brown, aluminum-frame storm windows, and blue-painted wood surrounds. A 1-over-1-light, double-hung sash window, with brown, aluminum frames, opens on the south face of the southeast corner. Three-light awning windows, with blue-painted wood frames, open on both stories at the north ends of the east and west elevations, south of the siding-clad additions. These additions feature bands of four-light casement windows, with blue-painted wood frames. A small, cutaway porch is located on the southeast corner of the building. It features a concrete floor, blue-painted pipe railing, and a single, brick support. The porch provides access to a four-panel, one-light, glass-in-wood-frame door, opening behind a blue-painted, wood-frame screen door. Above the doorway is a single-light transom. Another doorway opens just west of this door. While the doorway is not located under the porch, it is served by the same concrete stoop. The doorway hosts a wood slab door, opening behind a black, metal security storm door. Four more doorways, are concentrated at the center of the rear (north) elevation. On either end of the band of doorways are four-panel, one-light, glass-in-wood-frame doors, opening behind wood-frame screen doors. The eastern of the two center doors is a four-panel wood door; the western is a wood slab door. Gray, rolled asphalt sheets cover the shed roof. A parapet, with a blue-painted concrete cap, surrounds all but the north side of the roof.

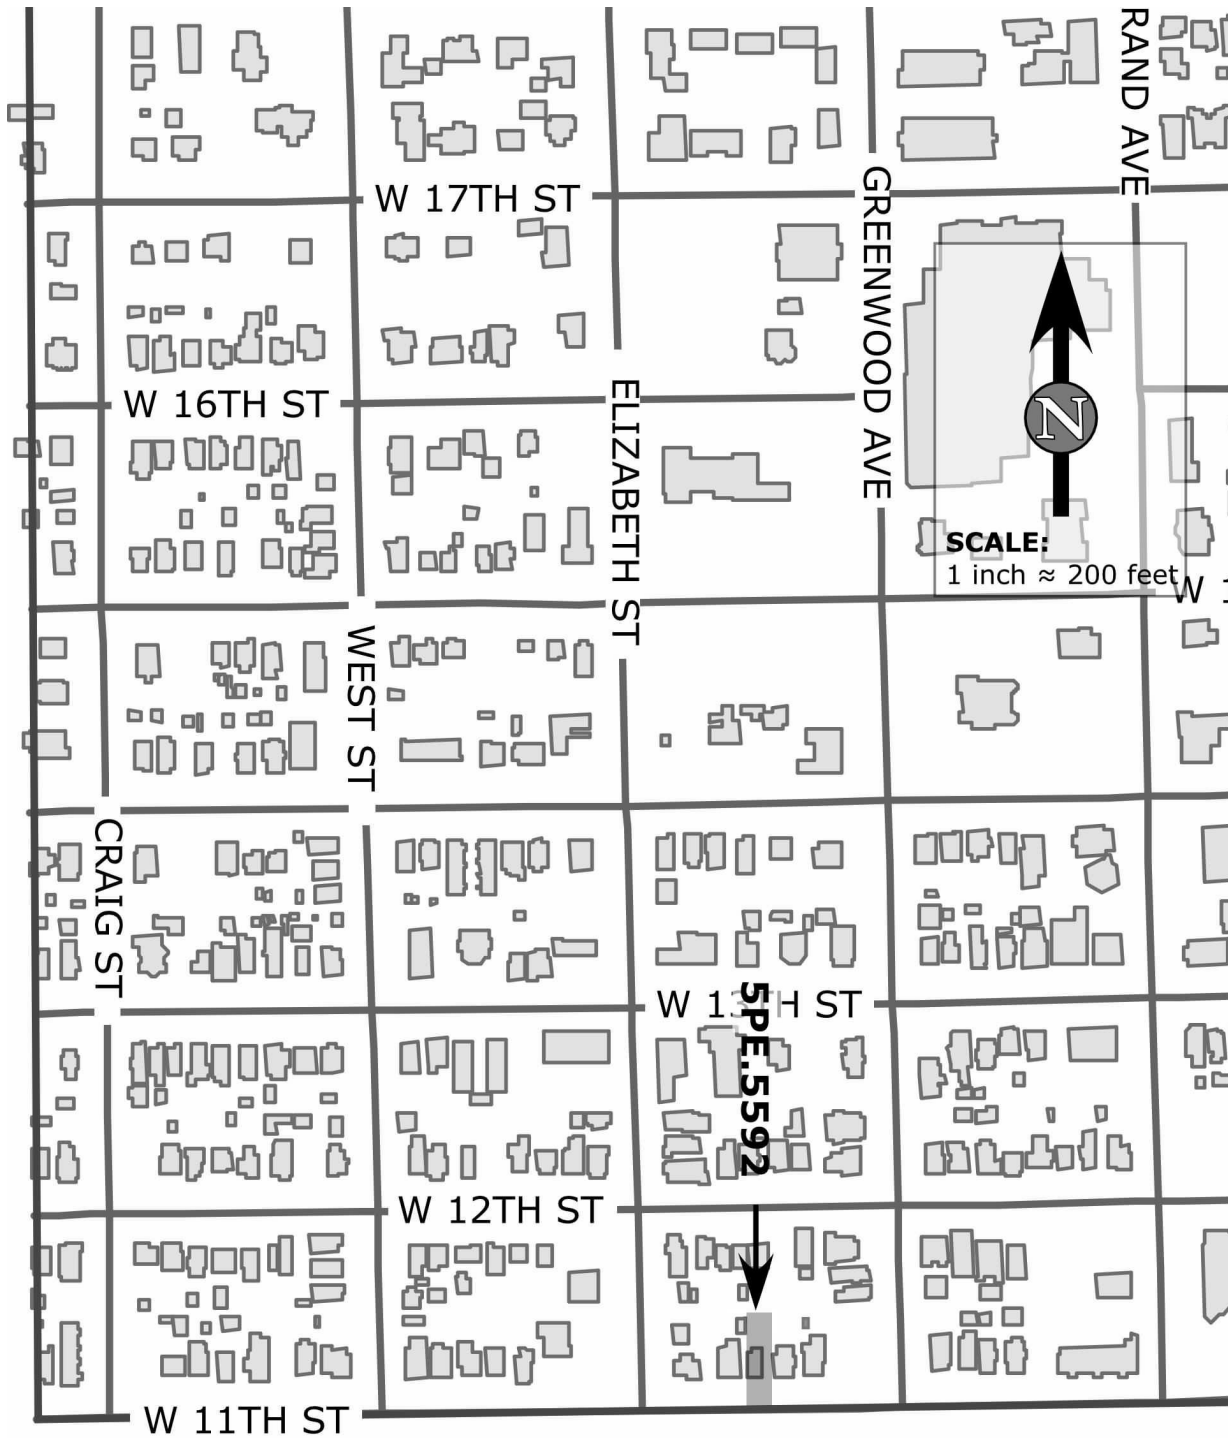
SITE SKETCH MAP

This property is located on terrain sloping gently downward from north to south, with an elevation of around 4,700 feet above mean sea level. The neighborhood features modest, one- and two-story houses. A grass strip, generally planted with large cottonwood or elm trees, separates the sidewalk from the street. This property is located on the north side of West 11th Street, an east-west-oriented thoroughfare. It is situated between 509 West 11th Street, to the east, and 519 West 11th Street, to the west. A planted grass yard, with mature landscaping, surrounds the building. A gravel driveway extends from West 11th Street, along the east side of the building, to the alley north of it. This driveway expands into a parking area behind (north of) the apartments. A large cedar tree obscures the southwest corner of the building.
