COLORADO CULTURAL RESOURCE SURVEY

Architectural Inventory Form

- 1. Resource number: **5PE.5597** Parcel number(s):
- 2. Temporary resource number: **051** **525423009**
- 3. County: **Pueblo**
- 4. City: **Pueblo**
- 5. Historic building name: **617 West 11th Street**
- 6. Current building name: **Carpenter, Tomich G. and Lerlyn K., House**
- 7. Building address: **617 W 11th Street**
- 8. Owner name: **Tomich G. and Lerlyn K. Carpenter**
- Owner organization:
- Owner address: **617 W 11th St**  
**Pueblo, CO 81003**

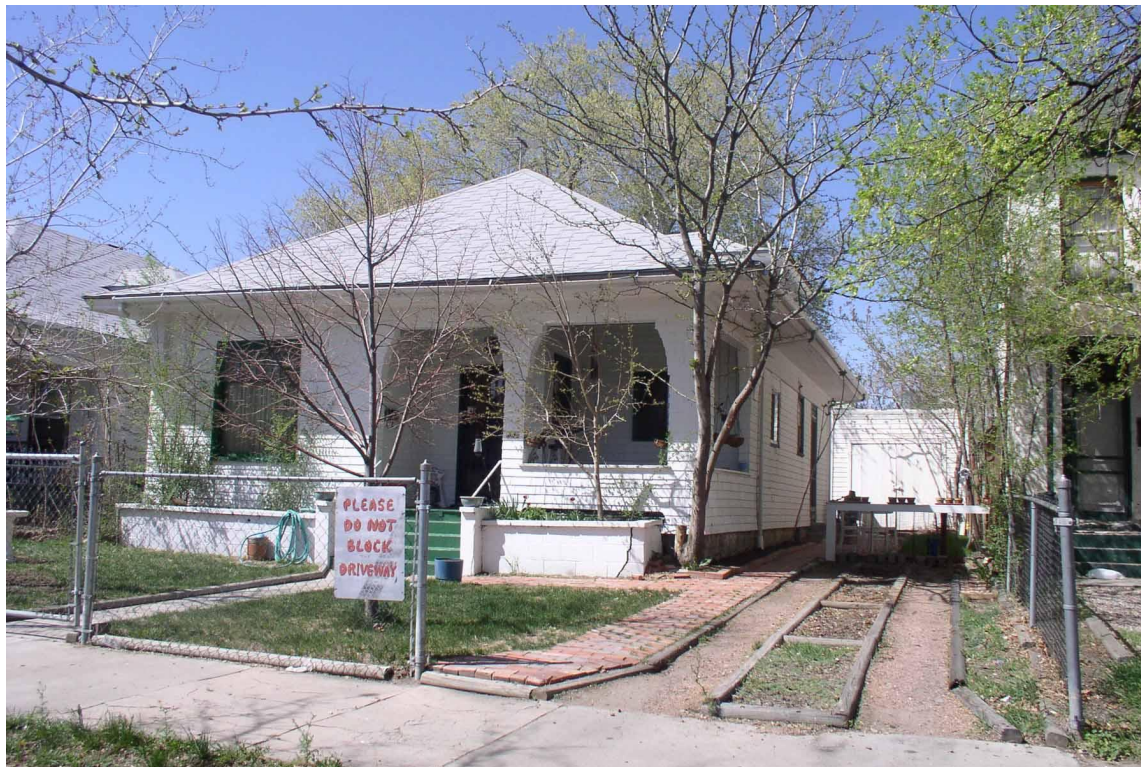
**Roof Treatment/Flared Eave**
21. General architectural description:  
**Oriented to the south, this house rests on a foundation of random-coursed, dressed sandstone ashlar. White-painted wood shingles clad the exterior walls. White-painted stucco covers a small, shed-roof addition across the rear (north) elevation of the house. All trim and window frames are wood and painted green. Most windows are 1-over-1-light, double-hung sash. A large window on the west end of the front (south) elevation features a narrow upper sash with diamond-shaped glazing. Similar upper sashes appear in a pair of window openings in the center of the west elevation. Between these windows is an awning window with the same glazing pattern. Windows in either face of the southeast corner are 1-beside-1-light, sliding-sash, with brown aluminum frames. Another 1-beside-1-light, sliding-sash window appears in the rear (north) elevation of the addition. An integral porch is located within the southeast corner. It features wide porch supports, curved outward at their tops, and a kneewall, all covered in white-painted wood shingles. Four, green-painted, concrete steps approach the porch on its western extreme, placing them just east of center on the asymmetrical facade. The steps align with the front doorway. This doorway hosts a 9-panel wood door, opening behind a black, aluminum-frame, security-type storm door. Another doorway opens on the rear (north) elevation of the addition. It is a 3-panel, 1-light, glass-in-wood-frame door, opening behind an aluminum-frame**

storm door. A two-step concrete stoop approaches the door. Gray, interlocking asphalt shingles cover the centrally hipped roof. The eaves are flared and boxed with white-painted wood fascia and beadboard soffit. Hipped-roof dormers emerge from the east and west slopes of the roof. Each dormer hosts a pair of square, hopper windows, with diamond-shaped glazing. A tall, brick chimney protrudes from the north end of the west-facing slope.

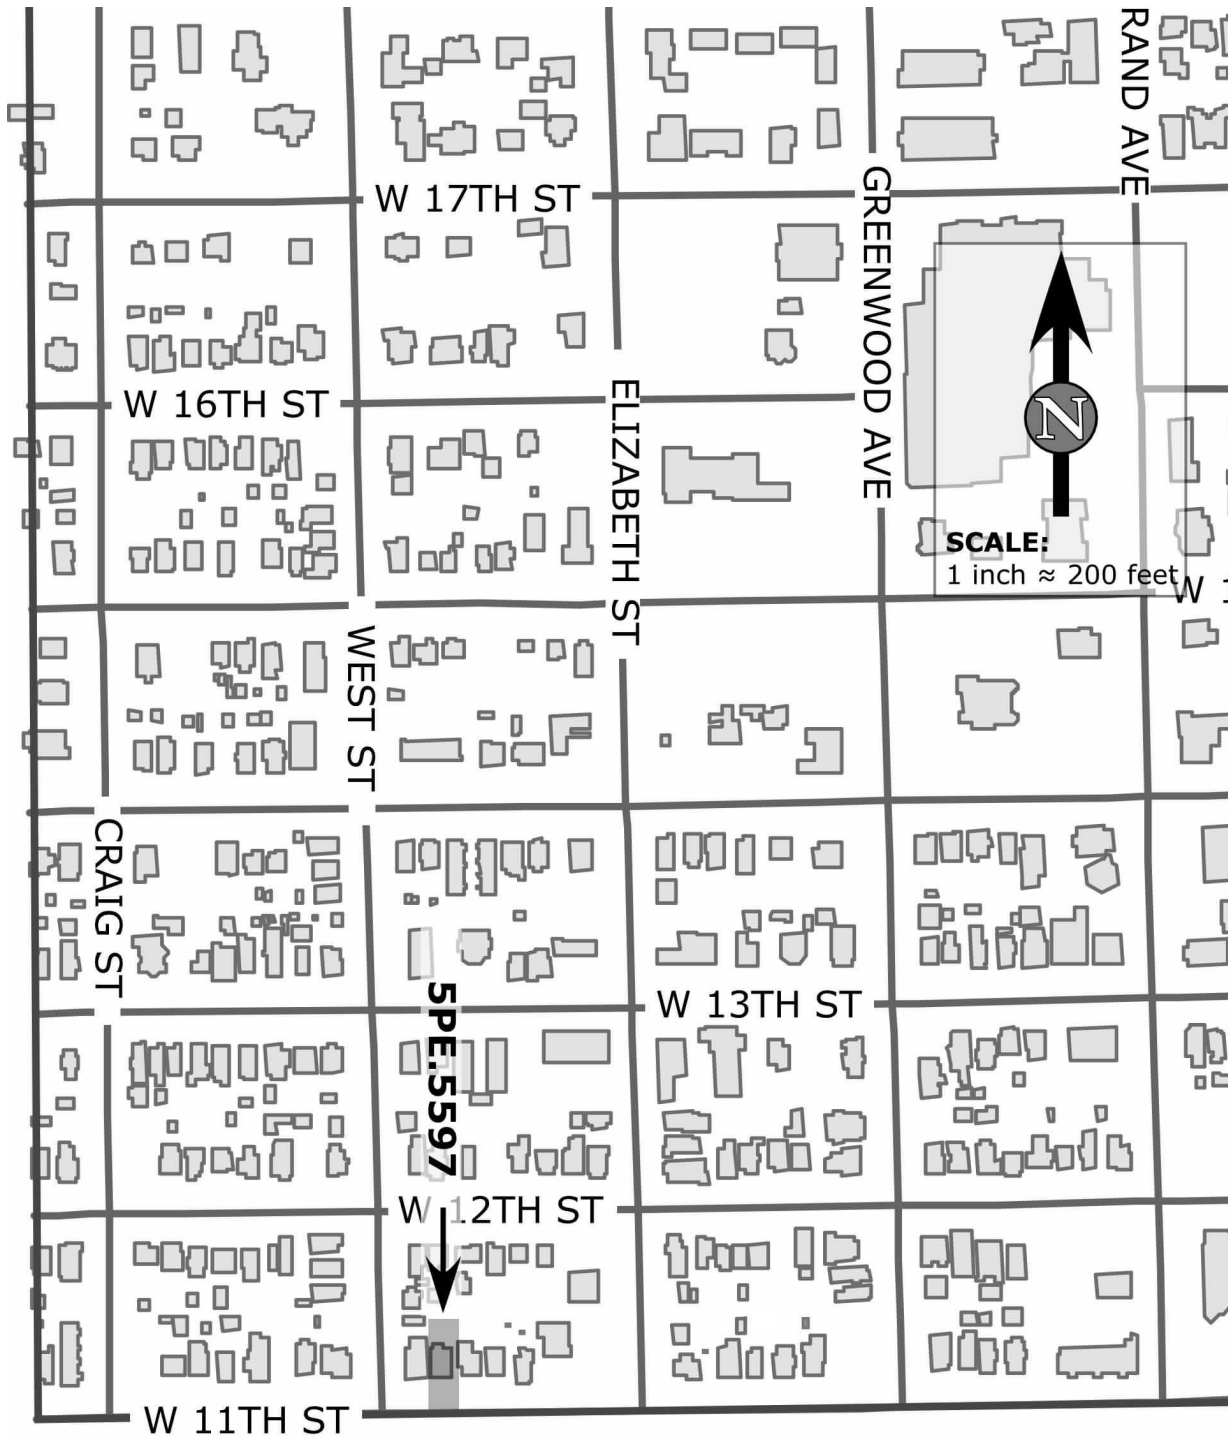
#### SITE SKETCH MAP

**This property is located on terrain sloping downward from north to south, with an elevation of around 4,700 feet above mean sea level. The neighborhood features modest, one- and two-story houses. A grass strip separates the sidewalk from the street. This property is located on the north side of West 11th Street, an east-west-oriented thoroughfare. It is situated between 615 West 11th Street, to the east, and 619 West 11th Street, to the west. A planted grass yard surrounds the house. A chain-link fence surrounds the property. A packed-earth driveway runs along the east side of the house; it originally connected West 11th Street to the garage northeast of the house, but has now been truncated by a fence. Concrete-block planters line either side of the front steps, and a brick patio is located behind the garage.**
