COLORADO CULTURAL RESOURCE SURVEY

Architectural Inventory Form

- 1. Resource number: **5PE.517.15** Parcel number(s):
- 2. Temporary resource number: **014** **525422005**
- 3. County: **Pueblo**
- 4. City: **Pueblo**
- 5. Historic building name: **Lewis, Thomas L., House**
- 6. Current building name: **701 West 11th Street**
- 7. Building address: **701 W 11th Street**
- 8. Owner name: **Eleventh Street Properties, LLC**
- Owner organization:
- Owner address: **421 W 11th St**  
**Pueblo, CO 81003**

48. Report title: Pueblo North Side Neighborhood Survey

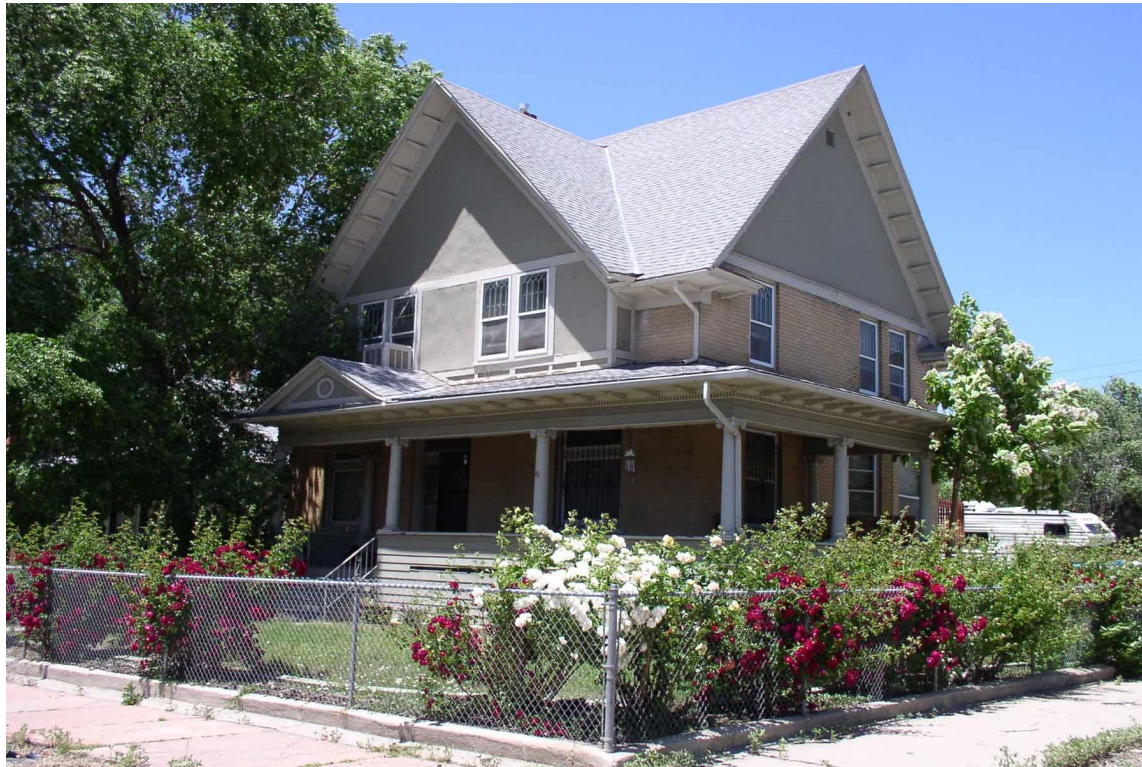
**Oriented to the south, this house rests on a random-coursed, pink sandstone ashlar foundation, with single-light and 3-light hopper basement windows. A buff-color, sandstone watertable separates the foundation from the walls above it. A tan-colored brick veneer clads most of the exterior walls. Gray-painted stucco covers the faces of the pedimented gables. Horizontal, wooden-composition siding clads the front (south) porch kneewalls and a 2-story addition to the west side of the rear (north) elevation. Windows are generally 1-over-1-light, double-hung sash, with white-painted wood frames and white, aluminum-frame storm windows. Windows opening within the brick-clad portions of the house feature buff-colored, rough-faced sandstone sills. A large, fixed-frame window, opening to the east of the front (south) door, has a transom with diamond-shaped, leaded glass. A narrower but similar window opens to the west of the front door. Above these windows, on the front (south) façade's second story are two sets of paired, 1-over-1-light, double-hung sash windows. These windows and those in the second story of the east elevation feature diamond-shaped glazing in the upper sash. A pair of 1-beside-1-light, sliding sash windows, with white, aluminum frames, pierce the second story of the rear (north) addition. A single-story, canted bay protrudes from the north end of the east elevation. The bay features a crenellated parapet. A large, hipped-roof porch spans most of the front (south) façade and wraps around the southeast corner. The porch features gray-painted columns with ionic capitals. These columns rest on the kneewall. The porch is accessed via 5 wood steps at its westernmost end. Above the steps, a pediment emerges from the porch roof, hosting the house number in an oval border. The porch roof features a dentiled cornice with**

modillions lining the soffit. The front door, which opens west of center in the front (south) façade, is an oak door with an oval-shaped light. It opens behind a black, metal, security storm door. A single-light sidelight is west of the door; and a transom, with diamond-shaped, leaded glass, is above both the door and transom. A concrete ramp, with a pipe railing, approaches the front porch from the north. A red-painted wood deck protrudes from the rear (north) addition's north elevation. The deck provides access to a two-light, wood slab door. A wood staircase rises across the rear (north) elevation and provides direct access to the second story, via a doorway on the rear addition's east elevation. Gray, asphalt shingles cover the cross-gabled roof. Cream-painted beadboard soffit, with evenly spaced modillions, boxes the eaves. A gabled dormer protrudes from the west end of the roof's north slope, above the rear addition, which has a shed roof. A tan brick chimney emerges from the east-west roof ridge, west of center.

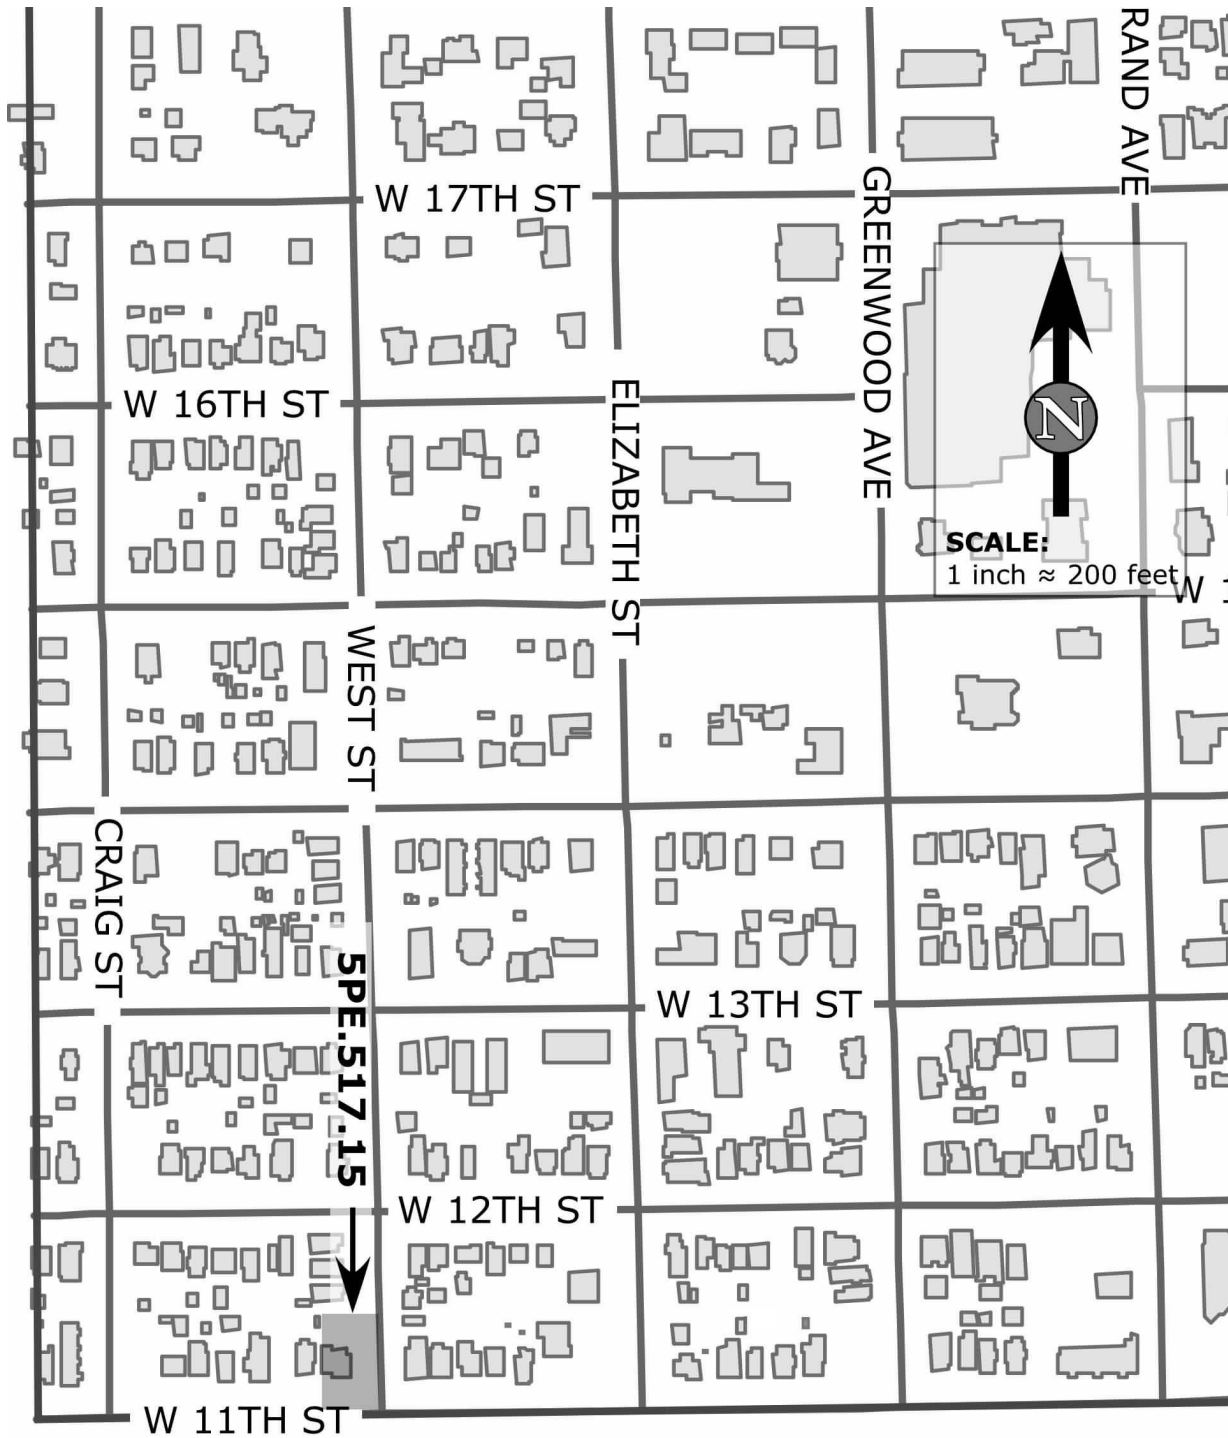
#### SITE SKETCH MAP

This property is located on terrain sloping downward from north to south, with an elevation of around 4,700 feet above mean sea level. The neighborhood features modest, one- and two-story houses. A gravel-covered strip separates the pink sandstone sidewalk from the street. The house is situated on the northwest corner of West 11th and West streets. A planted grass yard surrounds the house. A chain-link fence delimits the east and south sides of the property; a wood fence lines the north side. A gravel parking area is located behind (north and east) of the house.
