COLORADO CULTURAL RESOURCE SURVEY

Architectural Inventory Form

- 1. Resource number: **5PE.5600**
- 2. Temporary resource number: **018**
- 3. County: **Pueblo**
- 4. City: **Pueblo**
- 5. Historic building name: **Haskell, J.W., House**
- 6. Current building name: **718 West Eleventh Street**
- 7. Building address: **719 W 11th Street**
- 8. Owner name: **Russell H. Longgear, III**
- Owner organization:
- Owner address: **29376 Hardin Pl
Pueblo, CO 81006**

47. Photograph numbers): **CD-ROM Photo Disc: North Side Photos**
File Name(s): 11thstw719
- Negatives filed at: **Special Collections**
Robert Hoag Rawlings Public Library
100 East Abriendo Avenue
Pueblo, CO 81004-4290
48. Report title: **Pueblo North Side Neighborhood Survey**
49. Date(s): **06/08/05**
50. Recorder(s): **Adam Thomas**
51. Organization: **Historitecture, L.L.C.**
52. Address: **PO Box 419**
Estes Park, CO 80517-0419
53. Phone number(s): **(970) 586-1165**

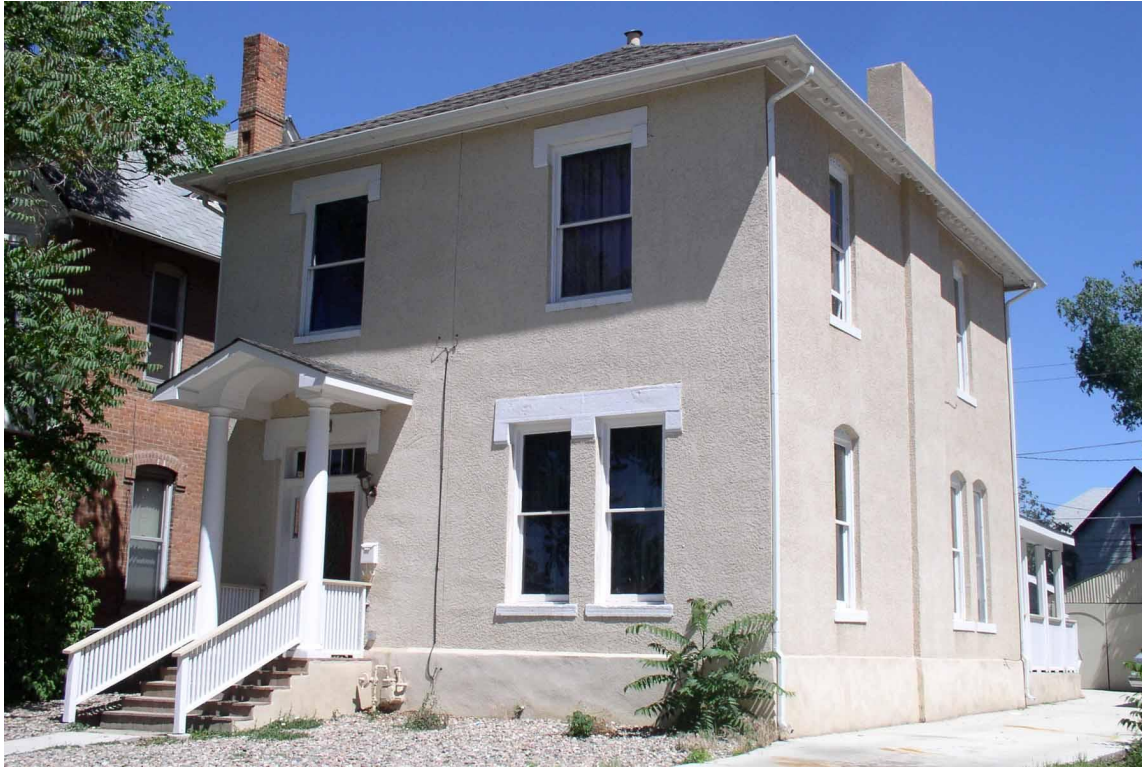
19. Primary external roof material: **Asphalt Roof/Composition Roof**
 Other roof materials:
20. Special features: **Chimney**
Porch
Window/Segmental Arch
21. General architectural description:
Oriented to the south, this house rests on a tan-tinted, stucco-covered foundation. Tan-painted stucco also covers all roof surfaces. Windows are 1-over-1-light, double-hung sash, with white-painted wood frames. Windows piercing the front (south) façade feature sandstone sills and lintels, painted white. Those in other elevations open beneath segmental arches. The area between the top sash and the arch hosts a symmetrical, carved decorative element. A 1-beside-1-light, sliding-sash window pierces the gable of a single-story structure attached to the rear (north) elevation. A small portico is located on the west side of the asymmetrical front (south) façade. It rests on a pair of white-painted, wood, Tuscan columns. A 5-step brick stoop approaches the portico. Flanking the stoop is a pair of white-painted, wood balustrades, with simple, square balusters. The principal (south) doorway opens beneath the portico. It hosts an elaborate oak door, with a single, oval-shaped light of leaded glass. Single-light sidelights flank the door, and a 7-light transom spans the door and sidelights. A French door provides access to a shed-roof porch extending across the inside (northeast-facing) corner of the building. This porch features a simple, white-painted wood balustrade and is approached from the north. Gray asphalt shingles cover the main, centrally hipped roof and all other roof surfaces. Evenly spaced, shaped wood modillions appear beneath the eaves. An engaged chimney protrudes from the center of the east elevation and another chimney emerges from the west side of the single-story structure on the rear of the building.

While Pueblo County tax records indicate a 1900 date of construction for this house, it appears in city directories and Sanborn insurance maps prior to that time. The most notable alteration has been the application of stucco over the original brick walls. The house underwent a remodeling within the last 2 years, during which the porches were rebuilt and the entire house was repainted.

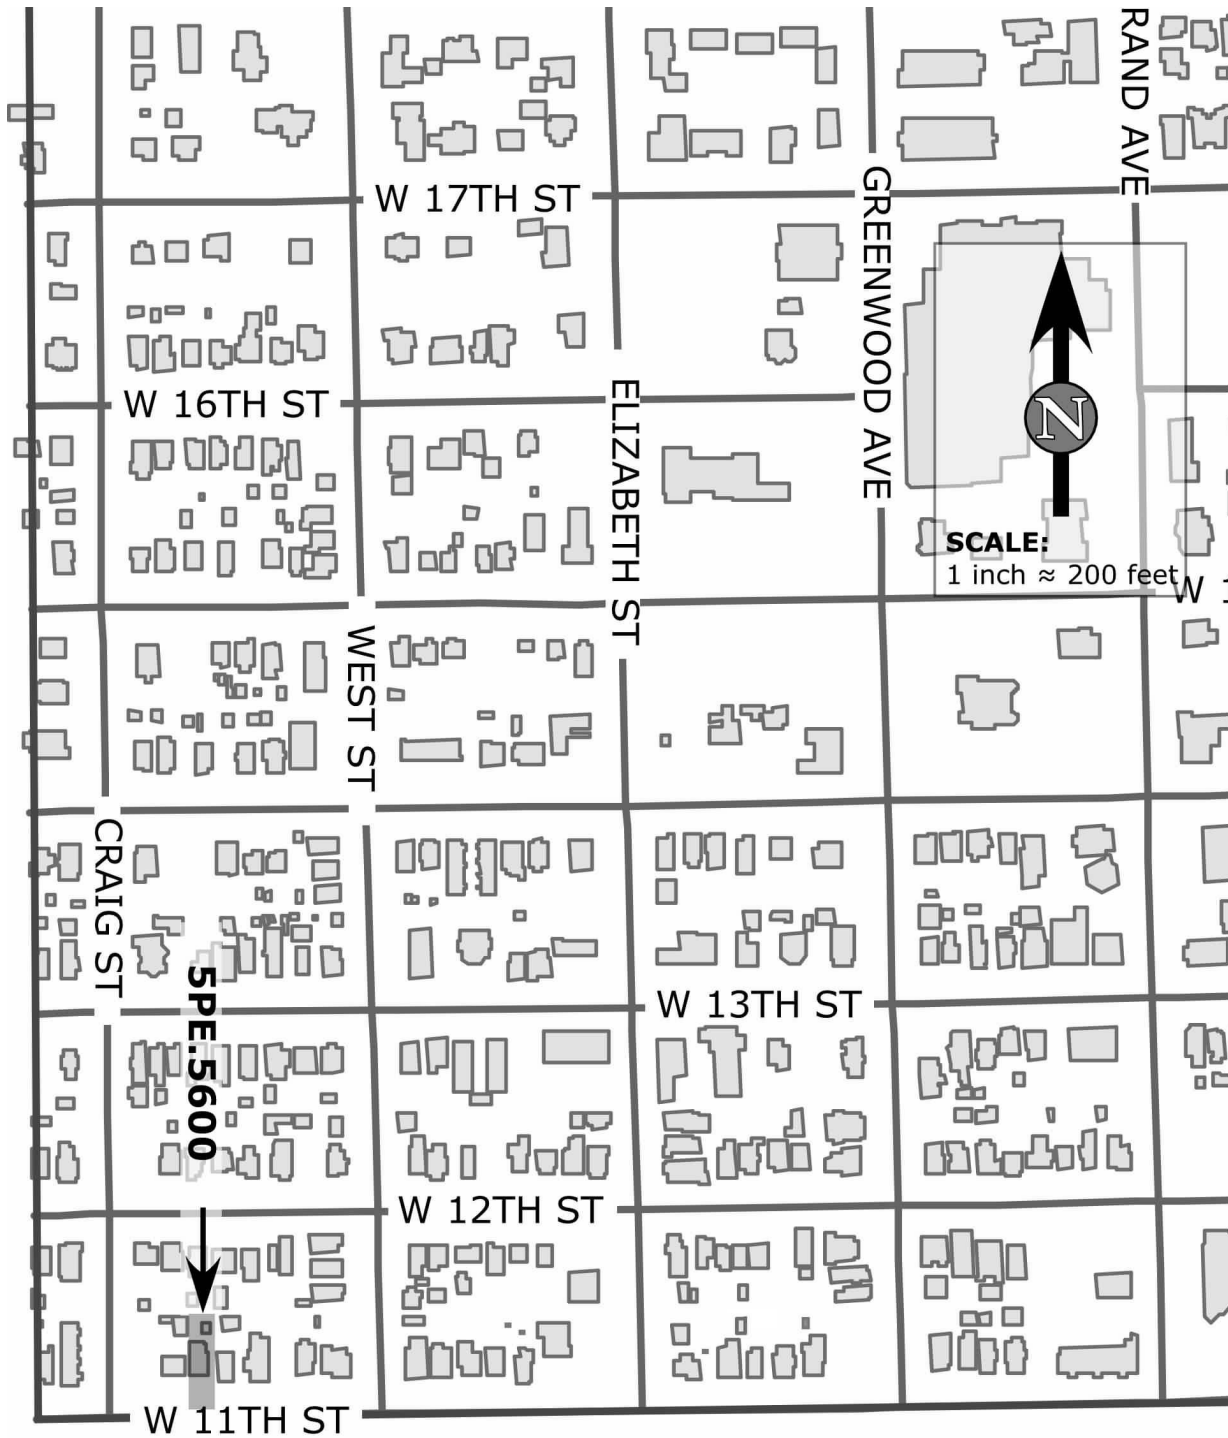
SITE SKETCH MAP

This property is located on terrain sloping downward from north to south, with an elevation of around 4,700 feet above mean sea level. The neighborhood features modest, one- and two-story houses. A gravel-covered strip separates the sidewalk from the street. This property is located on the north side of West 11th Street, an east-west-oriented thoroughfare. It is situated between 715 West 11th Street, to the east, and 721 West 11th Street, to the west. Gravel covers the front yard while the back yard is packed earth. A woven-wire fence delimits the north edge of the property, while a chain-link fence lines the east and west sides. A concrete driveway runs along the east side of the building, connecting West 11th Street to a garage northeast of the house. Behind the garage is an incinerator constructed of bricks.

Describe: **A 2-car garage is located northeast of the house. A concrete drive along the east side of the house approaches the garage from West 11th Street. Oriented to the south, the garage rests on a concrete slab. Tan-painted sheets of corrugated metal clad all of the exterior walls except for the rear (north) elevation, which has white-painted asbestos shingle siding. Two sets of paired, flakeboard doors, opening on metal strap hinges, dominate the front (south) elevation. A door constructed of vertical wood planks opens in the north end of the west elevation. Sheets of corrugated metal cover the front-gabled roof.**
