COLORADO CULTURAL RESOURCE SURVEY

Architectural Inventory Form

- 1. Resource number: **5PE.5601**
- 2. Temporary resource number: **023**
- 3. County: **Pueblo**
- 4. City: **Pueblo**
- 5. Historic building name: **Glenn, Edmund C., House**
- 6. Current building name: **Sutherland, Kyle A., House**
- 7. Building address: **409 W 12th Street**
- 8. Owner name: **Kyle A. Sutherland**
- Owner organization:
- Owner address: **409 W 12th St**
Pueblo, CO 81003

48. Report title: **Pueblo North Side Neighborhood Survey**

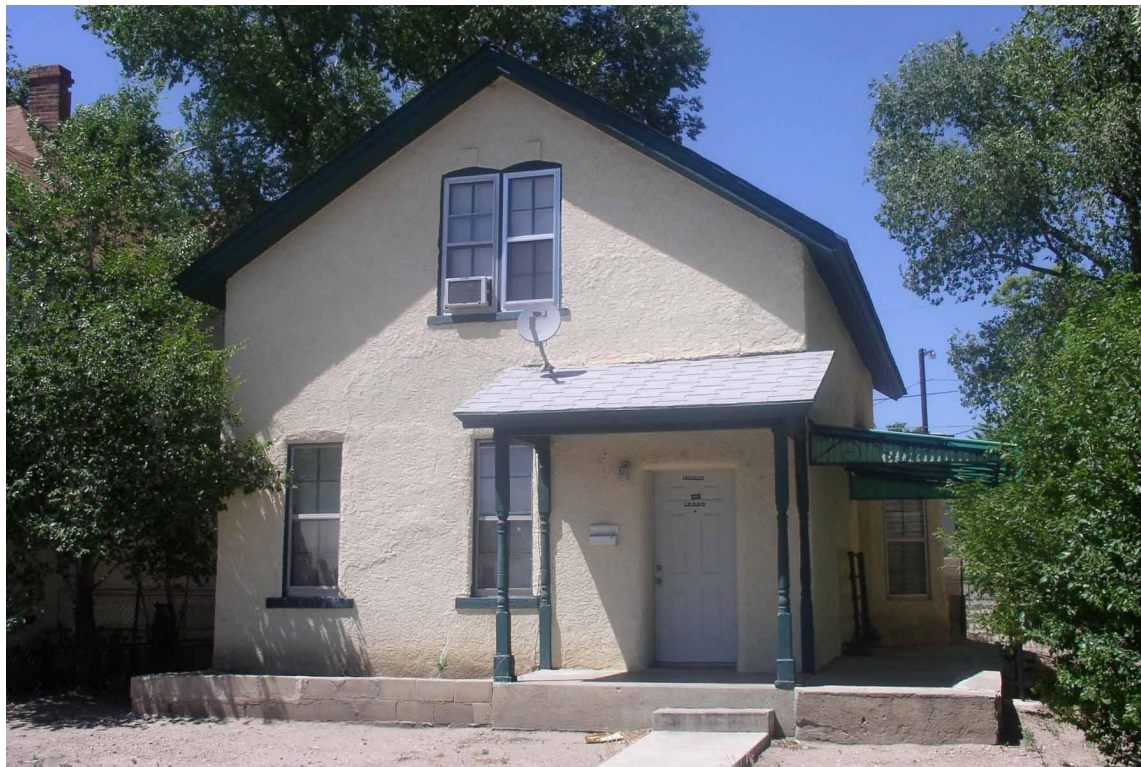
19. Primary external roof material: **Asphalt Roof/Composition Roof**
Other roof materials:
20. Special features: **Chimney**
Porch
Window/Segmental Arch
21. General architectural description:
Oriented to the south, this house rests on a tan-tinted stucco-covered foundation. Tan-tinted stucco also clads the exterior walls. Windows are 4-over-4-light, double-hung sash, with green-painted wood frames and aluminum-frame storm windows. They open between protruding, stucco-covered sills and segmental arches. The rear (north) elevation has 1-over-1-light, double-hung sash windows, with white, vinyl frames. The paired windows in the front- (south-) facing gable have protruding keystones. A single-story, canted bay protrudes from the north end of the east elevation. It features elaborate, scrolled brackets beneath its eaves. A small, shed-roofed porch is attached to the east end of the front (south) elevation. It has a concrete floor and green-painted, turned porch supports. The porch provides access to the principal (south) doorway, which hosts a 4-panel, white, metal door. The edges of the doorway are rounded. A white, metal slab door also opens on the west end of the rear (north) elevation. Attached to the eastern two-thirds of this same elevation is a deck constructed of pressure-treated lumber. A shed-roofed structure, consisting of wrought-iron supports and sheets of green, translucent fiberglass, covers a concrete patio on the south end of the east elevation. Gray, interlocking asphalt shingles cover the front-gabled roof, and the eaves are boxed with green-painted wood fascia and soffit. Stucco-covered chimneys protrude from the roof ridge, at the center and at the north end of the house.
