COLORADO CULTURAL RESOURCE SURVEY

Architectural Inventory Form

- 1. Resource number: **5PE.5603** Parcel number(s):
- 2. Temporary resource number: **025** **525418010**
- 3. County: **Pueblo**
- 4. City: **Pueblo**
- 5. Historic building name: **Duke, F.G. and J.W., House**
- 6. Current building name: **Friendly Harbor Drop In Center**
- 7. Building address: **417 W 12th Street**
- 8. Owner name: **Elizabeth A. Smith**
- Owner organization:
- Owner address: **440 Birdie Dr**
Pueblo West, CO 81007

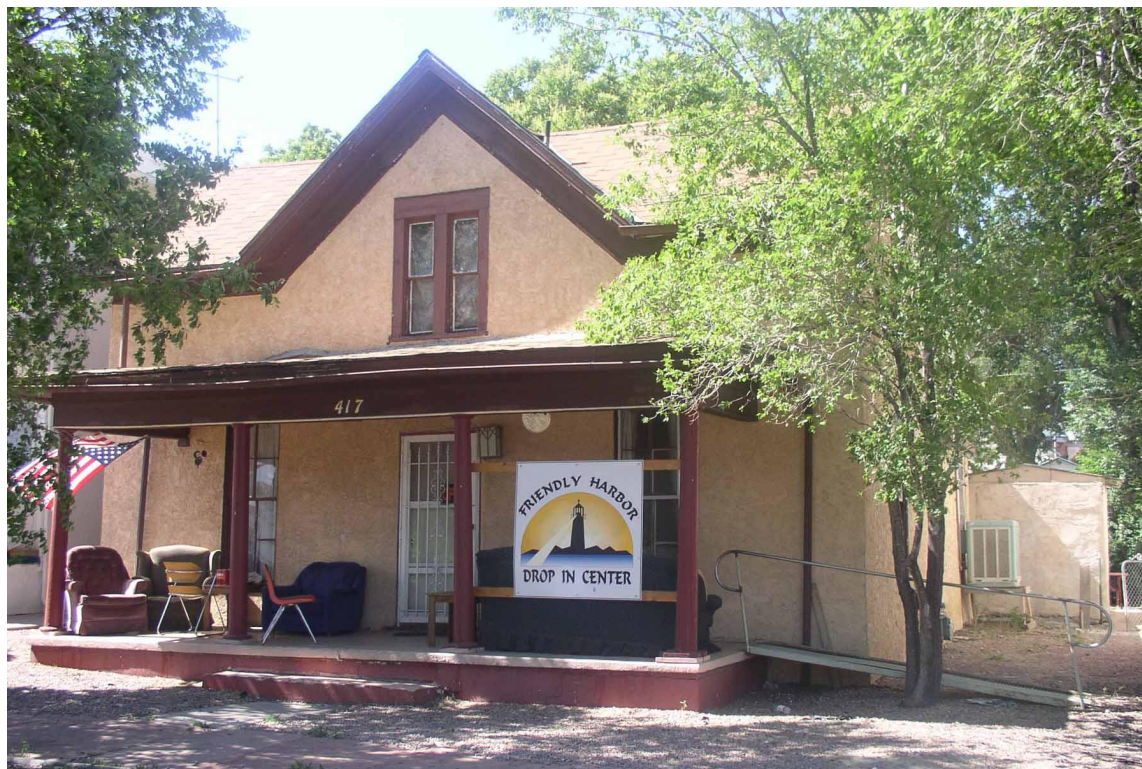
19. Primary external roof material: **Asphalt Roof/Composition Roof**
Other roof materials:
20. Special features: **Fence**
Porch
21. General architectural description:
Oriented to the south, this house rests on a low, sandstone rubble foundation, almost entirely concealed behind tan-tinted stucco. Tan-tinted stucco also clads the exterior walls. Windows are generally 4-over-4-light, double-hung sash, with brown-painted wood frames and aluminum-frame storm windows. Small, hipped-roof hoods, on scrolled brackets, appear above the windows on the first story of the front (south) façade. Paired, 1-over-1-light, double-hung sash windows, with brown-painted wood frames, pierce the front- (south-) facing gable. A hipped-roof porch spans nearly all of the front (south) façade. It features a concrete floor and round, red-painted, wood Tuscan columns. A single concrete step provides access to the porch at its center. Opening in the center of the symmetrical façade is the principal doorway. It hosts a white slab door, opening behind a white, security storm door. A small, shed-roofed porch protrudes from a single-story structure at the rear (north) of the house. This porch shelters a 6-panel, white, metal door, opening behind a white, aluminum-frame storm door. Brown, interlocking asphalt shingles cover all roof surfaces, and the eaves are boxed, with brown-painted wood fascia and soffit.

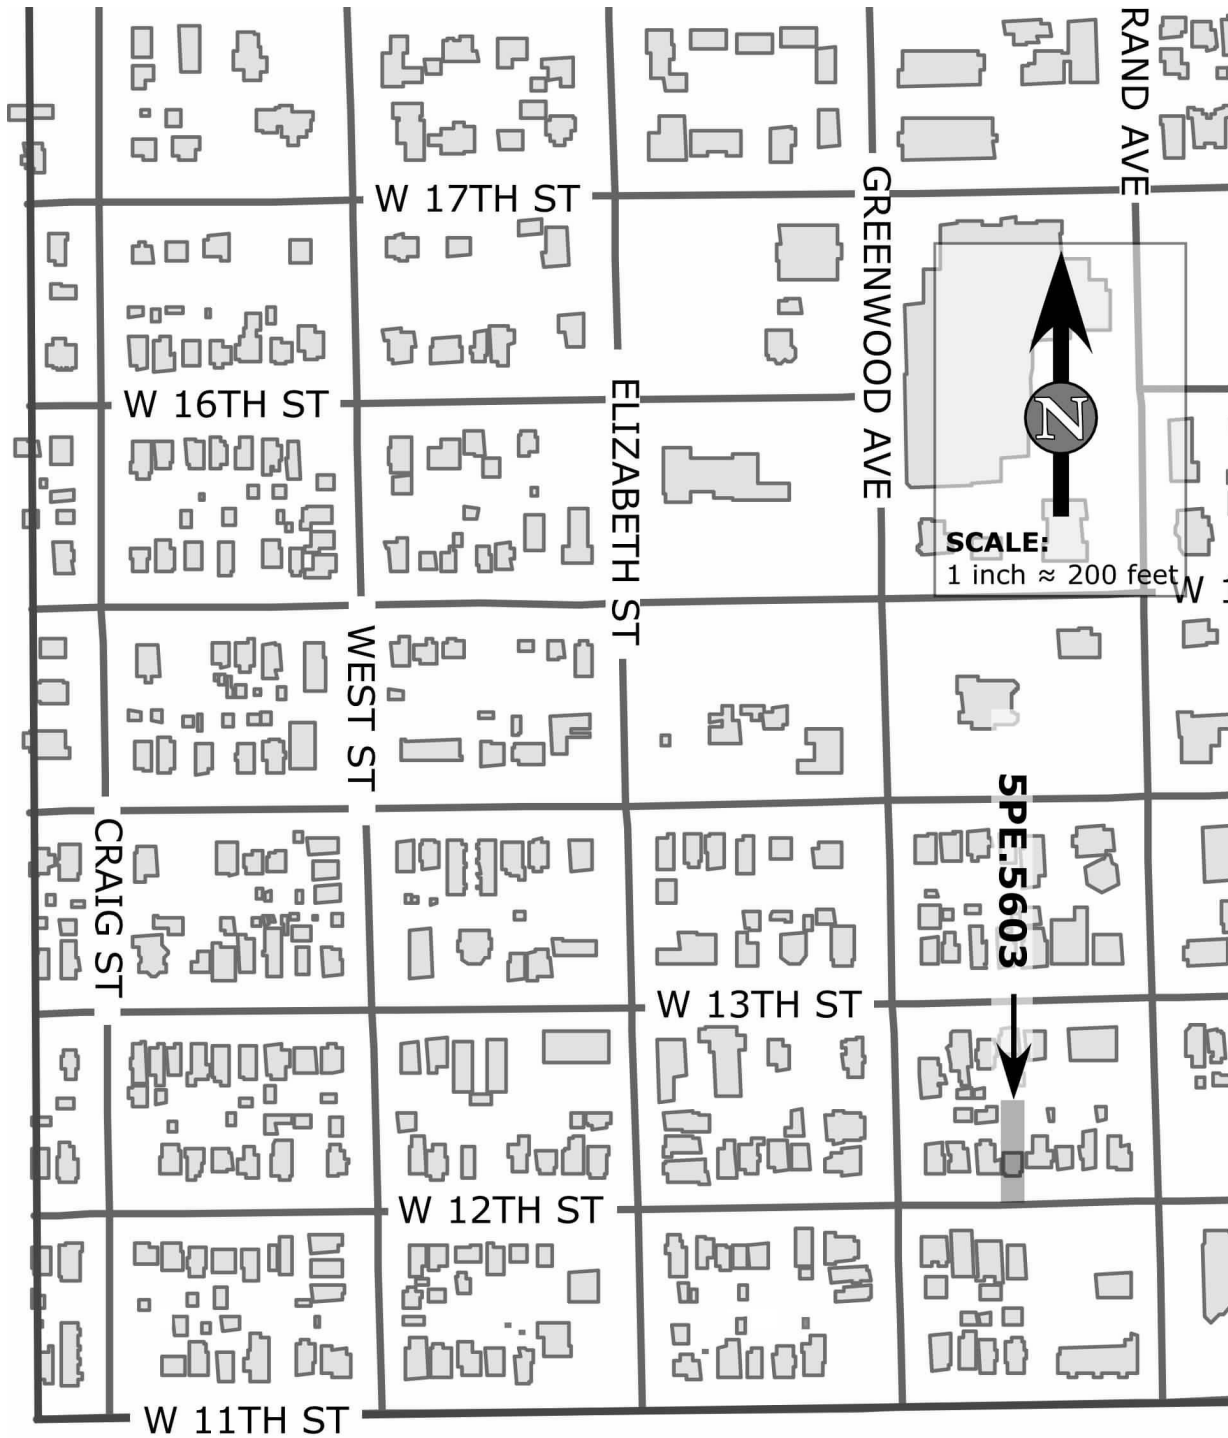
SITE SKETCH MAP

This property is located on terrain sloping downward from north to south, with an elevation of around 4,700 feet above mean sea level. The neighborhood features modest, one- and two-story houses. This property is located on the north side of West 12th Street, an east-west-oriented thoroughfare. It is situated between 411-415 West 12th Street, to the east, and 419-421 West 12th Street, to the west. A gravel-covered strip separates the sidewalk from the street. Pink-colored sandstone slabs comprise the sidewalk. Gravel covers the front yard, while the backyard consists of packed-earth and patches of grass. A wood fence divides the backyard in half, east-west.

- 1 : Type: **Shed**
Describe: **A small shed it located directly northeast of the house. Oriented to the north, the building appears to lack a formal foundation It is most likely constructed of adobe bricks, with corner buttresses, clad in a tan-colored stucco. A plywood door, on metal strap hinges, dominated the front (north) elevation. Sheets of corrugated metal cover the front-gabled roof.**
