COLORADO CULTURAL RESOURCE SURVEY

Architectural Inventory Form

- 1. Resource number: **5PE.5604** Parcel number(s):
- 2. Temporary resource number: **026** **525425004**
- 3. County: **Pueblo**
- 4. City: **Pueblo**
- 5. Historic building name: **McCloskey, Lydia, House**
- 6. Current building name: **Visiting Angels In-Home Senior Care**
- 7. Building address: **418 W 12th Street**
- 8. Owner name: **Eagles Wings Group, LLC**
- Owner organization:
- Owner address: **418 W 12th St**
- Pueblo, CO 81003**

47. Photograph numbers): **CD-ROM Photo Disc: North Side Photos**  
**File Name(s): 12thstw418**
- Negatives filed at: **Special Collections**  
**Robert Hoag Rawlings Public Library**  
**100 East Abriendo Avenue**  
**Pueblo, CO 81004-4290**
48. Report title: **Pueblo North Side Neighborhood Survey**
49. Date(s): **06/13/2005**
50. Recorder(s): **Adam Thomas**
51. Organization: **Historitecture, L.L.C.**
52. Address: **PO Box 419**  
**Estes Park, CO 80517-0419**
53. Phone number(s): **(970) 586-1165**

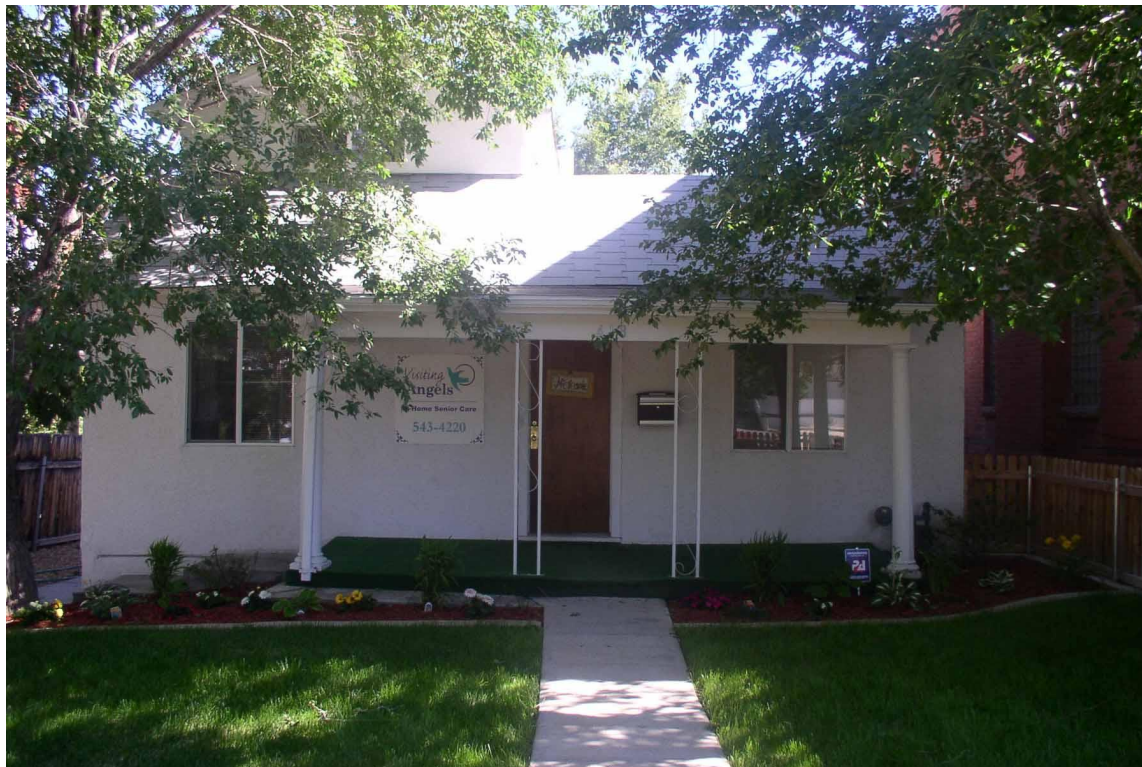
**Oriented to the north, this building rests on a concrete foundation, covered in white stucco. Piercing the foundation are 1-beside-1-light, sliding-sash windows, with aluminum frames. A small, shed-roofed structure near the southeast corner covers a basement stairwell. The structure hosts a white-painted, vertical-plank door. Windows are generally 1-beside-1-light, sliding-sash, with white vinyl frames and no surrounds. A tripartite window is located on the north end of the east elevation. Flanking the center, single-light, fixed-frame window are 1-over-1-light, double-hung sash windows, with white, vinyl frames. A shed-roof porch, offset west of center, protrudes from the front (north) facade. At its corners are white-painted, wood Tuscan columns. Between them are white, aluminum porch supports. The porch provides access to the principal doorway, which opens near the center of the façade. It hosts a wood slab door. Another identical slab door opens in the rear (south) elevation of a shed-roof structure protruding from the rest of the rear elevation. Approaching it is a 6-step concrete stoop, with black, wrought-iron railing. Gray interlocking asphalt shingles cover the main, side-gabled roof and all secondary roof surfaces. The eaves of most single-story roof surfaces are boxed, while shaped rafter ends are exposed beneath the roof over the two-story portion. A chimney, covered in white-painted stucco, is engaged to the south end of the 2-story portion's west elevation.**

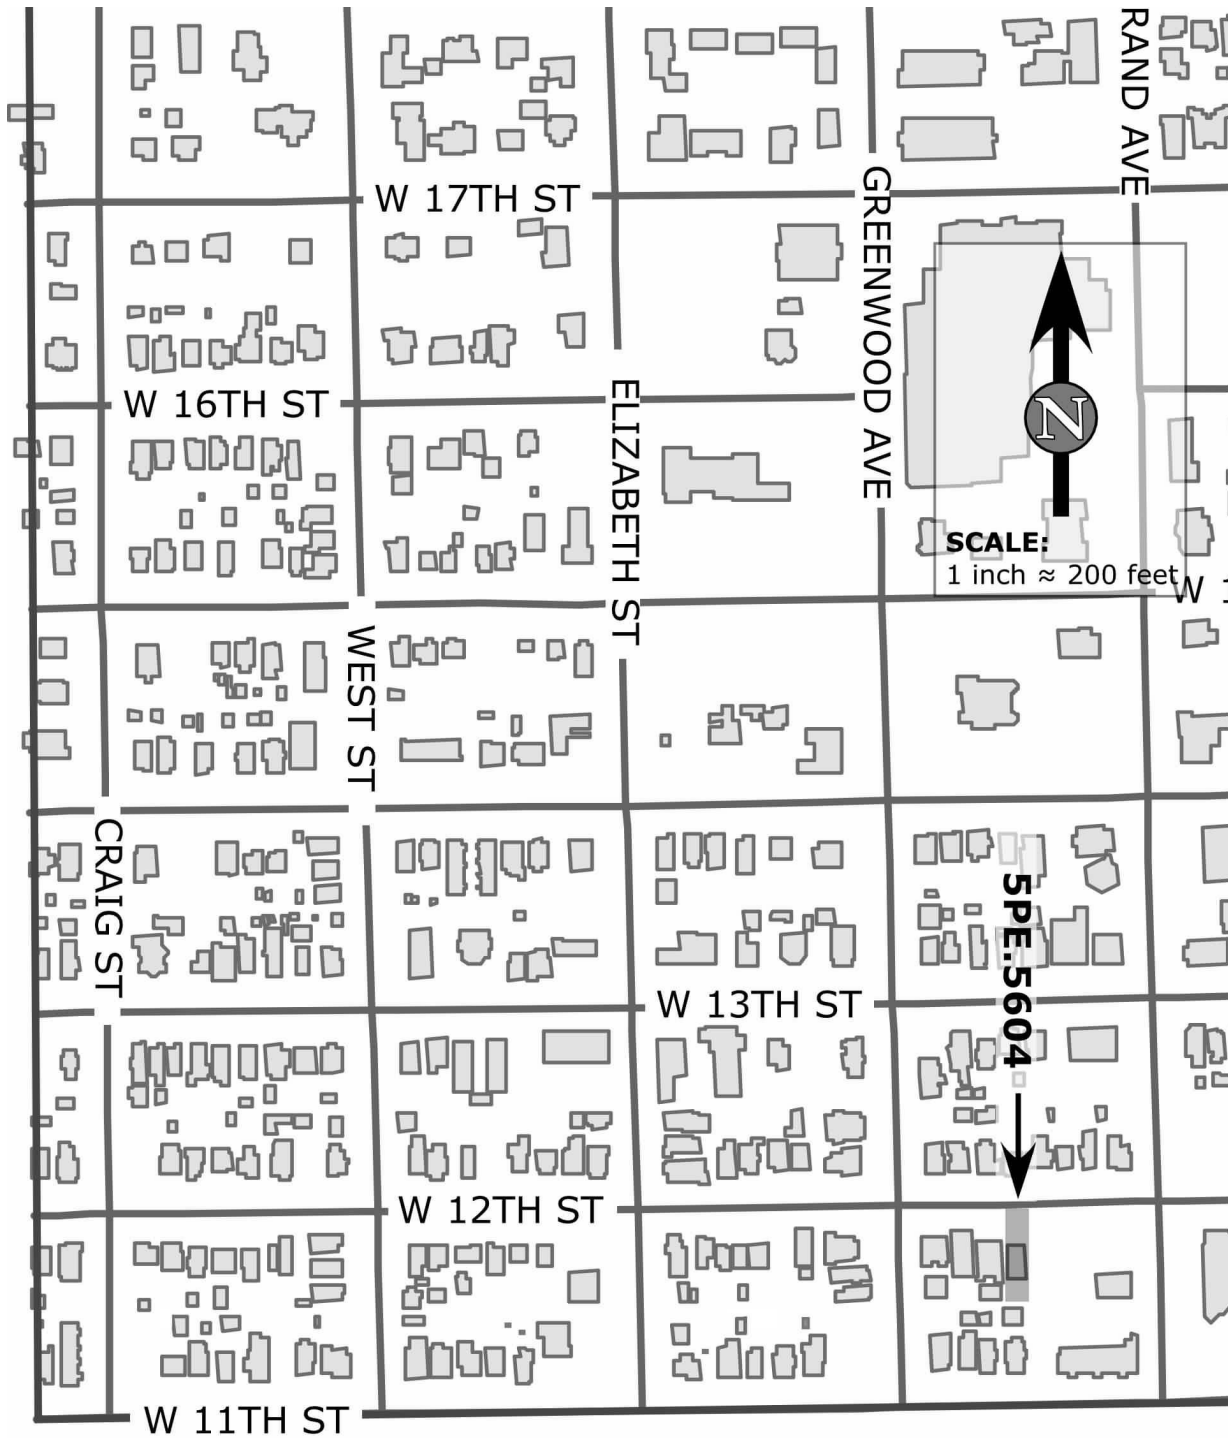
SITE SKETCH MAP

This property is located on terrain sloping downward from north to south, with an elevation of around 4,700 feet above mean sea level. The neighborhood features modest, one- and two-story houses. This property is located on the south side of West 12th Street, an east-west-oriented thoroughfare. It is situated between 402 West 12th Street, to the east, and 420-422 West 12th Street, to the west, and has an unusually deep setback from the street. A grass strip separates the sidewalk from the street. Surrounding the house is a planted grass yard. A wood picket fence delimits the north and west sides of the property. Behind (south of) the house is a gravel parking area.
