COLORADO CULTURAL RESOURCE SURVEY

Architectural Inventory Form

- 1. Resource number: **5PE.5605**
- 2. Temporary resource number: **027**
- 3. County: **Pueblo**
- 4. City: **Pueblo**
- 5. Historic building name: **Wells, R.H., House**
- 6. Current building name: **Gonzales, Lee, Apartments**
- 7. Building address: **419-421 W 12th Street**
- 8. Owner name: **Lee Gonzales Trust**
- Owner organization:
- Owner address: **PO Box 2242**
Pueblo, CO 81004

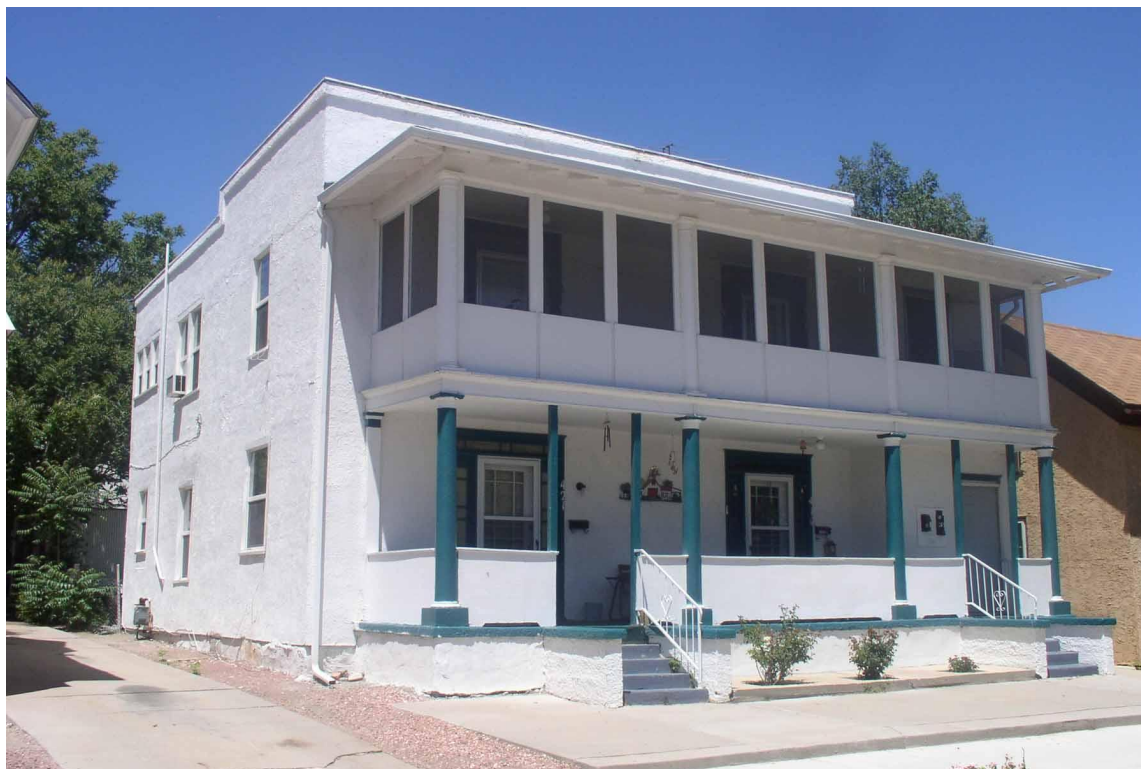
19. Primary external roof material: **Asphalt Roof/Composition Roof**
Other roof materials:
20. Special features: **Fence**
Chimney
Balcony
Porch
21. General architectural description:
Oriented to the south, this apartment building rests on a random-coursed sandstone foundation, covered in white-painted stucco. Rough-textured, white-painted stucco also clads the exterior walls. White-painted wood shingles cover a small, single-story, shed-roofed addition on the east elevation. Windows are 1-over-1-light, double-hung sash, with white-vinyl frames and surrounds. A two-story, hipped-roof porch spans the entire front (south) facade. The porch features wood Tuscan columns and white-painted, flakeboard kneewalls. Screens enclose the upper story. A pair of 4-step concrete stoops approach the porch from near its east and west sides. Two doorways, offset west of center on the nearly symmetrical facade, open beneath the porch. Both are identical and host 15-light, glass-in-wood-frame doors, painted white, opening behind white, aluminum-frame storm doors. Surrounding the doors are sidelights and a transom, with green-painted wood frames and surrounds. A gray, six-panel door on the east end of the porch provides access to an interior staircase. A two-story, shed-roof porch emerges from the center of the rear (north) elevation. Four doors, two on each floor, open from the porch. Both are white-painted, single-light, opening behind white, aluminum-frame storm doors. The doors in the second story provide access to a single, white-painted, wood staircase, descending to the north. Gray, rolled asphalt sheets cover the shed roof, which is surrounded by a parapet. The rafter ends of the front (south) porch roof are exposed, but capped by a fascia board. A white, stucco-clad chimney

protrudes from the northeast corner of the roof.
