COLORADO CULTURAL RESOURCE SURVEY

Architectural Inventory Form

- 1. Resource number: **5PE.5607** Parcel number(s):
- 2. Temporary resource number: **030** **525418008**
- 3. County: **Pueblo**
- 4. City: **Pueblo**
- 5. Historic building name: **Osgood, Daniel W., House**
- 6. Current building name: **Hoover, Ken and Mary Anne, Apartments**
- 7. Building address: **425 W 12th Street**
- 8. Owner name: **Ken and Mary Anne Hoover Trust**
- Owner organization:
- Owner address: **2110 Oakwood Ln**
Pueblo, CO 81005

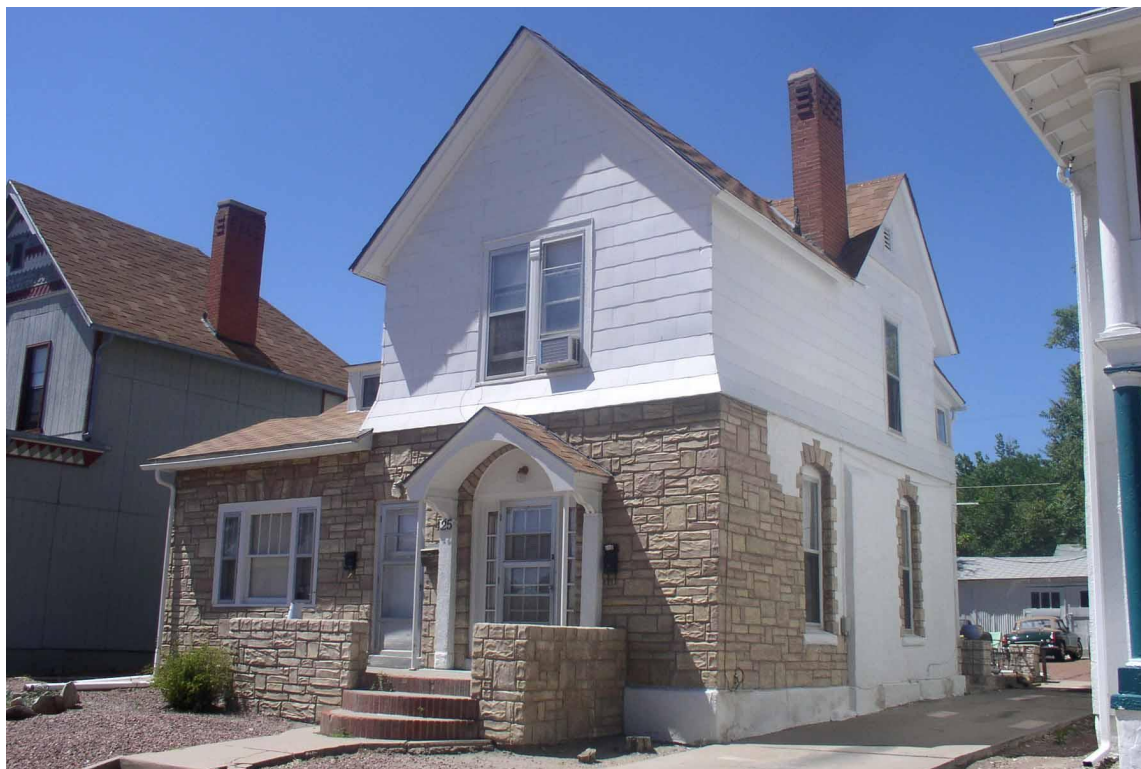
21. General architectural description:
Oriented to the south, this house rests on a foundation covered in a stone veneer. This same stone veneer covers all southern portions of the building and acts as a surround for windows opening in the first story. A white-painted stucco covers the remainder of first-story wall surfaces. White-painted asbestos shingle siding clads the exterior walls above the first story. Windows are generally 1-over-1-light, double-hung sash, with white-painted wood frames and aluminum-frame storm windows. Piercing the west side of the front (south) façade's first story is a tripartite window. The flanking windows are narrow, 2-(vertical)-over-1, while the center is 4-(vertical)-over-1. Above this window is a shed-roof dormer hosting a 1-beside-1-light, sliding-sash window, with wood frames. Windows in the first story of the east elevation open beneath segmental arches. Two doorways open in the east end of the asymmetrical facade. The eastern door opens beneath a wide, gabled hood, on scroll brackets. The doorway itself is located beneath a round arch. It hosts a 15-light, glass-in-wood-frame door, painted white. This door opens behind an aluminum-frame storm door. A pair of 5-light sidelights flanks this door. A small, uncovered porch, with a stone-veneered kneewall, provides access to this door and another doorway just west of it. This western doorway hosts a white-painted, 1-panel, 1-light, wood door, with a projecting, dented locking rail. It opens behind an aluminum-frame storm

door. A two-story, shed roof porch is attached to the east half of the rear (north) elevation. It protects, in the first story, a 15-light door, providing access to concrete patio extending north from the porch. This patio features a decorative, wrought-iron railing. A band of 1-beside-1-light, sliding-sash windows enclose the upper story of the porch. A doorway on the west side of the porch provides access to a white-painted wood staircase, descending to the north. Brown, interlocking asphalt shingles cover the main, cross-gabled roof and the cross-gabled roof of a single-story addition to the northwest corner. The eaves are boxed with white-painted wood fascia and soffit. A tall, red-brick chimney, with engaged hearth and elaborate corbelling, identical to 427 West 12th Street (5PE.5608), protrudes near the south end of the east elevation. Another tall, red brick chimney emerges from the west end of the roof's south-facing slope.

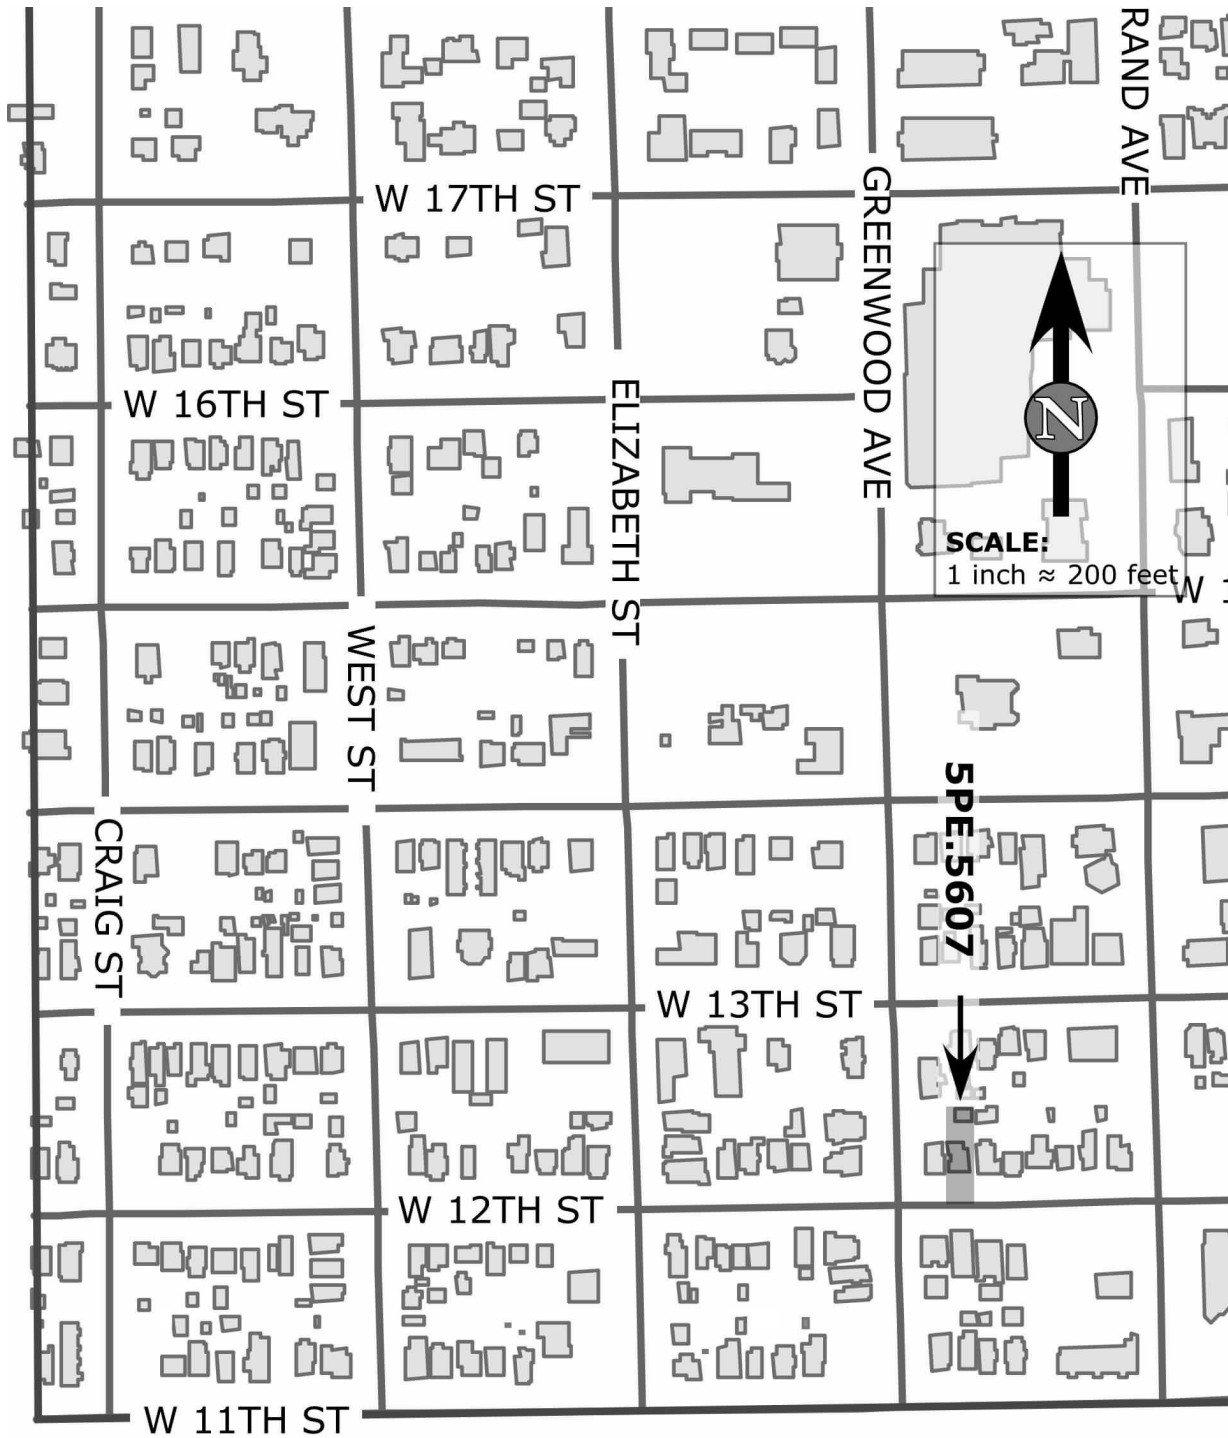
SITE SKETCH MAP

This property is located on terrain sloping downward from north to south, with an elevation of around 4,700 feet above mean sea level. The neighborhood features modest, one- and two-story houses. This property is located on the north side of West 12th Street, an east-west-oriented thoroughfare. It is situated between 419-421 West 12th Street, to the east, and 427 West 12th Street, to the west. A gravel-covered strip separates the sidewalk from the street. Gravel also covers much of the yard. The sidewalk consists of pink sandstone slabs. A woven-wire fence surrounds the backyard, with a white-painted plywood gate at its northwest corner.

Describe: **A 3-car garage is located north of the house. A concrete driveway running along the east side of the house approaches the garage from West 12th Street, providing access to two of the bays. The third bay is accessed via the alley behind (north of) the garage. Oriented to the south, the building appears to lack a formal foundation. Sheets of white-painted, corrugated metal clad the exterior walls. Offset to the east in the front (south) façade are 2 sets of paired, 3-light beadboard doors, opening on metal strap hinges. The west end of the same façade hosts a 4-panel wood door, painted gray. The west end of the rear (north) elevation hosts paired, white-painted beadboard doors, opening on metal strap hinges. Gray interlocking asphalt shingles cover the side-gabled roof, and the rafter ends are exposed.**
