COLORADO CULTURAL RESOURCE SURVEY

Architectural Inventory Form

- 1. Resource number: **5PE.5608**
- 2. Temporary resource number: **031**
- 3. County: **Pueblo**
- 4. City: **Pueblo**
- 5. Historic building name: **Burris, Samuel J. House**
- 6. Current building name: **427 West Twelfth Street**
- 7. Building address: **427 W 12th Street**
- 8. Owner name: **Neighborhood Services, Inc.**
- Owner organization:
- Owner address: **3937 Ivywood Ln  
Pueblo, CO 81005**

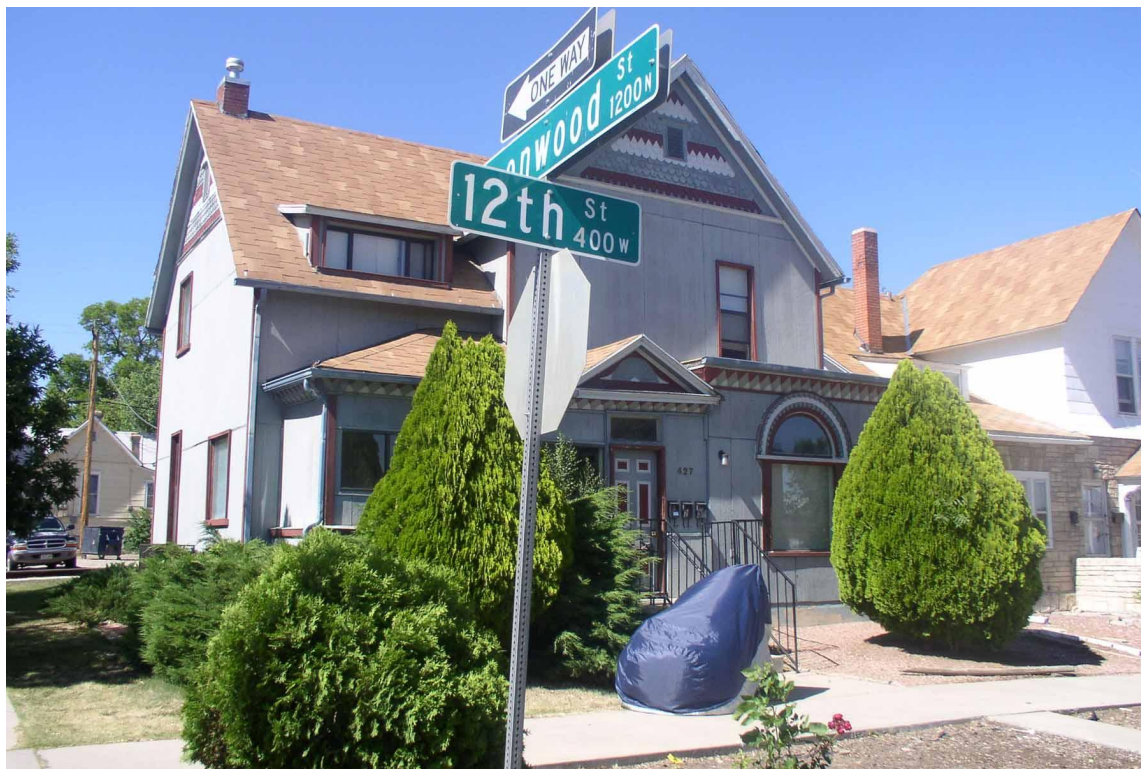
**Chimney**  
**Porch**
21. General architectural description:  
**Oriented to the south, this house rests on a random ashlar sandstone foundation, mostly covered in gray-painted stucco. A concrete stairwell, with a surrounding, wrought-iron railing, descends from the south to a doorway opening near the center of the basement's west elevation. Gray-painted sheets of particleboard, pressed into a vertical plank pattern and with red-painted cornerboards, clad the exterior walls. Red-, white-, and gray-painted, variegated wood shingles cover the gables. Diamond-shaped wood shingles clad the canted soffit across the single-story, enclosed porch protruding from the front (south) façade. Emerging from this soffit, corresponding to the original porch supports, are scrolled, wood brackets. Most windows are 1-over-1-light, double-hung sash, with brown aluminum frames and red-painted wood surrounds. Other windows are sliding sash or fixed frame. The principal doorway opens near the center of the asymmetrical front (south) facade. It hosts a 6-panel metal door, with transom. Approaching the doorway is a 4-step concrete stoop, with black, wrought-iron railing. The doorway provides access to a porch, enclosed with a band of sliding-sash windows. Above the doorway is a pediment with a decorative fan or sunrise pattern in its frieze. East of the door is a large picture window with round-arch transom. A projecting, dentiled cornice outlines the arch. Another doorway opens near the center of the rear (north) elevation's second story. It leads to a gray-painted, wood staircase, descending to the north. Brown, interlocking asphalt shingles cover the gable-on-hip roof, and gray-**

Painted wood soffit and white-painted wood fascia box the eaves. A tall, red-brick chimney, with elaborate corbelling identical to 425 12th Street (5PE.5607), protrudes near the eastern edge of the roof's east-facing slope. Another red-brick chimney emerges on the west end of the east-west roof ridge.

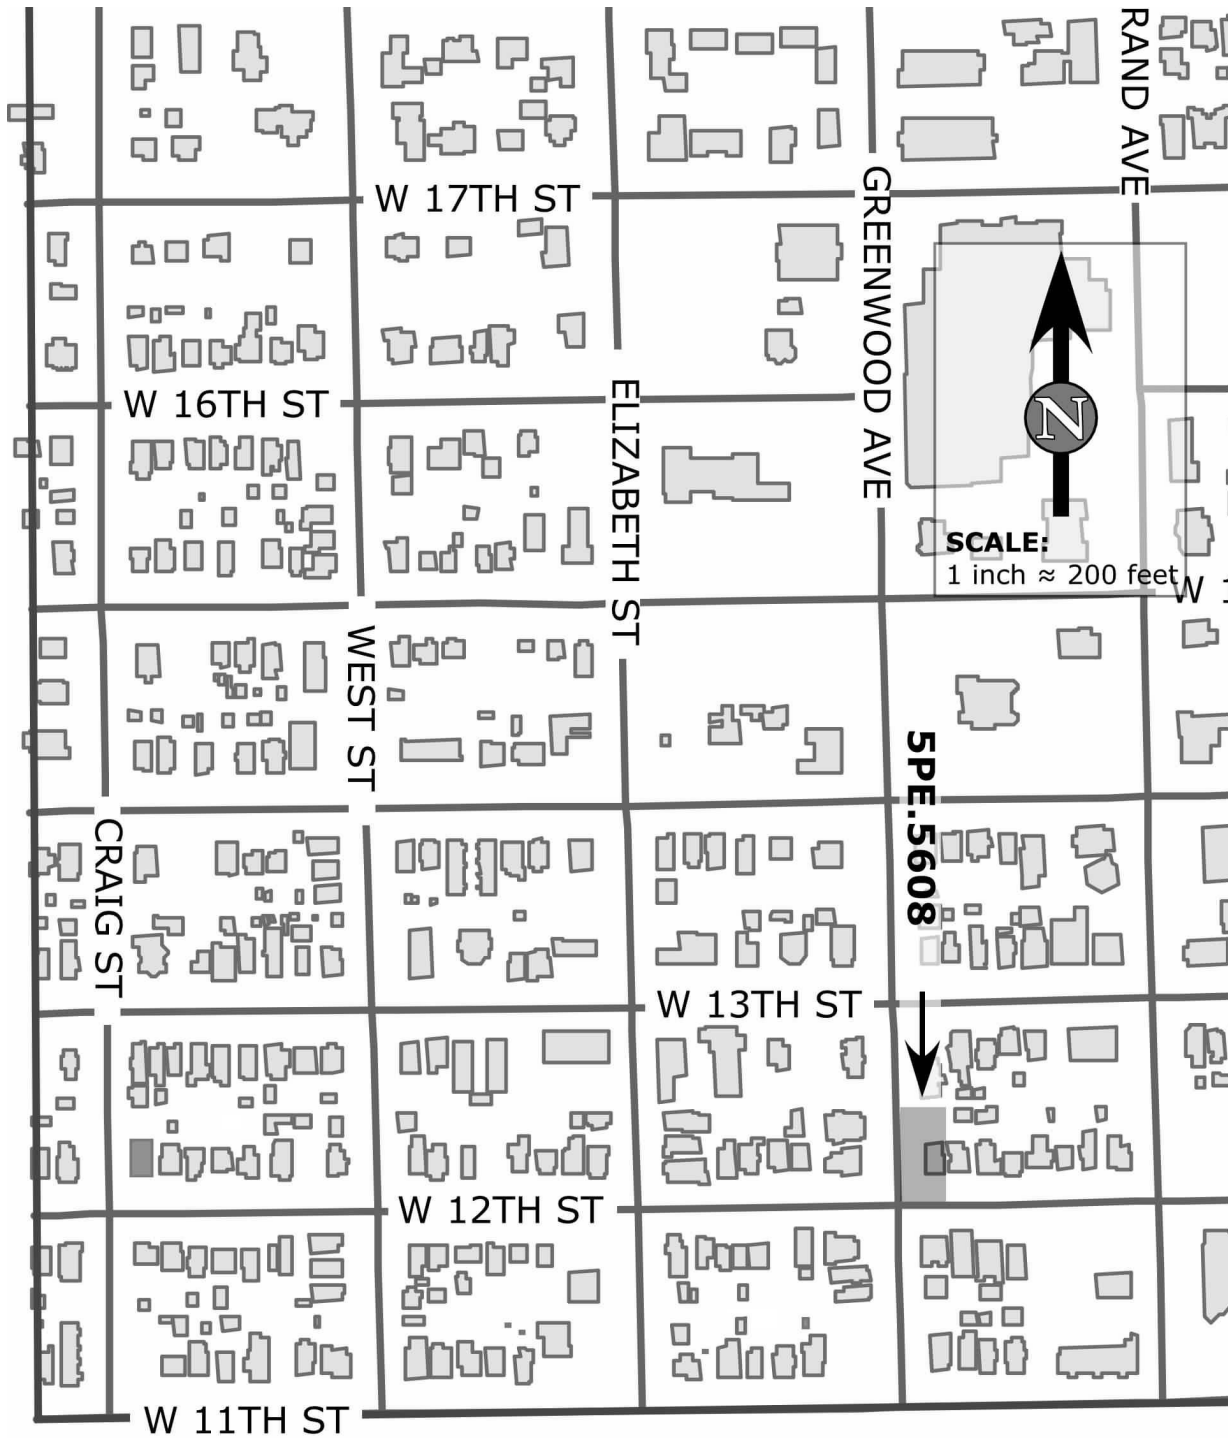
SITE SKETCH MAP

This property is located on terrain sloping downward from north to south, with an elevation of around 4,700 feet above mean sea level. The neighborhood features modest, one- and two-story houses. This property is located on the northeast corner of West 12th and North Greenwood streets. A mulch-covered strip, with mature landscaping, separates the sidewalk from the street. A planted-grass yard exists between the house and North Greenwood Street while a gravel parking lot dominates the backyard.
