COLORADO CULTURAL RESOURCE SURVEY

Architectural Inventory Form

- 1. Resource number: **5PE.517.22**
- 2. Temporary resource number: **034**
- 3. County: **Pueblo**
- 4. City: **Pueblo**
- 5. Historic building name: **Cazaly, George E., House**
- 6. Current building name: **511 West Twelfth Street**
- 7. Building address: **511 W 12th Street**
- 8. Owner name: **James F. and Susan Lusero**
- Owner organization:
- Owner address: **12 Barrington Ct**
Pueblo, CO 81005

47. Photograph numbers): **CD-ROM Photo Disc: North Side Photos
File Name(s): 12thstw511**
- Negatives filed at: **Special Collections
Robert Hoag Rawlings Public Library
100 East Abriendo Avenue
Pueblo, CO 81004-4290**
48. Report title: **Pueblo North Side Neighborhood Survey**
49. Date(s): **06/14/2005**
50. Recorder(s): **Adam Thomas**
51. Organization: **Historitecture, L.L.C.**
52. Address: **PO Box 419
Estes Park, CO 80517-0419**
53. Phone number(s): **(970) 586-1165**

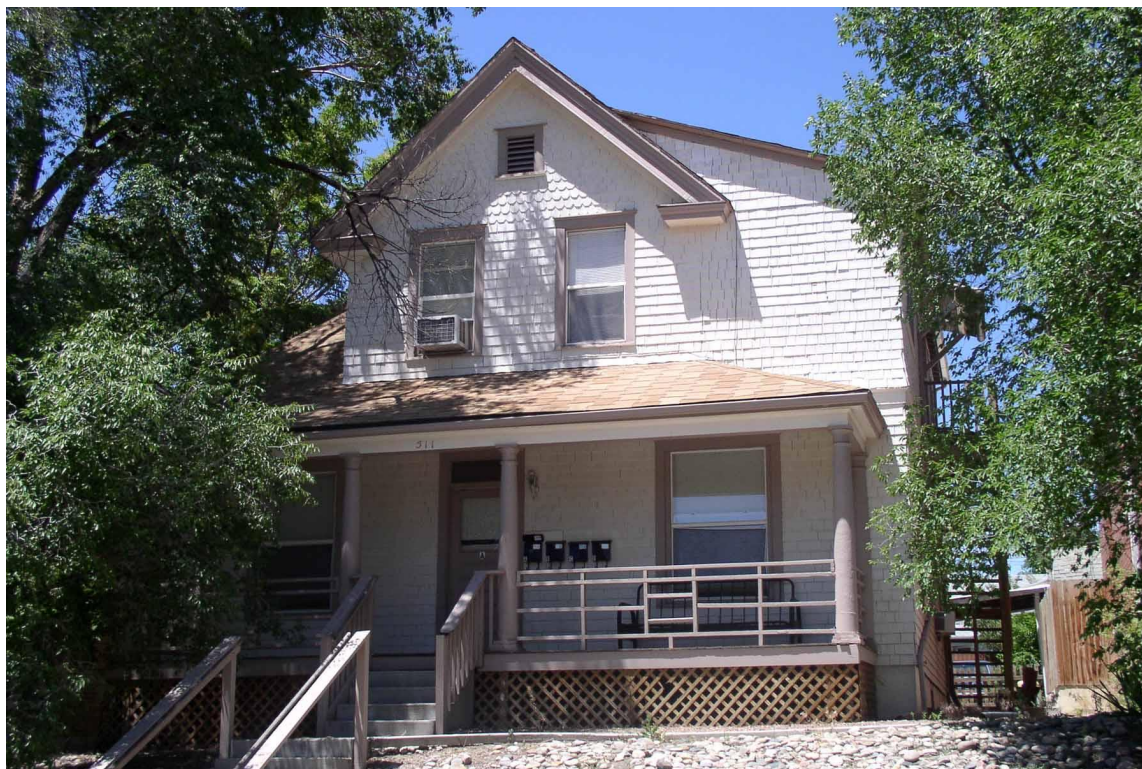
21. General architectural description:
Oriented to the south, this house rests on a combination of sandstone and concrete-block foundations, painted cream, with 1-light, hopper basement windows. Cream-painted, square-cut wood shingles clad the exterior walls. Octagon shingles cover the front- (south-) facing gable. Cream-painted plywood or particleboard panels cover the first story of the rear (north) elevation. Windows are generally 1-over-1-light, double-hung sash, with white vinyl frames and taupe-painted surrounds. The surrounds have projecting cornices. A hipped-roof porch spans nearly the entire front (south) facade. It features a wood floor and beadboard ceiling. Porch supports are taupe-painted, wood, Tuscan columns. Between the columns is a decorative balustrade constructed of 2-by-4s. Four concrete steps, flanked by a wood balustrade, approach the porch west of center. The principal doorway also opens slightly west of center in the asymmetrical facade. It hosts a 3-panel, 1-light, glass-in-wood-frame door, painted taupe. Above it is a single-light transom. Another doorway opens in the second story of the east elevation, providing access to a wood staircase that descends to the north. Two more doorways open on either end of the rear (north) elevation. They host identical 5-panel metal doors, painted white, with 1 fanlight each. Brown, interlocking asphalt shingles cover the main, front-gabled roof, and the hipped roof of additions. The front (south) gable features eave returns. Metal, louvered attic vents pierce the gables. The eaves are boxed with cream-painted wood soffit and taupe-painted wood fascia.

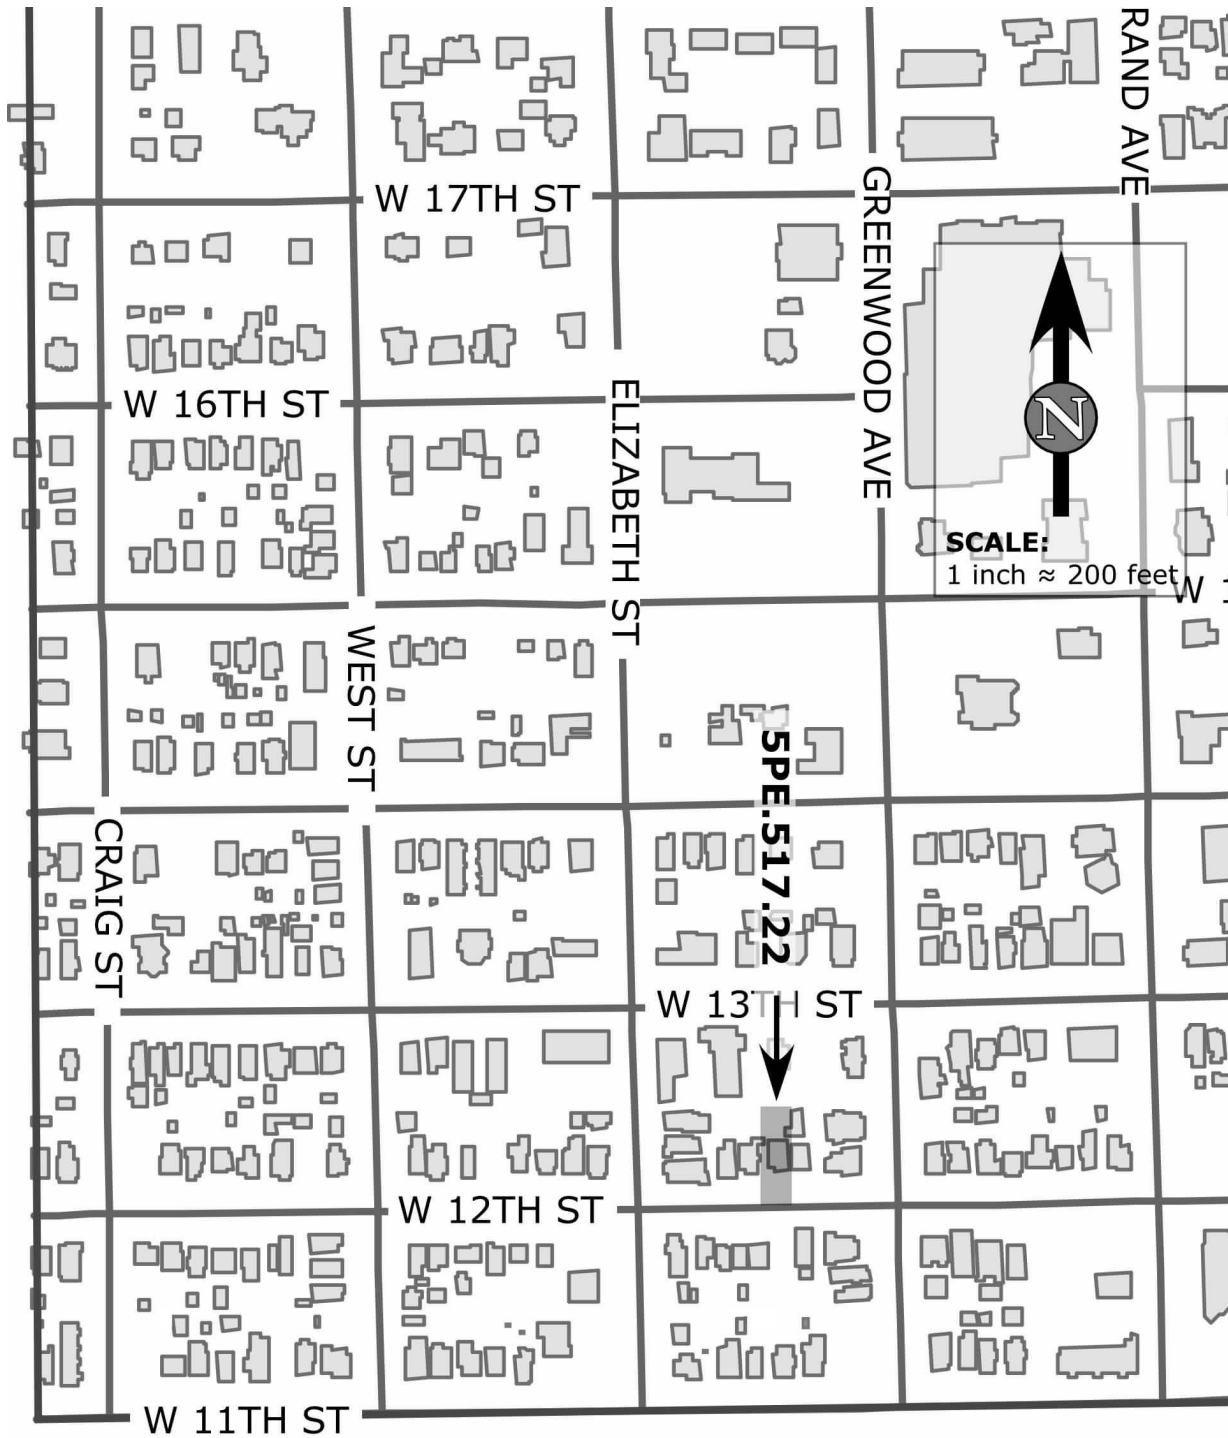
SITE SKETCH MAP

This property is located on terrain sloping steeply downward from north to south, with an elevation of around 4,700 feet above mean sea level. The neighborhood features modest, one- and two-story houses. This property is located on the north side of West 12th Street, an east-west-oriented thoroughfare. It is situated between 507 West 12th Street, to the east, and 515 West 12th Street, to the west. A gravel-covered strip separates the sidewalk from the street. Gravel also covers much of the back yard while river rock covers the front yard. Separating the sidewalk from the front yard is a retaining wall of buff-colored, rock-faced, coursed sandstone ashlar, with a pink-colored sandstone cap. A large elm tree grows off the southwest corner of the house. Separating the back yard from a parking area along the alley is a wood picket fence. A covered patio is located along the east edge of the property, just south of the parking area.
