COLORADO CULTURAL RESOURCE SURVEY

Architectural Inventory Form

- 1. Resource number: **5PE.5610**
- 2. Temporary resource number: **037**
- 3. County: **Pueblo**
- 4. City: **Pueblo**
- 5. Historic building name: **Brayton, Homer E., House**
- 6. Current building name: **Flores, Richard A. and Marylee, House (East)**
- 7. Building address: **520 W 12th Street**
- 8. Owner name: **Richard A. and Marylee Flores**
- Owner organization:
- Owner address: **520 W 12th St**
Pueblo, CO 81003

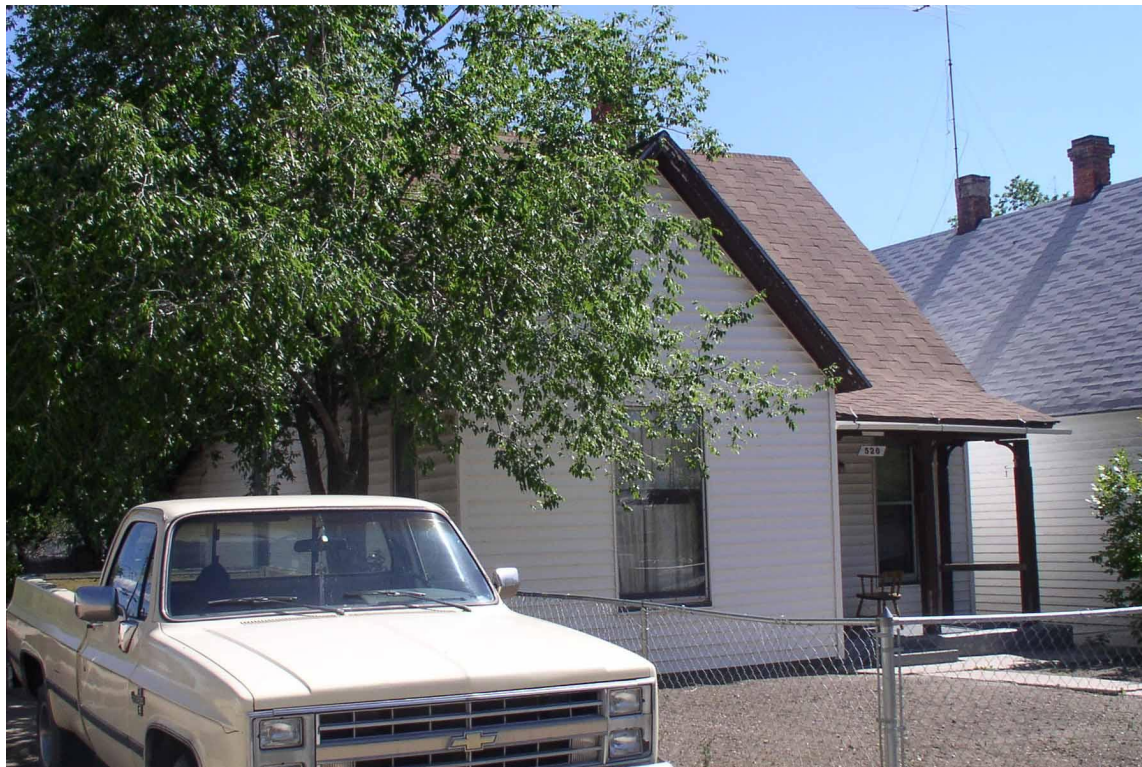
19. Primary external roof material: **Asphalt Roof/Composition Roof**
 Other roof materials:
20. Special features: **Fence**
Porch
Chimney
21. General architectural description:
Oriented to the north, this house rests on a combination of sandstone and concrete foundations, now mostly obscured behind siding. White vinyl siding clads the exterior walls. Windows are 1-over-1-light, double-hung sash, with brown-painted wood frames and no surrounds. They open behind aluminum-frame storm windows. The rear (south) elevation has 1-beside-1-light, sliding-sash windows, with aluminum frames. A small, shed-roof porch is located in the inside (northwest-facing) corner of the house. It features brown-painted, square supports, with scrolled brackets. The porch provides access to the principal doorway, which opens west of center in the asymmetrical front (north) façade. It hosts a wood slab door, with a single, diamond-shaped light. It opens behind and black, security-type storm door. An identical slab door opens west of center in a shed-roofed enclosed porch or addition across the rear (south) elevation. It opens behind an aluminum-frame storm door. Brown, interlocking asphalt shingles cover the cross-gabled roof, and brown-painted wood fascia and soffit box the eaves. A tall, red-brick chimney emerges from the center of the roof's north slope.

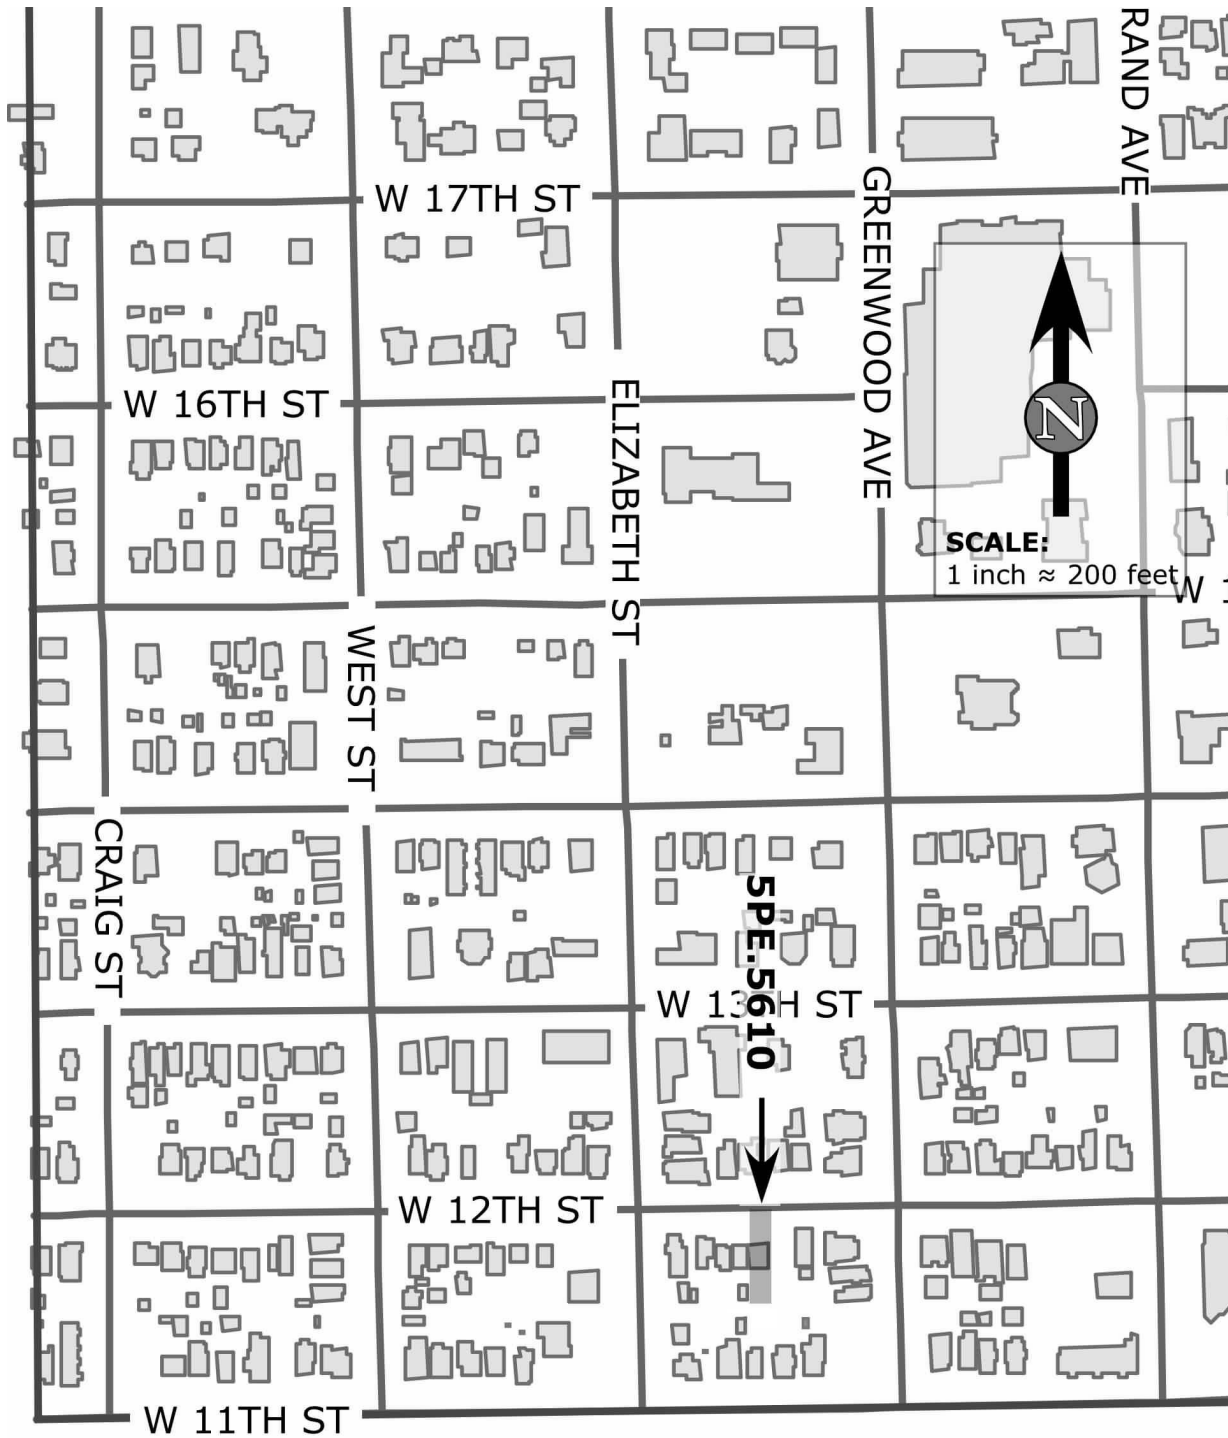
SITE SKETCH MAP

This property is located on terrain sloping downward from north to south, with an elevation of around 4,700 feet above mean sea level. The neighborhood features modest, one- and two-story houses. This property is located on the south side of West 12th Street, an east-west-oriented thoroughfare. It is situated between a vacant lot, to the east, and 522 West 12th Street, to the west. A gravel-covered strip separates the sidewalk from the street. A chain-link fence surrounds the backyard while and combination of chain-like and wood privacy fences surround the back yard. These yards lack planted grass.
