COLORADO CULTURAL RESOURCE SURVEY

Architectural Inventory Form

- 1. Resource number: **5PE.517.25** Parcel number(s):
- 2. Temporary resource number: **038** **525424006**
- 3. County: **Pueblo**
- 4. City: **Pueblo**
- 5. Historic building name: **Martini, Joseph F., House**
- 6. Current building name: **Flores, Richard A. and Marylee, House (West)**
- 7. Building address: **522 W 12th Street**
- 8. Owner name: **Richard A. and Marylee Flores**
- Owner organization:
- Owner address: **522 W 12th St**
Pueblo, CO 81003

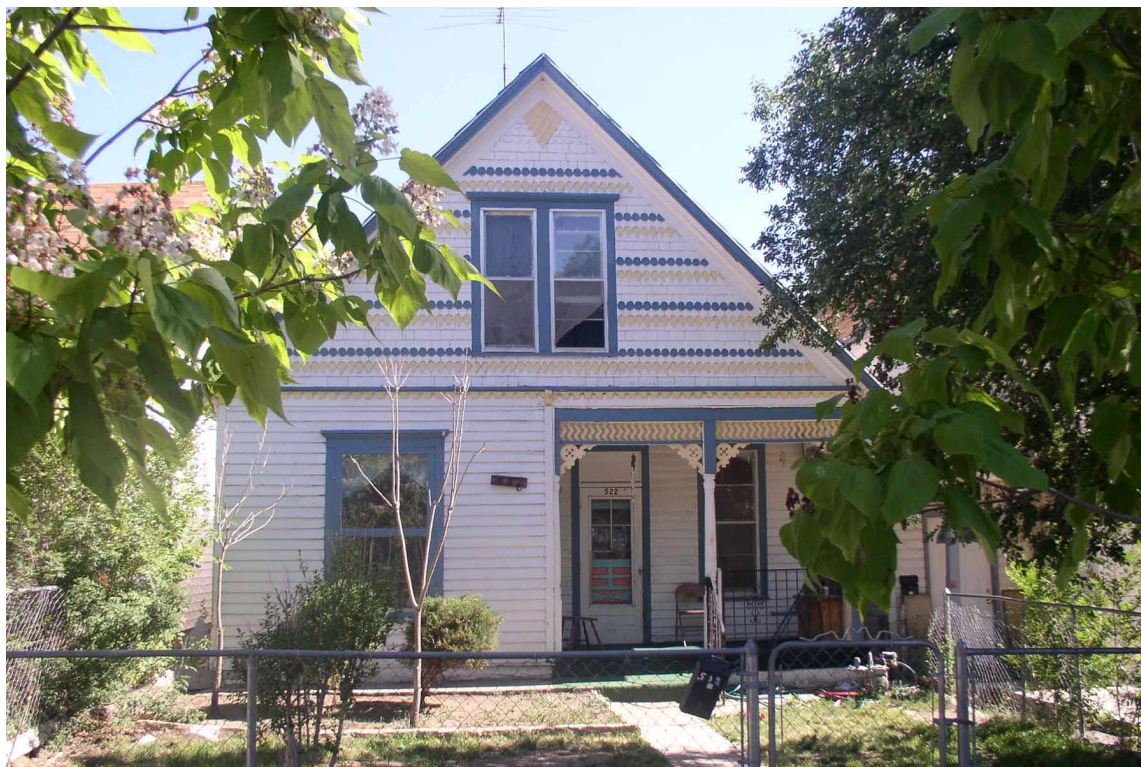
21. General architectural description:
Oriented to the south, this house rests on a sandstone foundation, almost entirely obscured under siding. White-painted wood siding, with white, 1-by-4-inch cornerboards, clads the exterior walls. Variagted wood shingles, painted white with bands of yellow and blue, cover the gables. Windows are 1-over-1-light, double-hung sash, with blue-painted wood frames, aluminum-frame storm windows, and blue-painted, wood surrounds. These surrounds feature projecting cornices. An integral porch is located on the west half of the front (north) elevation. It features white- and blue-painted, turned supports, with decorative brackets and friezes. The porch has a wrought-iron railing. A single step approaches the porch on its east side. The principal doorway is located west of center on the asymmetrical facade. It is a six-panel, one-light, glass-in-wood-frame door, with carved rails. Door details are painted pink on a blue field. A white-painted, wood-frame storm door protects this door, and the transom above them has been boarded shut. A shed-roof enclosed porch or addition spans the rear (south) elevation. The addition contains another doorway. Across this addition or enclosed porch is a simple, shed-roofed porch. It has square, wood supports and a sheet metal roof. Interlocking, gray asphalt shingles cover the front-gabled roof, and blue-painted wood fascia and white-painted wood soffit box the eaves. Red-brick chimneys emerge from either end of the roof ridge.

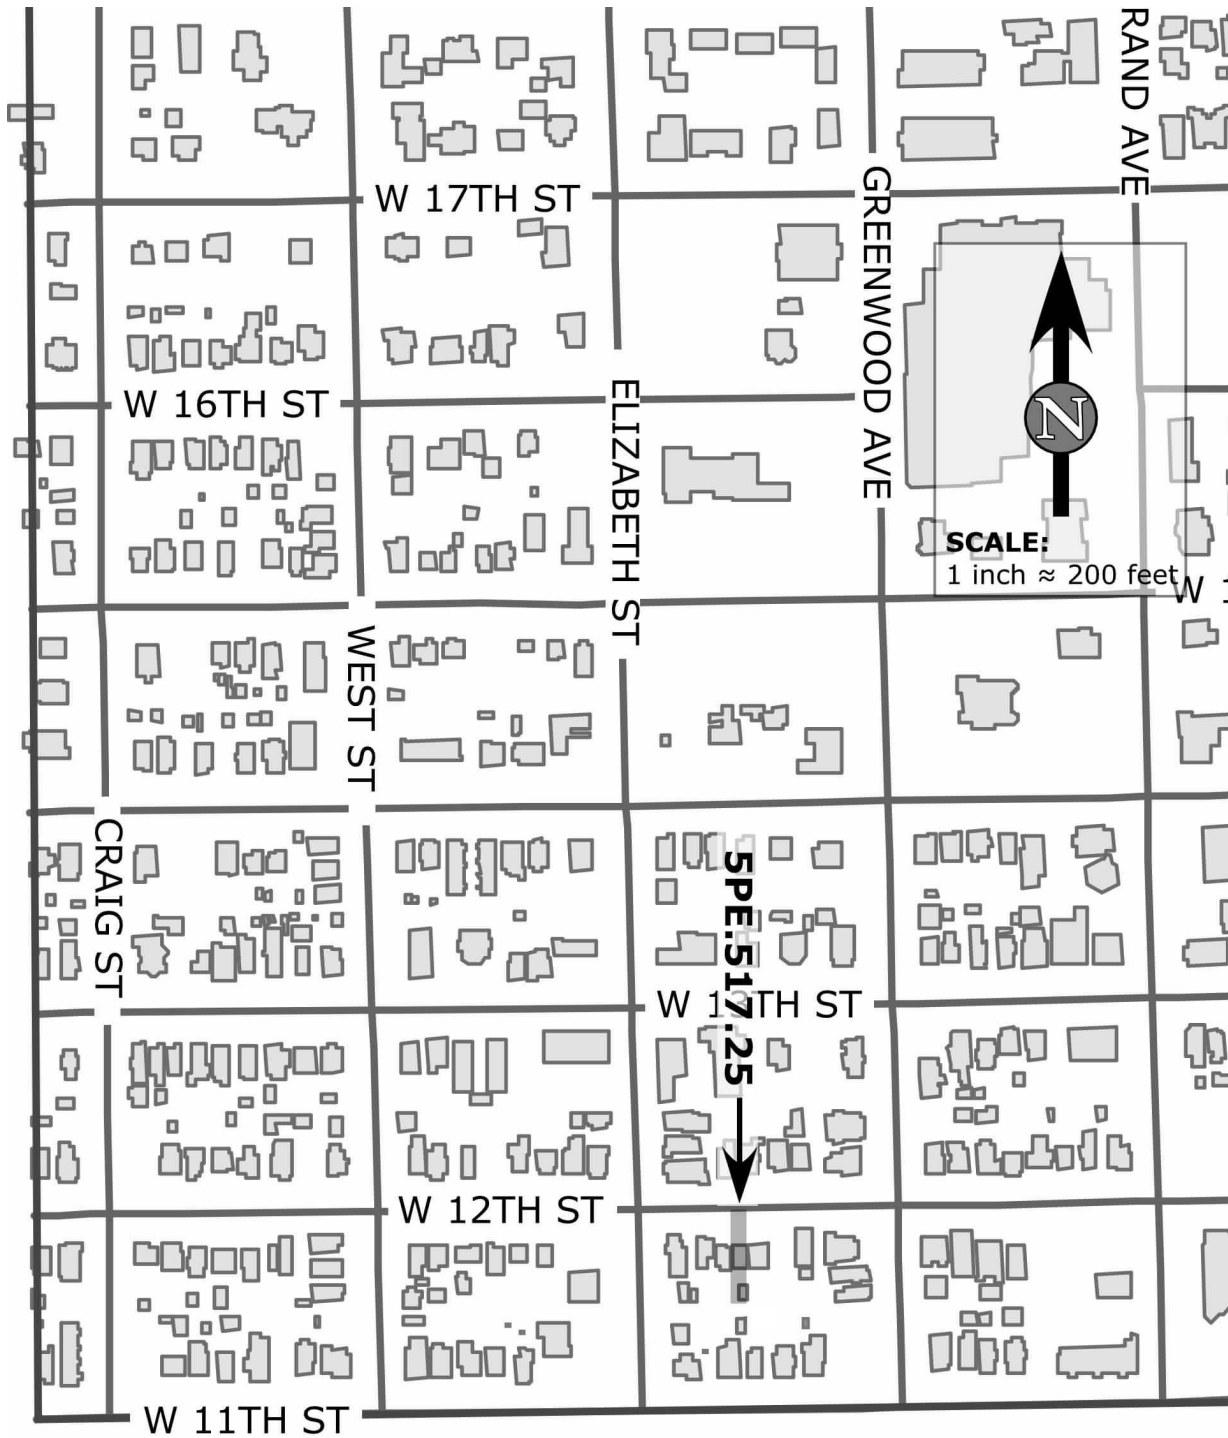
SITE SKETCH MAP

This property is located on terrain sloping downward from north to south, with an elevation of around 4,700 feet above mean sea level. The neighborhood features modest, one- and two-story houses. This property is located on the south side of West 12th Street, an east-west-oriented thoroughfare. It is situated between 520 West 12th Street, to the east, and 524 West 12th Street, to the west. A gravel-covered strip, with catalpa saplings, separates the sidewalk from the street. A planted grass yard, with mature landscaping, surrounds the house. A chain-link fence delimits the front yard while a wood privacy fence encircles the back yard.
