COLORADO CULTURAL RESOURCE SURVEY

Architectural Inventory Form

- 1. Resource number: **5PE.517.26**
- 2. Temporary resource number: **039**
- 3. County: **Pueblo**
- 4. City: **Pueblo**
- 5. Historic building name: **Crane, Leroy A., House**
- 6. Current building name: **Pumphrey, Sarah S., House**
- 7. Building address: **524 W 12th Street**
- 8. Owner name: **Sarah S. Pumphrey**
- Owner organization:
- Owner address: **524 W 12th St**  
**Pueblo, CO 81003**

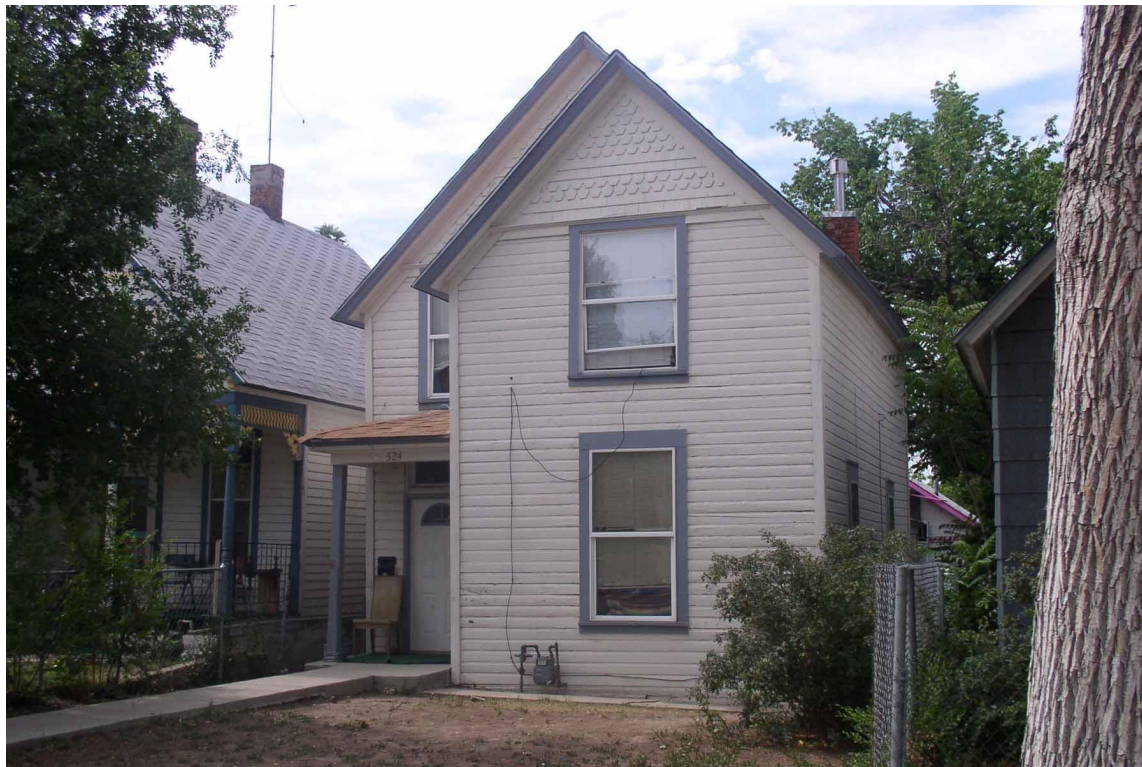
21. General architectural description:  
**Oriented to the north, this house rests on a combination of sandstone and concrete foundations, now largely obscured beneath siding. White-painted, horizontal wood weatherboard, with 1-by-4-inch cornerboards, clads the exterior walls. Variegated wood shingles, painted white, cover the gables. Windows are 1-over-1-light, double-hung sash, with white vinyl frames and blue-painted wood surrounds. A single-light awning window opens near the center of the (rear) south elevation, and a 1-beside-1-light, a sliding-sash window appears in the west end of the same elevation. A small, hipped-roof porch is located within the inside (northeast-facing) corner of the L-shaped building. It has a concrete floor and a single, square, wood support, with chamfered corners. The principal doorway opens beneath this porch. It is a white-painted, 4-panel metal door, with a fan light. Above it is a transom. A six-panel, white-painted metal door opens near the west side of the rear (south) elevation. Brown asphalt shingles cover the front-gabled roof. Boxing the eaves is white-painted wood soffit and blue-painted wood fascia with a projecting cornice. A red-brick chimney protrudes from the roof's west-facing slope, almost centered on the west elevation.**

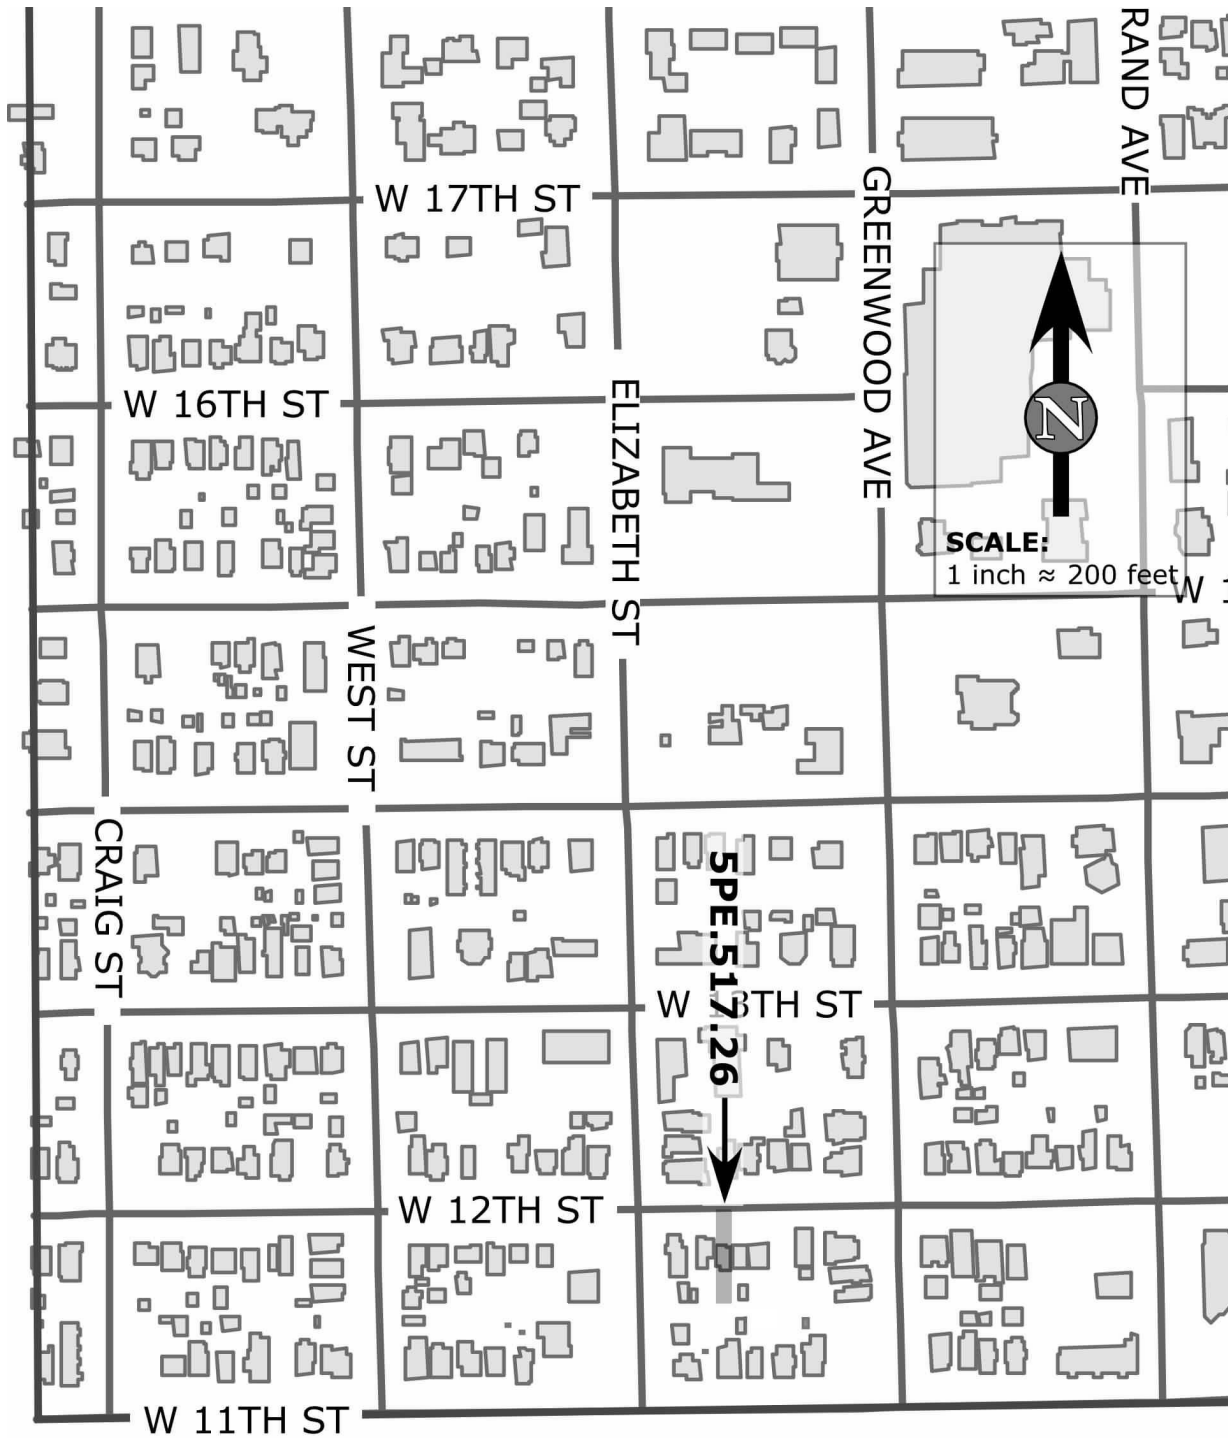
#### SITE SKETCH MAP

**This property is located on terrain sloping downward from north to south, with an elevation of around 4,700 feet above mean sea level. The neighborhood features modest, one- and two-story houses. This property is located on the south side of West 12th Street, an east-west-oriented thoroughfare. It is situated between 522 West 12th Street, to the east, and 526 West 12th Street, to the west. A gravel-covered strip separates the sidewalk from the street. A packed-earth yard, with some mature shrubs bushes, and trees, surrounds the house. Dividing the back yard in half east-west is a wood picket fence. A wood privacy fence delimits the east edge of the property while and chain-link fence runs along the west edge.**
