COLORADO CULTURAL RESOURCE SURVEY

Architectural Inventory Form

- 1. Resource number: **5PE.5611**
- 2. Temporary resource number: **040**
- 3. County: **Pueblo**
- 4. City: **Pueblo**
- 5. Historic building name: **Pifer, Charles H., House**
- 6. Current building name: **Imblum-Arnott House**
- 7. Building address: **526 W 12th Street**
- 8. Owner name: **Elaine Arnott and Norman Imblum**
- Owner organization:
- Owner address: **1814 Lark Bunting Ln**
Pueblo, CO 81001

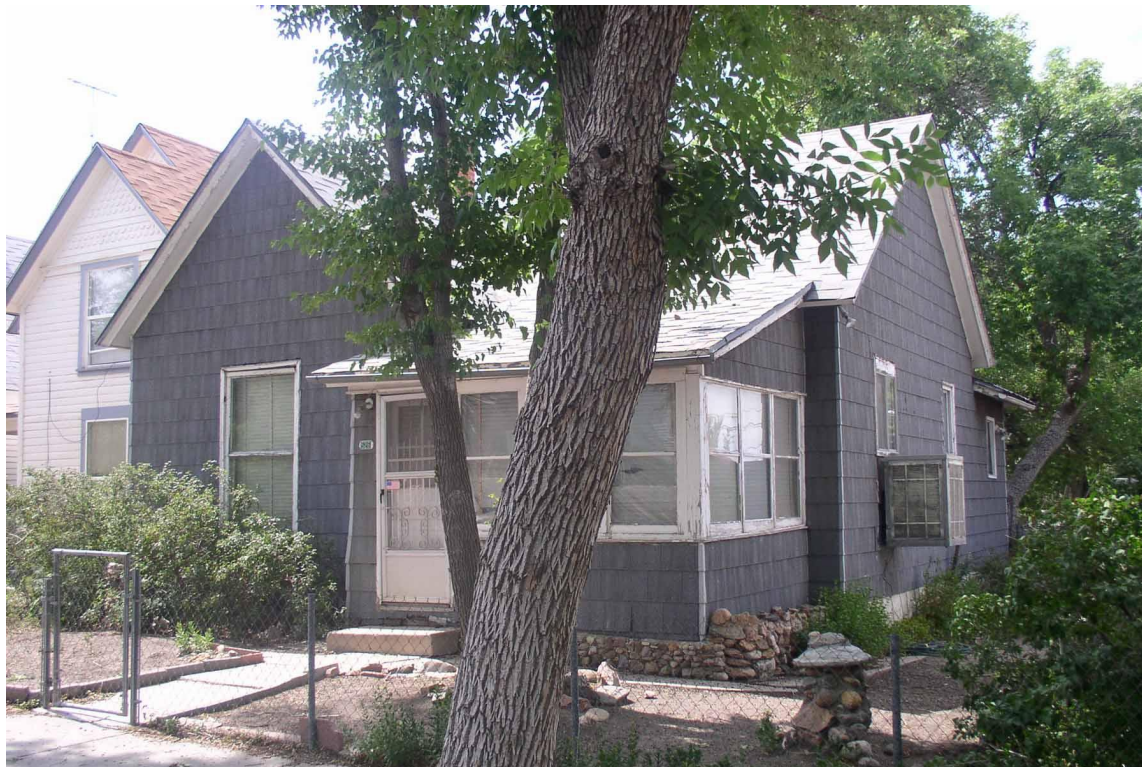
19. Primary external roof material: **Asphalt Roof/Composition Roof**
Other roof materials:
20. Special features: **Fence**
Chimney
Porch
21. General architectural description:
Oriented to the north, this house rests on a white, stucco-covered foundation. A cobblestone veneer covers the foundation of the front (north) porch, extending into a planter along its west elevation. Gray, asphalt shingle siding clads the exterior walls. Windows are generally 1-over-1-light, double-hung sash, with white-painted wood frames and thin, white-painted wood surrounds. The south elevation hosts 1-beside-1-light, sliding-sash windows, with aluminum frames. A shed-roofed porch protrudes from the inside (northwest-facing) corner of the house. A band of two-light awning, hopper, or casement windows enclose the porch. A doorway opens on the porch's east side. It hosts a white-painted, 4-light, glass-in-wood-frame door, with 3 raised panels. It opens behind an aluminum-frame storm door. A single, concrete step approaches the door. A hipped-roof enclosed porch or addition protrudes from the west side of the rear (south) elevation. It hosts a doorway, at the center of its south elevation, protected beneath a small, fiberglass awning, on wrought-iron supports. Approaching the doorway is a 6-step, concrete-block stoop. Gray, interlocking asphalt shingles cover the cross-gabled roof. Boxing the eaves are white-painted wood soffit and fascia, with protruding cornice. The rafter ends of the rear (south) enclosed porch or addition are exposed. A red-brick, corbelled chimney protrudes at the junction of the east-west and north-south roof ridges.
