COLORADO CULTURAL RESOURCE SURVEY

Architectural Inventory Form

I. IDENTIFICATION

- 1. Resource number: **5PE.5612**
- 2. Temporary resource number: **041**
- 3. County: **Pueblo**
- 4. City: **Pueblo**
- 5. Historic building name: **Birch, Harvey, House**
- 6. Current building name: **603 West Twelfth Street**
- 7. Building address: **603 W 12th Street**
- 8. Owner name: **Normandy Realty, Inc.**
- Owner organization:
- Owner address: **220 Nelson Ave**
Pueblo, CO 81004

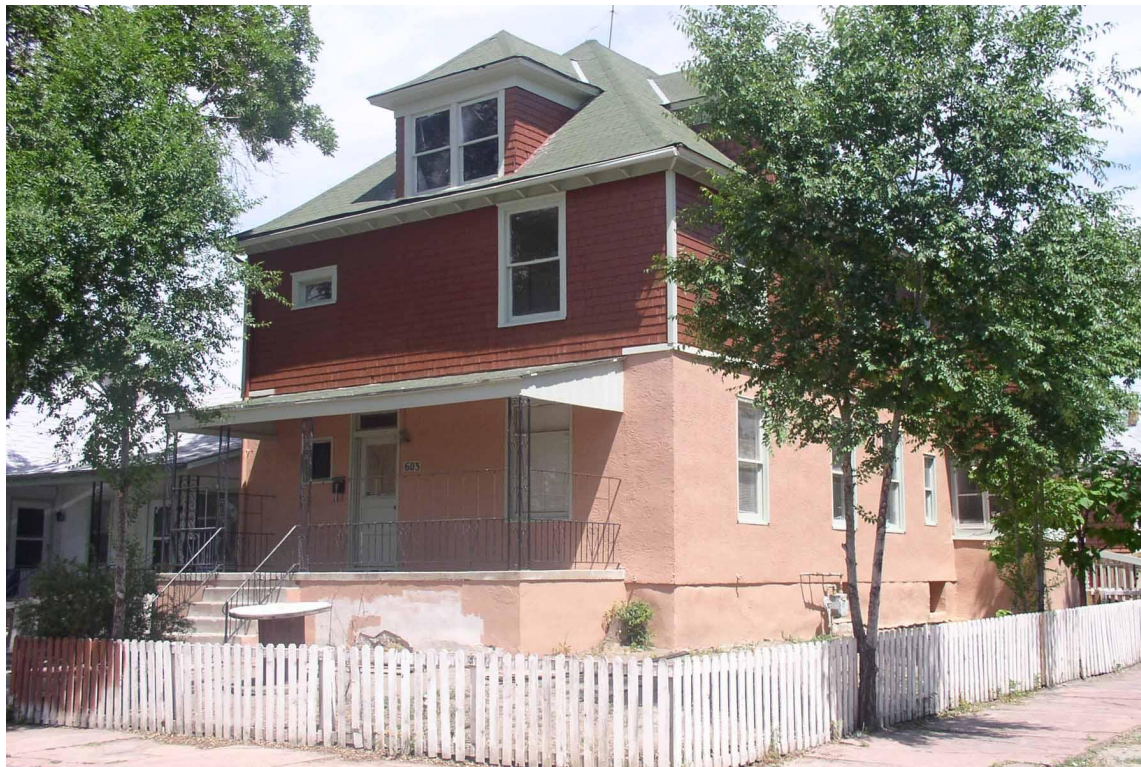
21. General architectural description:
Oriented to the south, this house rests on a sandstone foundation, covered in tan-painted stucco, with 2-light, hopper basement windows. Tan-painted stucco also clads the exterior walls of the first story. Brown-painted, square-cut wood shingles cover all exterior wall surfaces above the first floor. Windows are generally 1-over-1-light, double-hung sash, with green-painted wood frames and surrounds. The surrounds have projecting cornices. The east end of the front (south) façade's first story has a 1-over-1-light window with a narrow upper sash. In the opposite end of the façade is a square window opening hosting a stained-glass sash depicting a diamond framed in squares. Above this window, in the second story, is a single-light awning or hopper window. A shed-roofed porch spans nearly the entire front (south) façade. It has a concrete floor and black, wrought-iron supports. Approaching the porch west of center are 5 concrete steps. The principal doorway opens west of center in the façade. It hosts a green-painted, 2-panel, glass-in-wood-frame door, with a projecting locking rail. Beneath this rail is an embossed floral motif. Above the door is a transom. A two-story, shed-roof porch protrudes from the north end of the east elevation. A band of 1-over-1-light, aluminum-frame windows encloses the first story, while a band of single-light awning or hopper windows encloses the second story. A green-painted, wood slab door opens in the north-facing end of the porch. An

identical door appears on the west end of the rear (north) elevation's second story. It provides access to a green-painted wood staircase, which descends to the east. Green, asphalt shingles cover the centrally hipped main roof and all other roof surfaces. Hipped-roof dormers, hosting paired, 1-over-1-light windows, protrude from the roof's east- and south-facing slopes. A red brick chimney emerges from the edge of the roof's north-facing slope, while the remnants of another chimney, now largely collapsed above the roofline, appear near the apex of the roof. Evenly spaced, shaped brackets appear beneath the eaves.

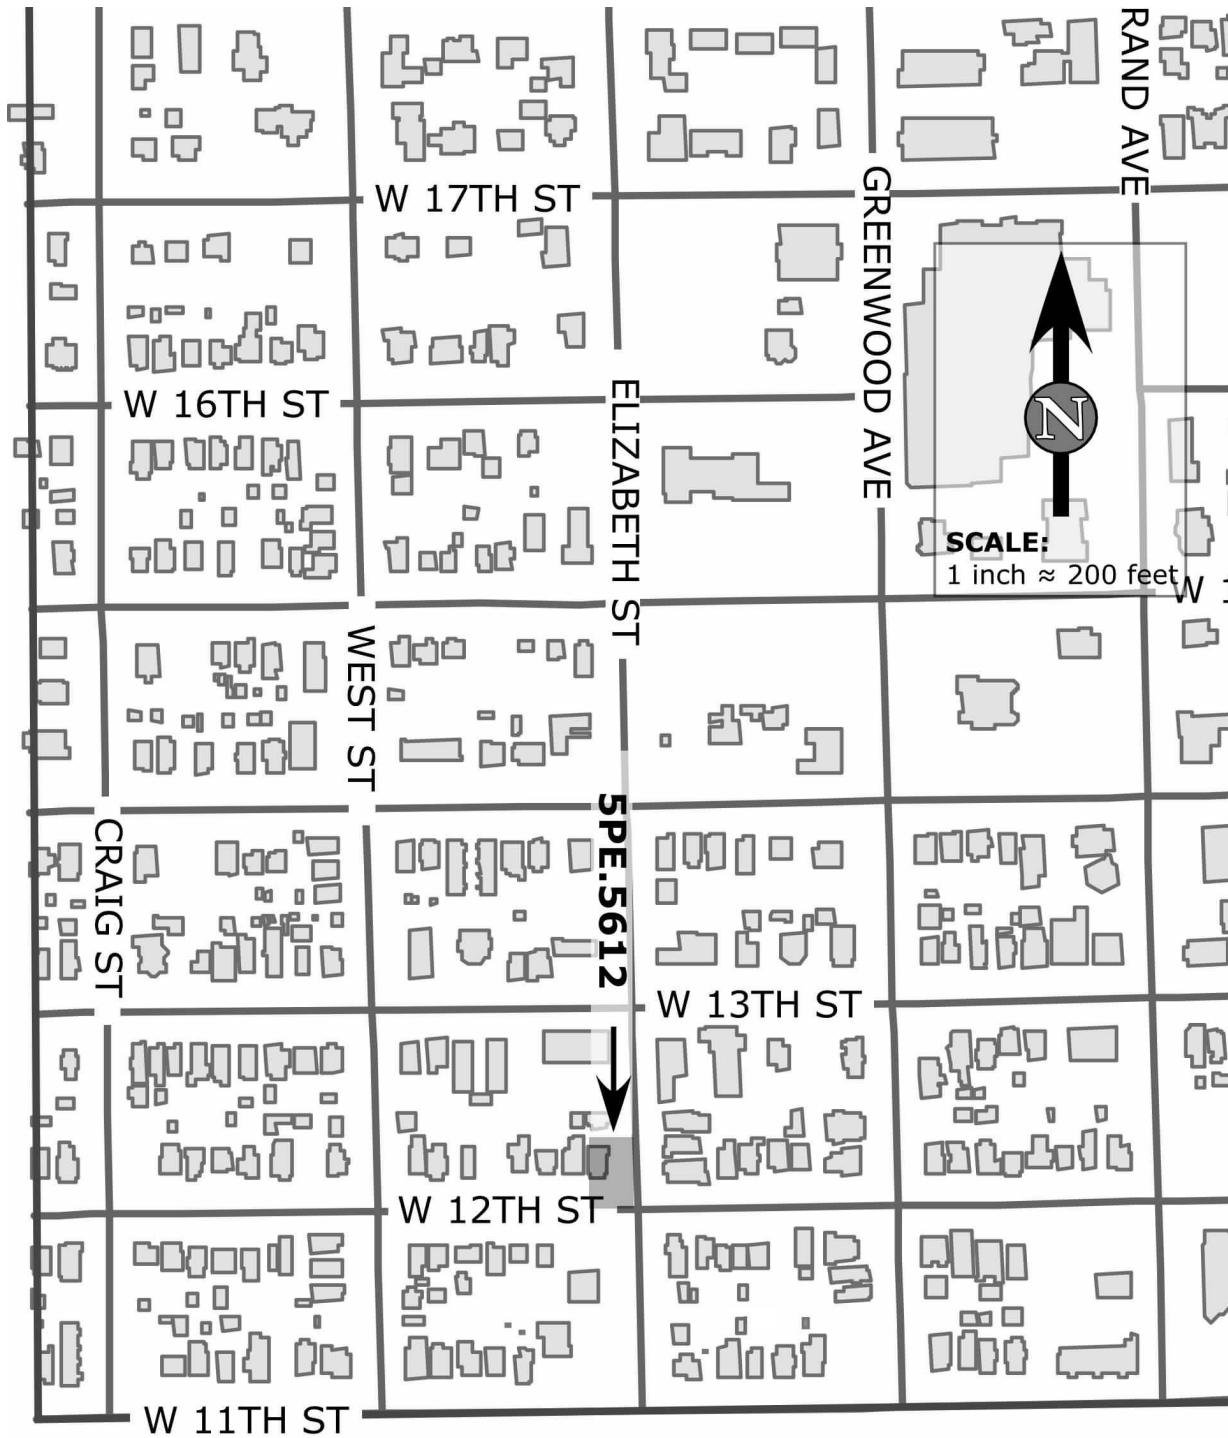
SITE SKETCH MAP

This property is located on terrain sloping downward from north to south, with an elevation of around 4,700 feet above mean sea level. The neighborhood features modest, one- and two-story houses. This property is situated on the northwest corner of West 12th and North Elizabeth streets. Running parallel to both streets is a sidewalk of pink-colored sandstone. A grass-covered strip separates the sidewalk from the street. A planted grass yard, with mature landscaping, surrounds the house. Delimiting the south and east sides of the property is a white-painted, wood picket fence.
