COLORADO CULTURAL RESOURCE SURVEY

Architectural Inventory Form

- 1. Resource number: **5PE.5613**
- 2. Temporary resource number: **042**
- 3. County: **Pueblo**
- 4. City: **Pueblo**
- 5. Historic building name: **Innes, W.E.A., House**
- 6. Current building name: **605 West Twelfth Street**
- 7. Building address: **605 W 12th Street**
- 8. Owner name: **Aspire, LLC**
- Owner organization:
- Owner address: **4887 E Mineral Cir  
Littleton, CO 80122**

47. Photograph numbers): **CD-ROM Photo Disc: North Side Photos**  
**File Name(s): 12thstw605**
- Negatives filed at: **Special Collections**  
**Robert Hoag Rawlings Public Library**  
**100 East Abriendo Avenue**  
**Pueblo, CO 81004-4290**
48. Report title: **Pueblo North Side Neighborhood Survey**
49. Date(s): **06/15/2005**
50. Recorder(s): **Adam Thomas**
51. Organization: **Historitecture, L.L.C.**
52. Address: **PO Box 419**  
**Estes Park, CO 80517-0419**
53. Phone number(s): **(970) 586-1165**

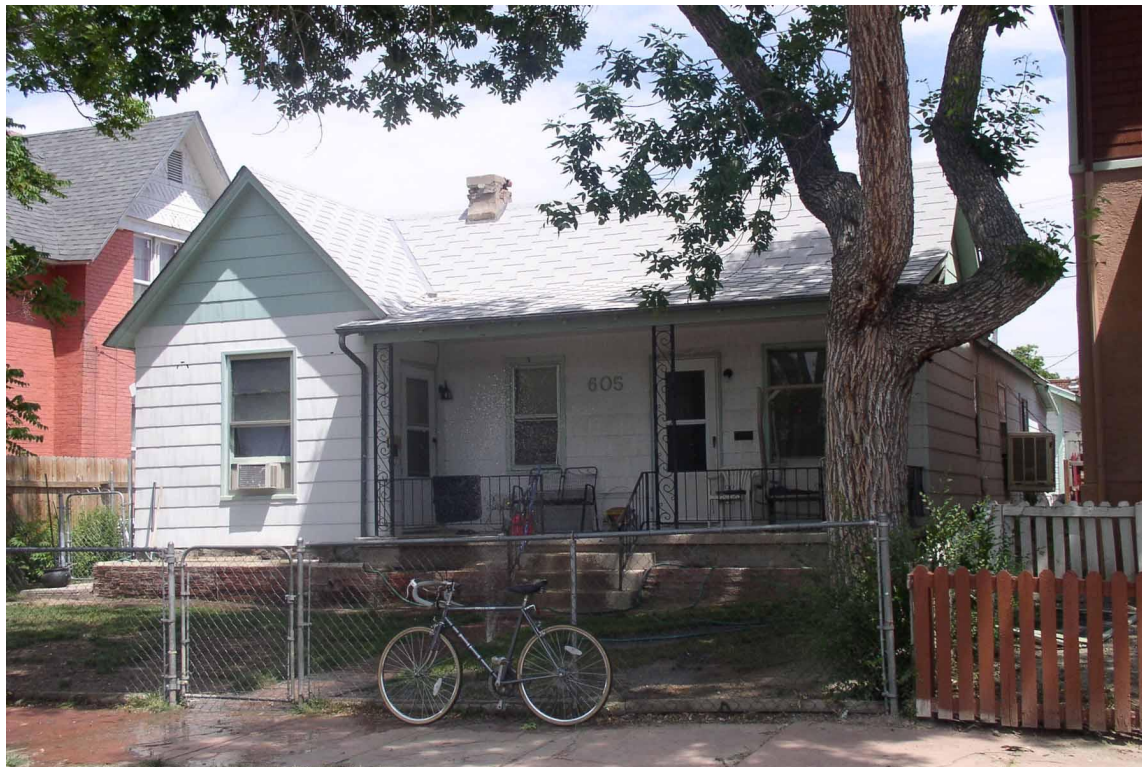
**Oriented to the south, this house rests on a combination of random-coursed sandstone and concrete foundations. Asbestos shingle siding clads the exterior walls. It is painted white, except in the gables, where it is blue-green. Windows are generally 1-over-1-light, double-hung sash, with blue-green-painted wood frames and surrounds. A picture window appears in the east end of the front (south) façade. The rear (north) and northern portions of the east and west elevations have wood-frame and aluminum-frame, 1-beside-1-light, sliding-sash windows. A shed-roof porch fills the inside (southeast-facing) corner of the house. It has a concrete porch and black, wrought-iron railing. Three concrete steps, with flanking wrought-iron railings, approach the porch at its center. Two doorways open onto the porch. One is located east of center in the façade. The other actually opens on the east-facing portion of the front-gabled wing, which protrudes from the west side of the façade. Both doorways host wood slab doors opening behind white, aluminum-frame storm doors. A covered patio traces the inside (northwest-facing) corner of the house. It has a concrete floor and black, wrought-iron supports. Pink sheets of translucent, corrugated fiberglass cover the sides of the roof, while corrugated metal covers the shed roof itself. Two doorways open onto the patio, one from each face of the inside corner. Both are identical to those in the front façade. Gray, interlocking asphalt shingles cover the cross-gabled roof, and gray, rolled asphalt sheets cover shed-roofed additions to the rear (north) elevation. Blue-green-painted wood soffit and fascia box the eaves of the original (southern) portion of the house. The rafter ends are exposed beneath the roof of additions to the rear elevation. A short, brick chimney, encased in concrete, protrudes near the**

**junction of the roof ridges.**22. Architectural style: **No Style**

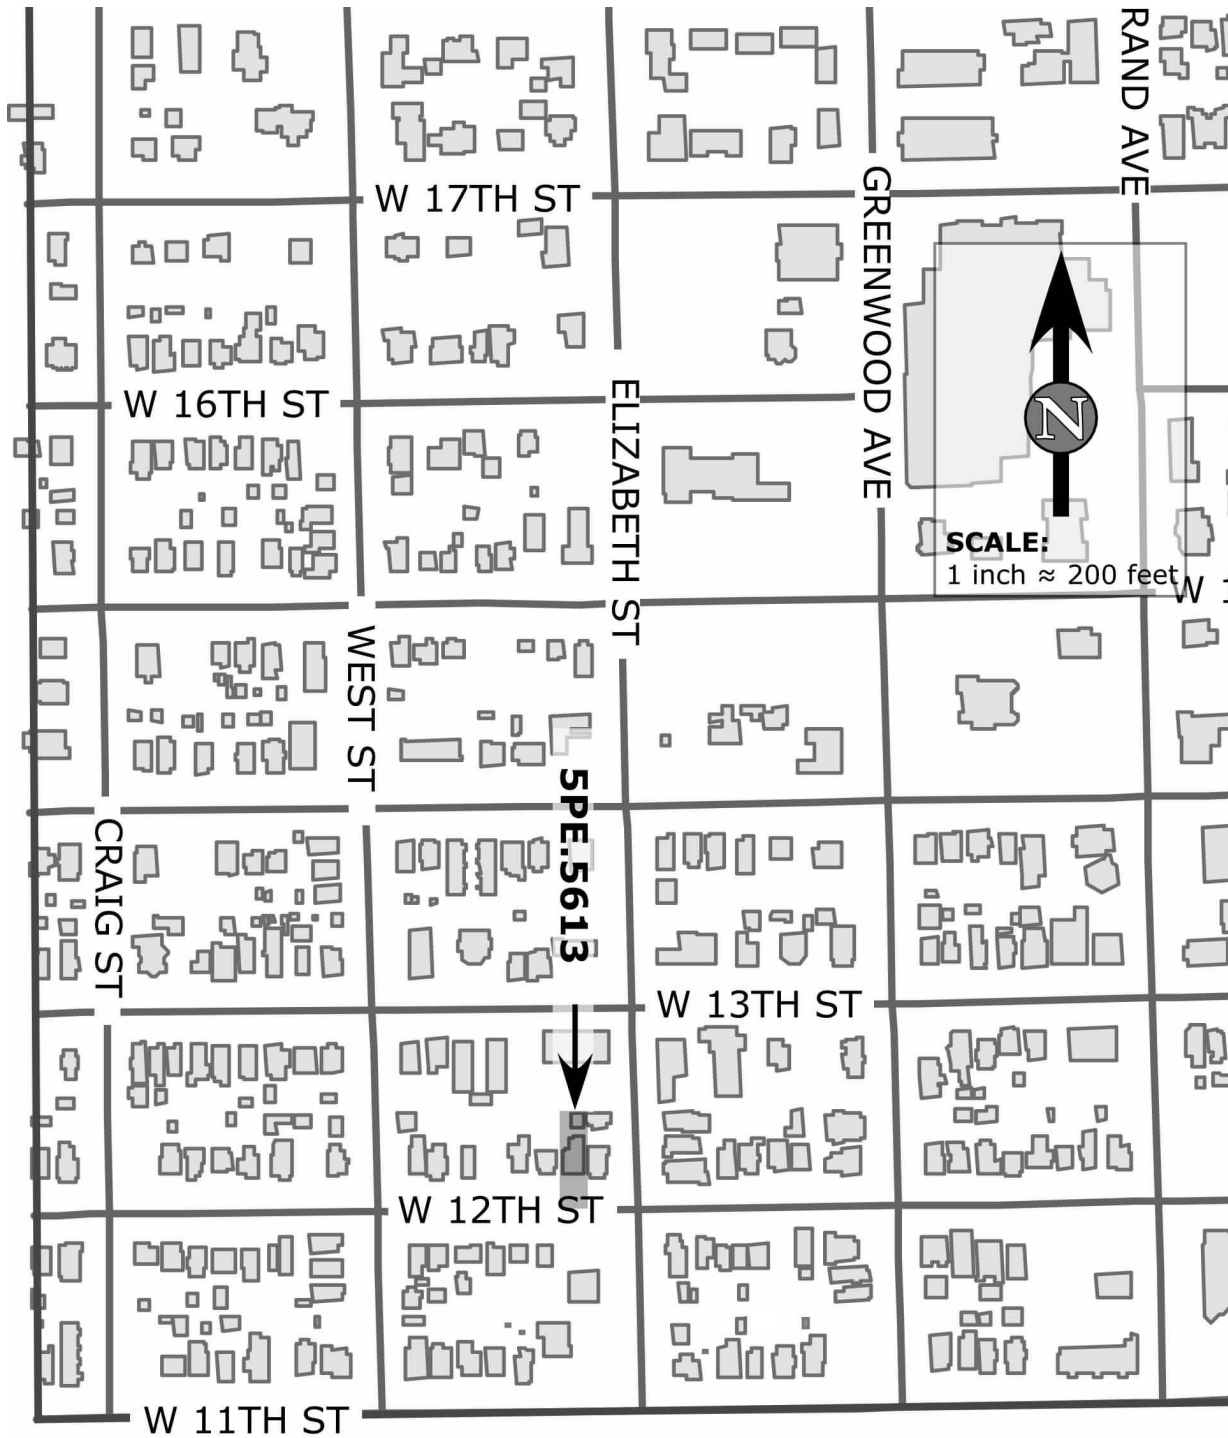
#### SITE SKETCH MAP

**This property is located on terrain sloping downward from north to south, with an elevation of around 4,700 feet above mean sea level. The neighborhood features modest, one- and two-story houses. This property is located on the north side of West 12th Street, an east-west-oriented thoroughfare. It is situated between 603 West 12th Street, to the east, and 607 West 12th Street, to the west. Running parallel to the street is a sidewalk of pink-colored sandstone slabs. A grass strip separates the sidewalk from the street. A planted-grass yard surrounds the house. Along the front yard is a chain-link fence while a combination of chain-link and wood privacy fences encloses the backyard.**

Describe: **A 2-car garage is located on the northeast corner of the lot, adjacent to an east-west alley. Oriented to the north, this garage rests on a concrete-block foundation. White-painted wood weatherboard, with blue-green-painted cornerboards, clad the exterior walls. Unpainted, square-cut wood shingles cover the gables. Dominating the front (north) elevation is a pair of brown, 16-panel, overhead retractable garage doors. Gray, interlocking asphalt shingles cover the front-gabled roof, and the rafter ends are exposed.**
