COLORADO CULTURAL RESOURCE SURVEY

Architectural Inventory Form

- 1. Resource number: **5PE.5616**
- 2. Temporary resource number: **043**
- 3. County: **Pueblo**
- 4. City: **Pueblo**
- 5. Historic building name: **Mayer, Edna I., House**
- 6. Current building name: **612 West Twelfth Street**
- 7. Building address: **612 W 12th Street**
- 8. Owner name: **Russell H. Longgear, III**
- Owner organization:
- Owner address: **29376 Hardin Rd**
Pueblo, CO 8106

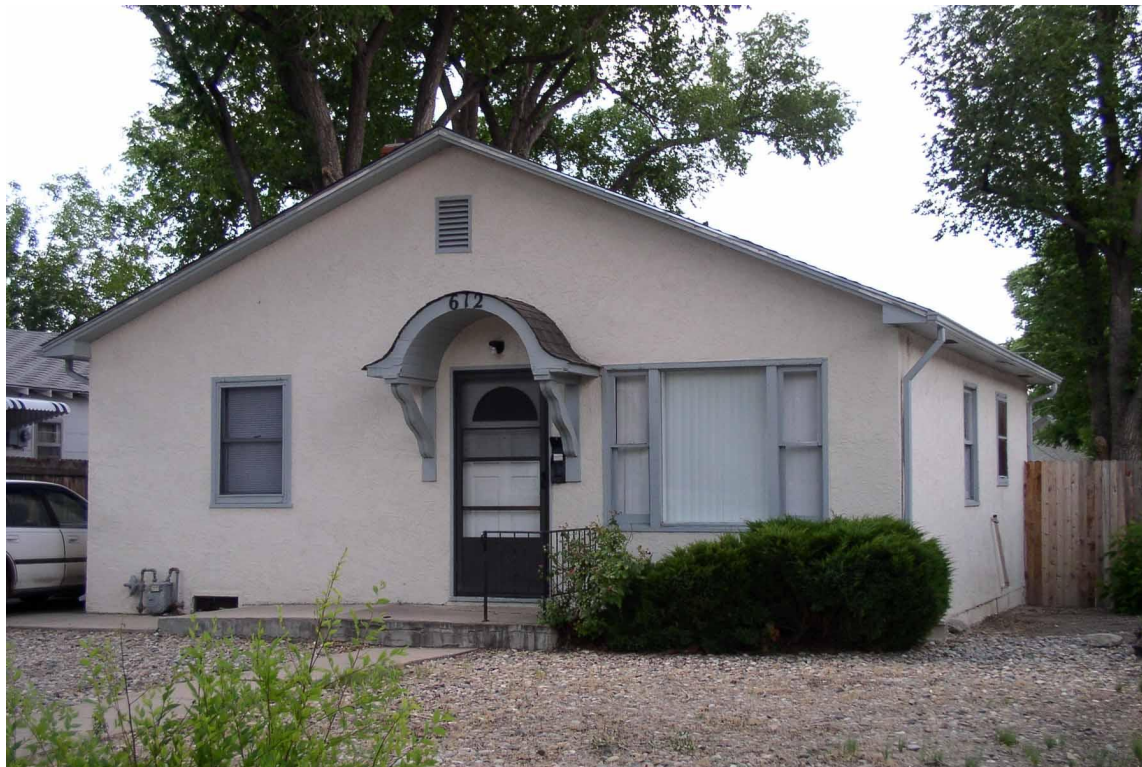
19. Primary external roof material: **Asphalt Roof/Composition Roof**
Other roof materials:
20. Special features: **Fence**
Chimney
21. General architectural description:
Oriented to the north, this house rests on a concrete foundation. Cream-painted stucco covers the exterior walls. Windows are 1-over-1-light, double-hung sash, with sage-green-painted wood frames, screens, and surrounds. A tripartite picture window opens in the west side of the front (north) facade. It consists of a central, single-light fixed frame and flanking 1-over-1-light sash windows. The principal doorway opens west of center in the facade. It hosts a white, four-panel metal door, with fanlight. Protecting this door is a brown, aluminum-frame storm door. A single-step concrete stoop approaches the door from the north and the east. A black, wrought-iron railing flanks the west side of the stoop. Above the stoop is a barrel-roofed hood, on scrolled brackets. Another doorway opens west of center in the rear (south) elevation. It hosts a single-light, sage-green-painted, wood slab door, opening behind a brown, aluminum-frame storm door. A two-step concrete stoop approaches the doorway. Brown, asphalt shingles cover the front-gabled roof, and sage-green-painted, wood fascia and soffit box the eaves. A red-brick chimney protrudes from the roof's east-facing slope.

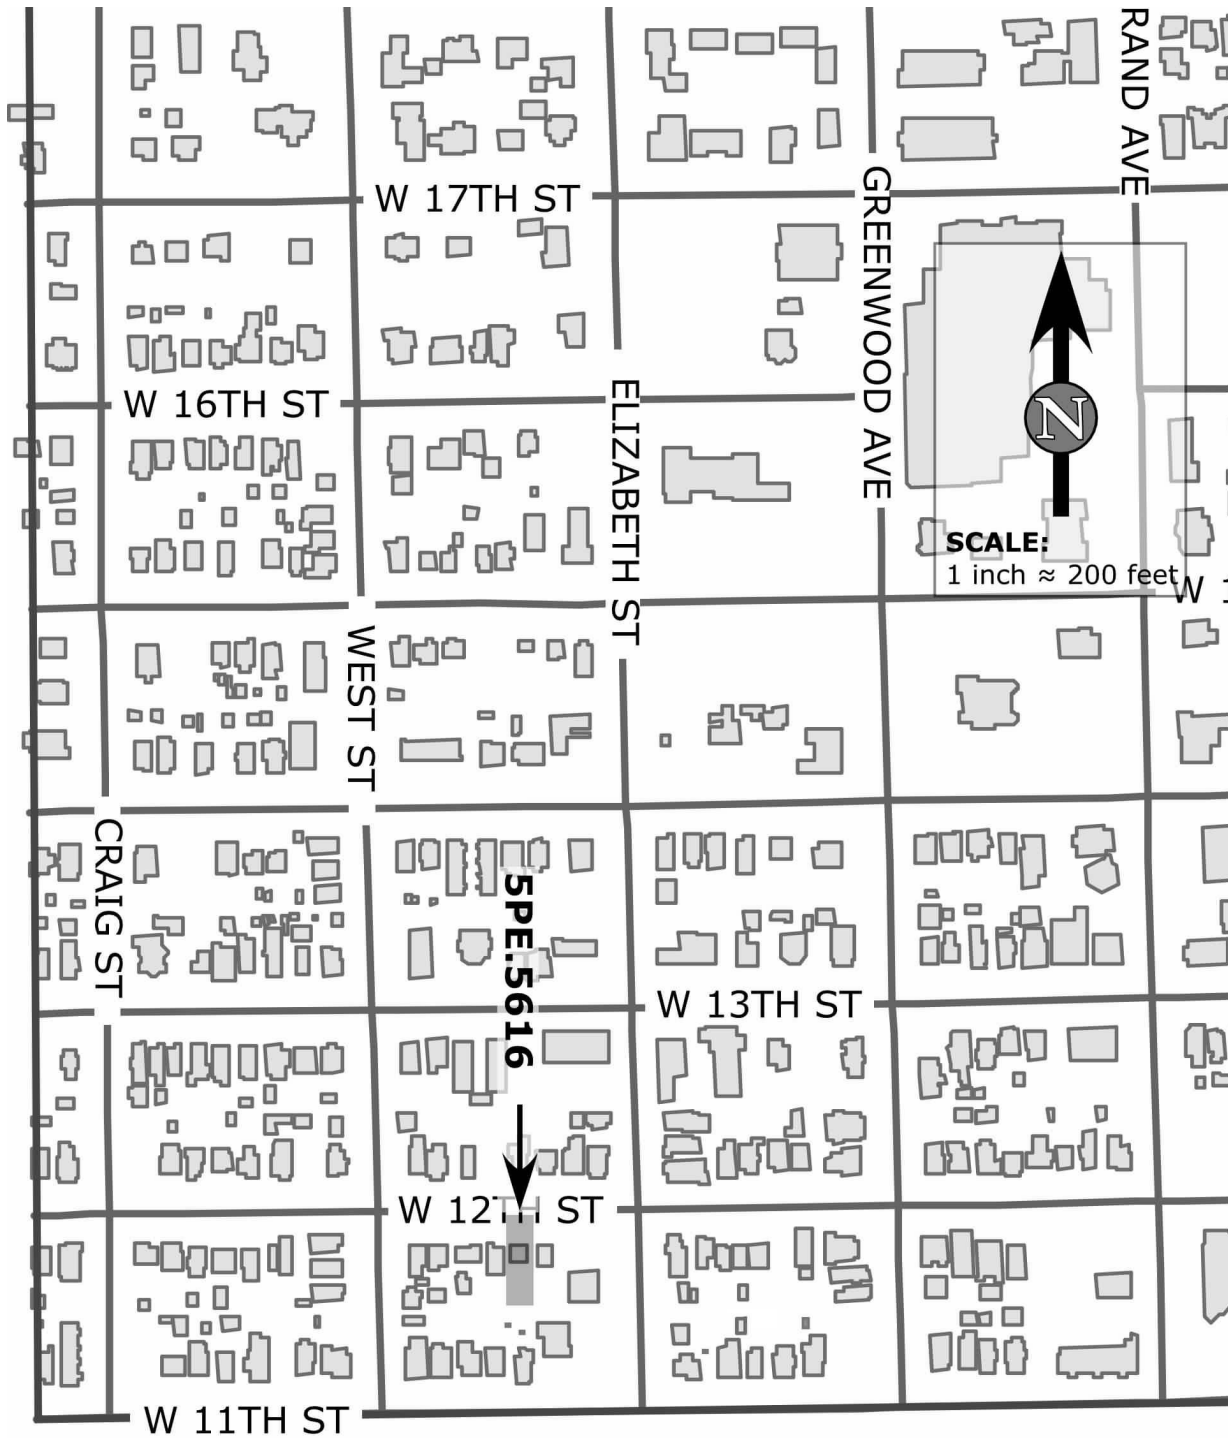
SITE SKETCH MAP

This property is located on terrain sloping downward from north to south, with an elevation of around 4,700 feet above mean sea level. The neighborhood features modest, one- and two-story houses. This property is located on the south side of West 12th Street, an east-west-oriented thoroughfare. It is situated between 610 West 12th Street, to the east, and 616 West 12th Street to the west. A concrete driveway along the east edge of the property connects the street to a parking area off the northeast corner of house. A gravel-covered strip separates the sidewalk from the street. Gravel also covers the front yard. A combination of wood privacy and chain-link fences surrounds the backyard.

Describe: **A shed is located on the east edge of the property, off the southeast corner of the house. Oriented to the west, this shed lacks a formal foundation. Cream-painted sheets of particleboard clad the exterior walls. Covering the seams and corners are blue-painted 1-by-4s. Opening in the center of the front (west) elevation is a white-painted wood slab door. A 1-beside-1-light, sliding-sash widow appears in the center of the south elevation. Brown asphalt shingles cover the front-gabled roof, and the rafter ends are exposed.**
