COLORADO CULTURAL RESOURCE SURVEY

Architectural Inventory Form

- 1. Resource number: **5PE.5617**
- 2. Temporary resource number: **044**
- 3. County: **Pueblo**
- 4. City: **Pueblo**
- 5. Historic building name: **Clanton-Stilwell House**
- 6. Current building name: **Klipfel, Charles H., IV, and Jennifer H., House**
- 7. Building address: **613 W 12th Street**
- 8. Owner name: **Charles H. Klipfel, IV, and Jennifer H. Klipfel**
- Owner organization:
- Owner address: **613 W 12th St**
Pueblo, CO 81006

47. Photograph numbers): **CD-ROM Photo Disc: North Side Photos**
File Name(s): 12thstw613
- Negatives filed at: **Special Collections**
Robert Hoag Rawlings Public Library
100 East Abriendo Avenue
Pueblo, CO 81004-4290
48. Report title: **Pueblo North Side Neighborhood Survey**
49. Date(s): **06/15/2005**
50. Recorder(s): **Adam Thomas**
51. Organization: **Historitecture, L.L.C.**
52. Address: **PO Box 419**
Estes Park, CO 80517-0419
53. Phone number(s): **(970) 586-1165**

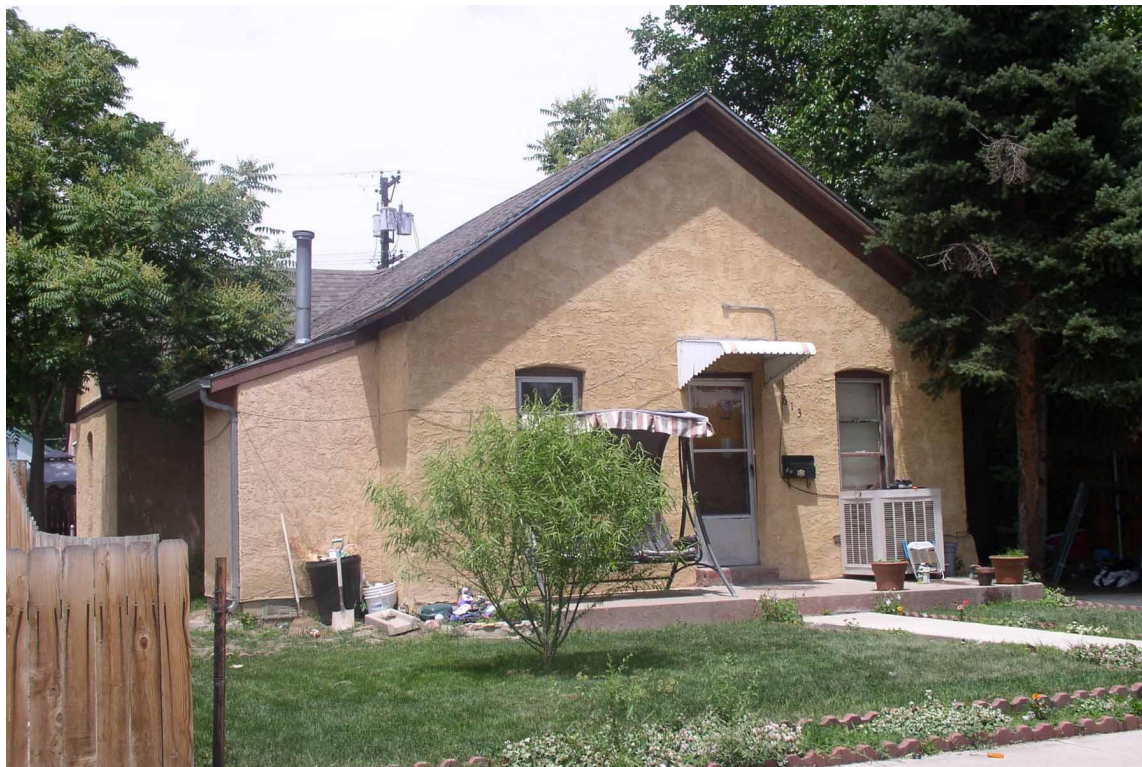
19. Primary external roof material: **Asphalt Roof/Composition Roof**
Other roof materials:
20. Special features: **Fence**
21. General architectural description:
Oriented to the south, this house is essentially T-shaped, with the stem of the T facing south, toward the street. The building rests on a tan-tinted, stucco-covered foundation. The same stucco clads the exterior walls. Windows are 1-over-1-light, double-hung sash, with brown-painted wood frames and aluminum-frame storm windows. Opening on the north ends of the east and west elevations are 1-beside-1-light, sliding-sash windows, with aluminum frames. The west end of the rear (north) elevation also has a single-light casement window. They open beneath segmental arches. A single-step, uncovered concrete stoop extends across most of the principal (south) façade. It provides access to the principal doorway, which opens just east of center in the otherwise symmetrical façade. The doorway hosts a two-light, wood slab door, opening behind an aluminum-frame storm door. A metal awning, white with 2 brown stripes, protects the doorway. Another doorway opens into a room projecting from the east half of the rear (north) elevation. It hosts a door identical to the front (south). Brown-gray asphalt shingles cover the cross-gabled roof. Brown-painted wood fascia and soffit box the eaves.
