COLORADO CULTURAL RESOURCE SURVEY

Architectural Inventory Form

- 1. Resource number: **5PE.5619**
- 2. Temporary resource number: **046**
- 3. County: **Pueblo**
- 4. City: **Pueblo**
- 5. Historic building name: **Williams, G.P., House**
- 6. Current building name: **Buehler, Richard., Jr., House**
- 7. Building address: **618 W 12th Street**
- 8. Owner name: **Richard Buehler, Jr.**
- Owner organization:
- Owner address: **618 W 12th St**
Pueblo, CO 81003

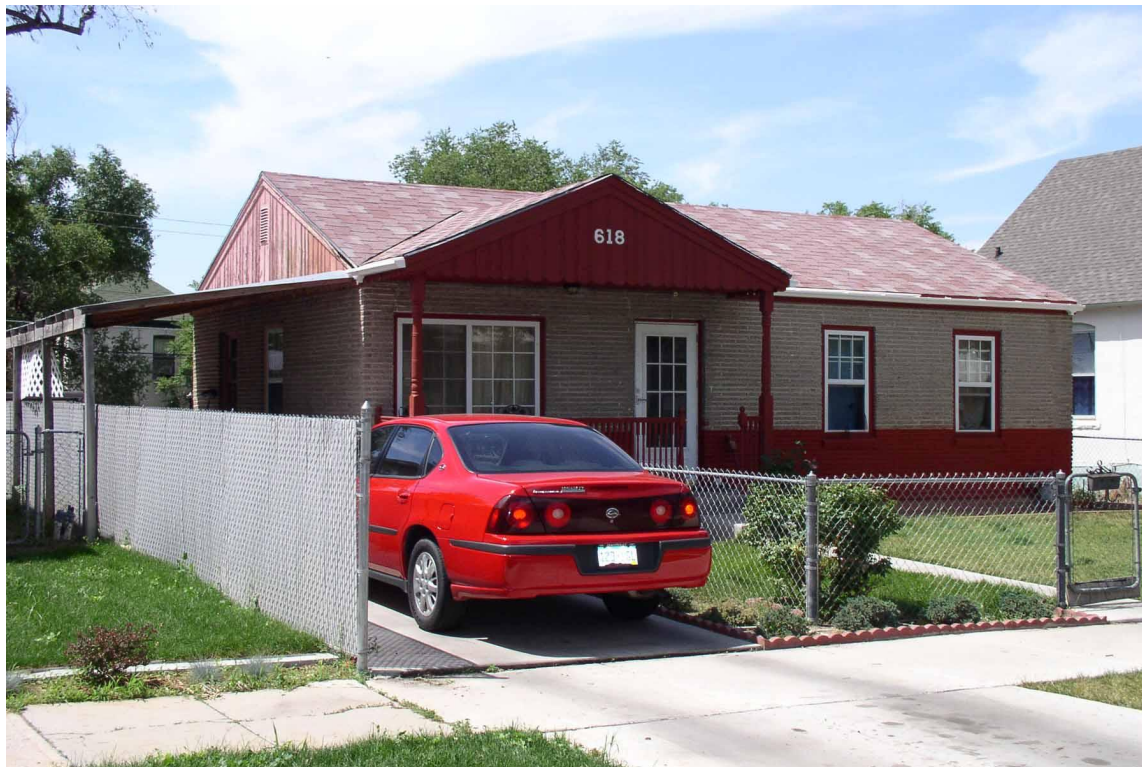
19. Primary external roof material: **Asphalt Roof/Composition Roof**
Other roof materials:
20. Special features: **Fence**
Car Port
Porch
21. General architectural description:
Oriented to the north, this house rests on a concrete foundation. A tan, Roman brick veneer clads the exterior walls. From the foundation to just above the window sills, the bricks are painted red. A vertical wood siding, painted-red and with a scalloped bottom edge, covers the face of all gables. A single-car, shed-roofed carport extends from the east elevation. It consists of a simple, wood frame, and a roof of corrugated, metal sheets. Windows are generally 6-over-6-light, double-hung sash, with white vinyl frames and red-painted wood surrounds. Some windows, particularly those in the rear (south) elevation, have wood frames. The windows have brick sills. A 12-beside-12-light, fixed-frame window opens in the east end of the front (north) façade. A front-gabled porch protrudes from the eastern third of the house. It has a concrete floor and red-painted, wood, turned balusters and supports. A single, concrete step approaches the porch near its west end. The principal doorway opens east of center in the front (north) façade. It hosts a white, 6-panel metal door, with a fanlight. A white, aluminum-frame storm door protects it. Another doorway opens east of center in the rear (south) elevation. It hosts a three-panel, 4-light, glass-in-wood-frame-door, painted pink. Above the door is a small shed-roofed hood. This doorway provides access to a concrete porch off the southeast corner of the house. Red-gray, interlocking asphalt shingles cover the side-gabled roof. The eaves do not overhang, but the fascia is red-painted wood.

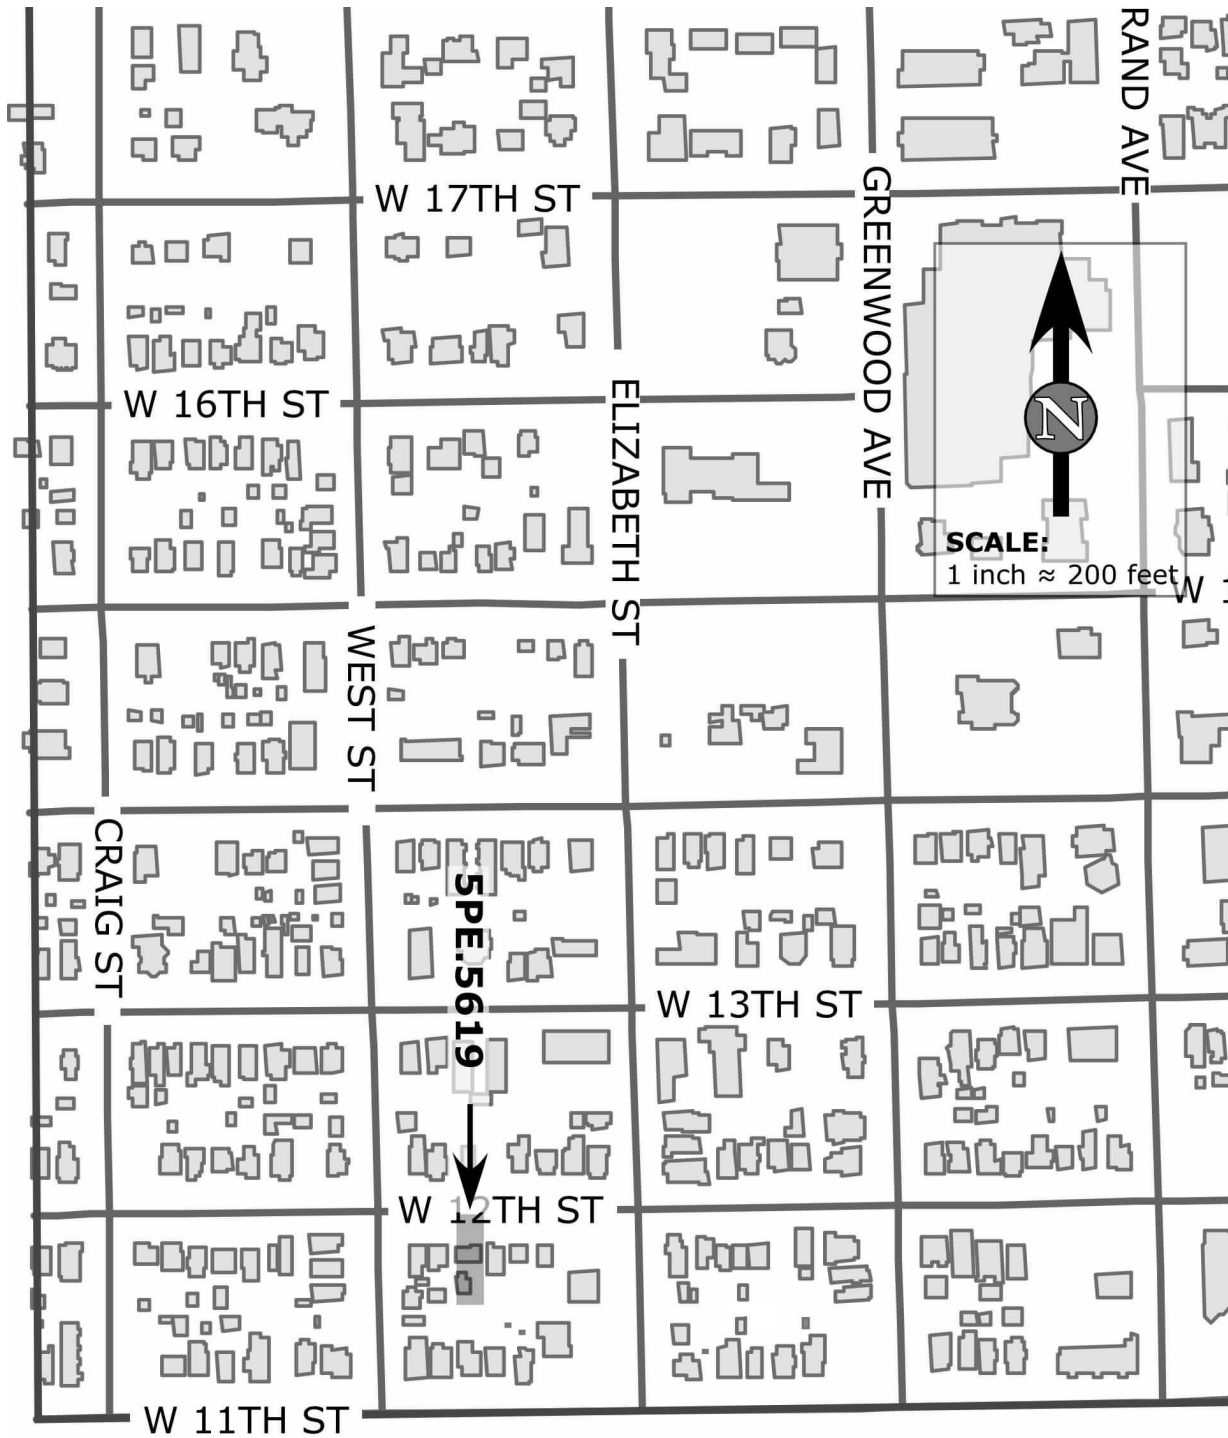
SITE SKETCH MAP

This property is located on terrain sloping downward from north to south, with an elevation of around 4,700 feet above mean sea level. The neighborhood features modest, one- and two-story houses. This property is located on the south side of West 12th Street, an east-west-oriented thoroughfare. It is situated between 616 West 12th Street, to the east, and 624 West 12th Street to the west. A concrete driveway along the east edge of the property connects the street to a carport on the northeast corner of the house. A grass strip separates the sidewalk from the street. Surrounding the house is a planted-grass yard, with mature landscaping. A chain-link fence encloses the property.

Describe: **A 2-car garage is located near the southwest corner of the property. Oriented to the south, the garage rests on a concrete slab. The walls consist of concrete blocks, tinted red from the foundation up approximately 54 inches. Pink-painted, vertical wood siding, with a scalloped bottom edge, covers the gables. Dominating the front (south) elevation is a pair of garage doorways. The east doorway hosts a fiberglass, overhead-retractable garage door. White-painted, vertical beadboard encloses the west doorway. A white-painted, 4-panel, 1-light door opens in the north end of the east elevation. Red-gray, interlocking asphalt shingles cover the front-gabled roof.**
