COLORADO CULTURAL RESOURCE SURVEY

Architectural Inventory Form

- 1. Resource number: **5PE.5621**
- 2. Temporary resource number:
- 3. County: **Pueblo**
- 4. City: **Pueblo**
- 5. Historic building name: **Collins, Horace E., House**
- 6. Current building name: **Martinez, David M., House**
- 7. Building address: **624 W 12th Street**
- 8. Owner name: **David M. Martinez**
- Owner organization:
- Owner address: **624 W 12th St**  
**Pueblo, CO 81003**

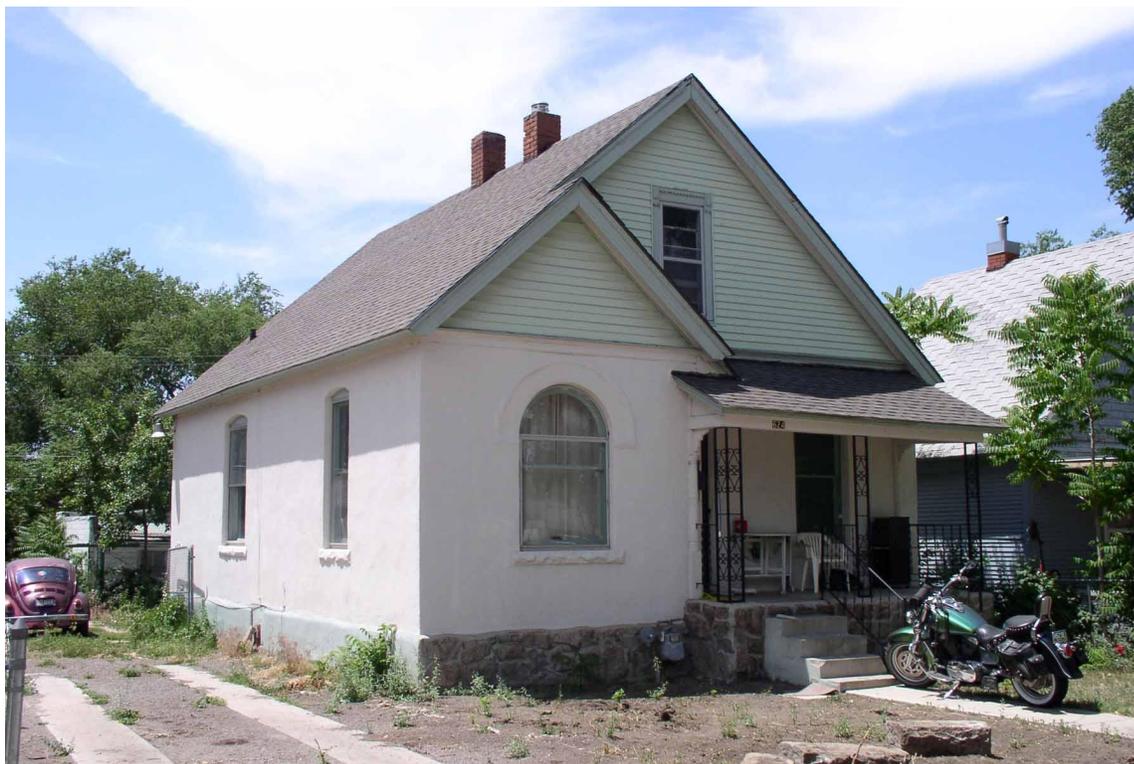
21. General architectural description:  
**Oriented to the north, this house rests on a foundation covered in green-painted stucco, except across the front (north) façade, where it has a random-laid, sandstone veneer. White-painted stucco clads the exterior walls. Green-painted, horizontal wood siding covers the gables. Windows are generally 1-over-1-light, double-hung sash, with green-painted wood frames and aluminum-frame storm windows. Those appearing within the stucco-covered first story open between white-painted, rock-faced sandstone sills and segmental arches. A front-gabled bay projects slightly from the east end of the front façade. The large window dominating this bay has a round-arch transom. Projecting masonry work, now obscured beneath stucco, highlights the arch. Another window opens in the center of the front (north-facing) gable. It has an elaborate, wood architrave. Extending across the rest of the facade is a shed-roofed porch. It has a concrete floor and black, wrought-iron supports and balustrade. On either end of the porch are turned, wood, engaged columns, which most likely resembled the original porch supports. Approaching the east side of the porch are 5 concrete steps, with a wrought-iron railing. The principal doorway opens within a canted wall between the projecting bay and the rest of the porch. It hosts a 3-panel, 1-light, glass-in-wood-frame-door, opening behind a black, security-type, metal storm door. A small shed-roofed enclosed porch or addition protrudes from the west half of the rear (south) elevation. Opening in its east elevation is another doorway. It hosts a green-painted, 6-panel metal door,**

approached by a 5-step concrete stoop. Gray-green asphalt shingles cover the front-gabled roof. Green-painted wood fascia and soffit box the eaves, and the gables have plain, narrow vergeboards. A pair of red-brick chimneys emerges from the roof ridge.
