COLORADO CULTURAL RESOURCE SURVEY

Architectural Inventory Form

- 1. Resource number: **5PE.517.66** Parcel number(s):
- 2. Temporary resource number: **525423007**
- 3. County: **Pueblo**
- 4. City: **Pueblo**
- 5. Historic building name: **Hunter, Andrew J., House**
- 6. Current building name: **Sodamann, Frederick D. and Lois J., House**
- 7. Building address: **626 W 12th Street**
- 8. Owner name: **Frederick D. and Lois J. Sodamann**
- Owner organization:
- Owner address: **2603 Greenwood Ave**  
**Pueblo, CO 81003**

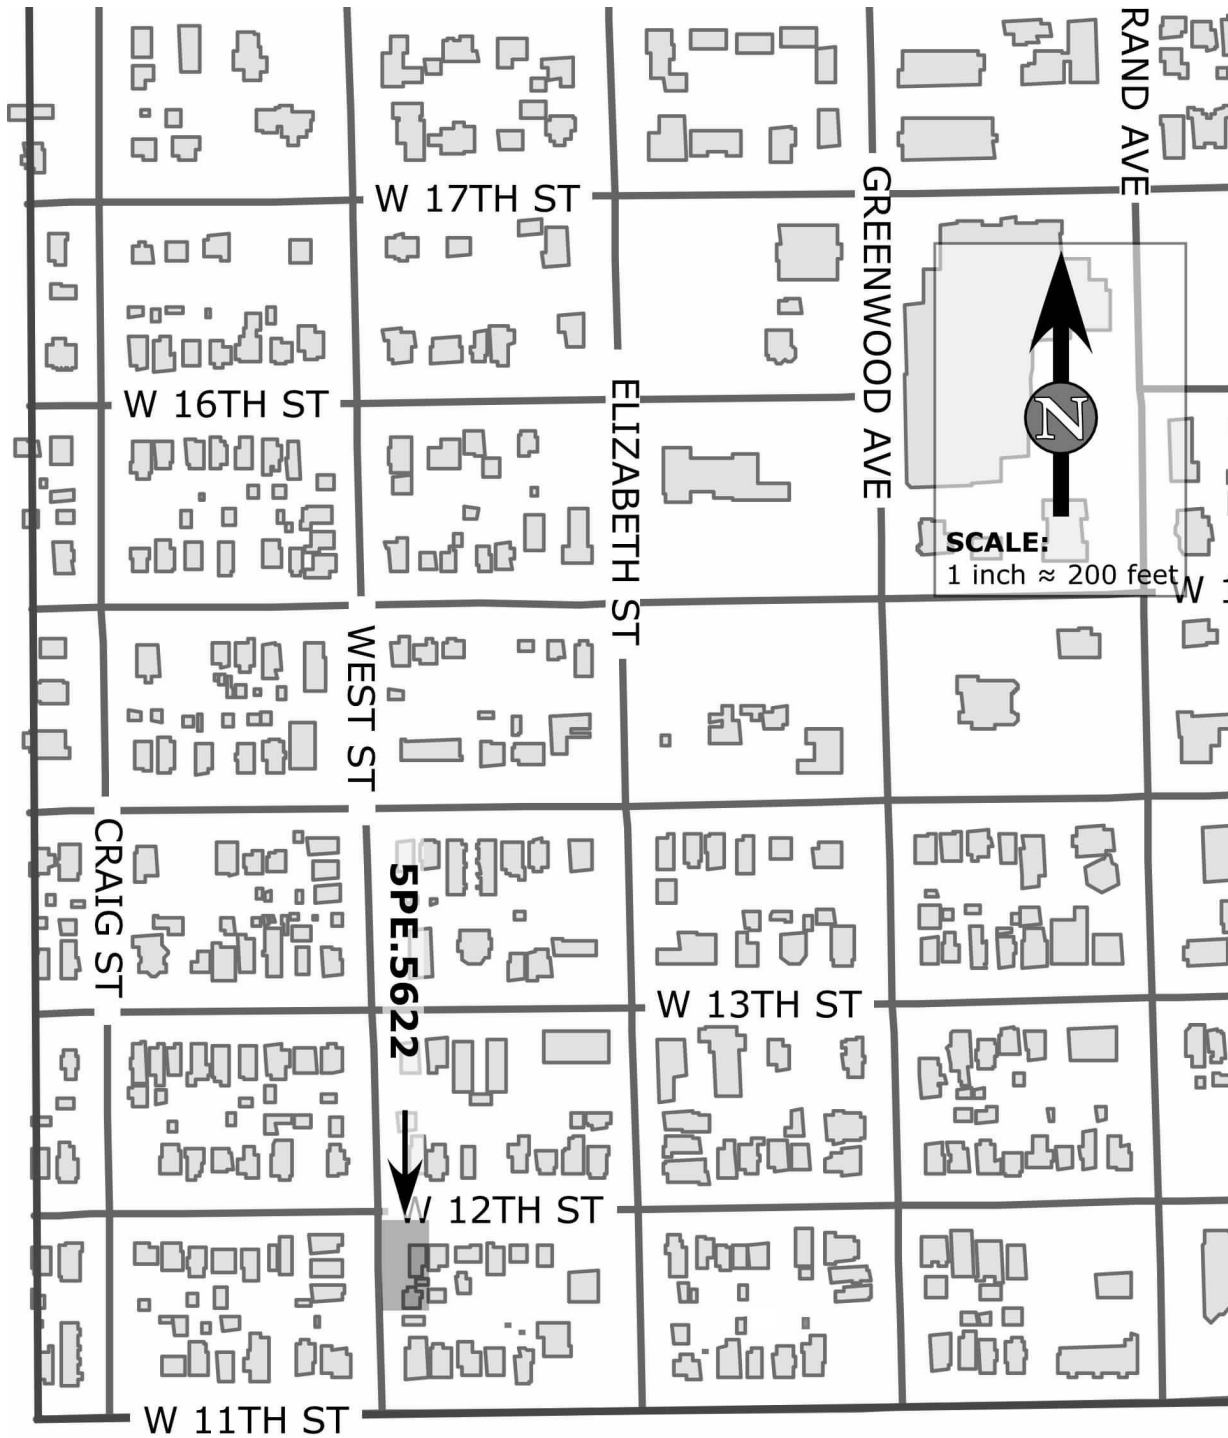
SITE SKETCH MAP

**This property is located on terrain sloping downward from north to south, with an elevation of around 4,700 feet above mean sea level. The neighborhood features modest, one- and two-story houses. This property is situated on the southwest corner of West 12th and West streets. Running parallel to both streets is a sidewalk of pink-colored sandstone. A grass-covered strip separates the sidewalk from the street. A planted grass yard, with mature landscaping, surrounds the house. A chain-link fence encircles the yard.**
