COLORADO CULTURAL RESOURCE SURVEY

Architectural Inventory Form

- 1. Resource number: **5PE.5623** Parcel number(s):
- 2. Temporary resource number: **050** **525420005**
- 3. County: **Pueblo**
- 4. City: **Pueblo**
- 5. Historic building name: **Knebel, George M. and Leo J., House**
- 6. Current building name: **631 West Twelfth Street**
- 7. Building address: **631 W 12th Street**
- 8. Owner name: **Midwest Hotel Management, LLC**
- Owner organization:
- Owner address: **PO Box 5507**
Pueblo, CO 81002

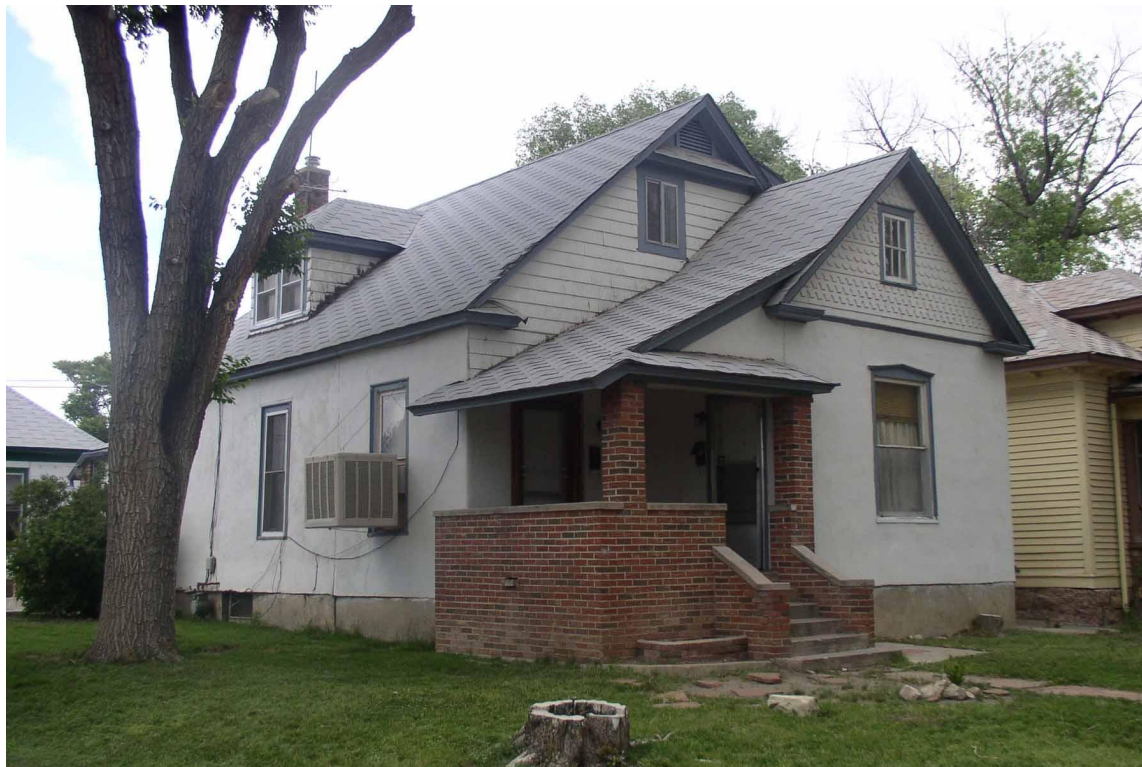
21. General architectural description:
Oriented to the south, this house rests on a concrete foundation, with single-light, hopper basement windows. Gray-painted stucco clads the exterior walls of the first story. Gray-painted, square-cut wood shingles cover the main gables and the sides of a hipped-roof dormer emerging from the roof's west-facing slope. Variegated wood shingles cover the smaller gable of a south-facing bay. A red-brick veneer covers an entrance on the north end of the west elevation and an attached garage to the north. Windows are generally 1-over-1-light, double-hung sash, with white-painted wood frames and blue-painted wood surrounds. The surrounds feature projecting cornices. The architrave surrounding the only south-facing window is pedimented. Opening in the smaller, south-facing gable is a 6-light window. Behind it, piercing the main gable, is an aluminum-frame, sliding-sash window. A small, single-light awning or hopper window opens in a shed-roofed dormer protruding from the north slope of the roof. A single-light window pierces a front-gabled dormer on the roof's east-facing slope. A small, integral porch is located within the building's southwest corner. It features a concrete floor and a kneewall of red brick, capped in concrete. The same

brick comprises the porch supports. Approaching it from the south are 5 concrete steps. Two doorways open onto the porch, one in each face of the inside corner. The eastern doorway has a 3-panel, white-painted wood door, opening behind an aluminum-frame storm door. The western doorway is identical, except that it has a wood-frame storm door. Another doorway, addressed as 1206 West Street, opens in the north end of the west elevation. It hosts a white, 6-panel metal door. Approaching it is a 3-step concrete stoop, with brick kneewalls. North of this door is an attached garage. It has a white-painted, overhead, pivot-type garage door, constructed of beadboard. The door has 2 lights. A concrete driveway approaches the garage from West Street. Gray, interlocking asphalt shingles cover all roof surfaces, and blue-painted wood soffit and fascia, with projecting cornice, box the eaves. Framing the gables are eave returns. A red brick chimney emerges just north of the west-facing dormer.

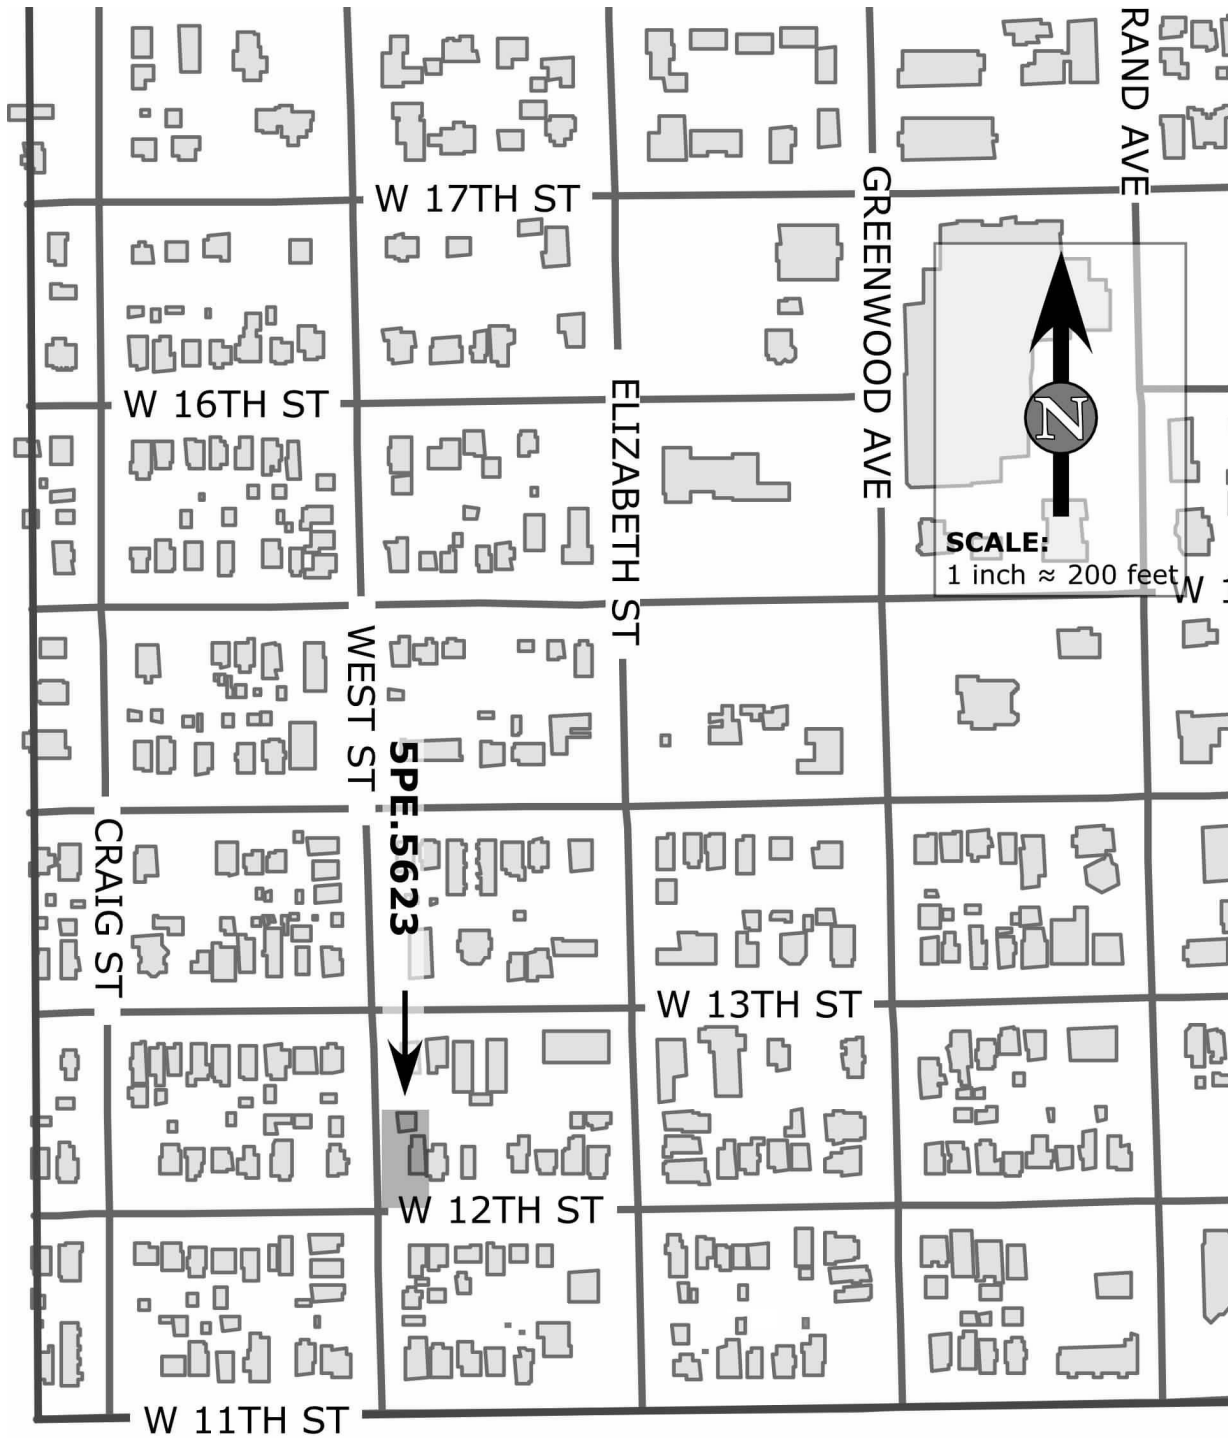
SITE SKETCH MAP

This property is located on terrain sloping downward from north to south, with an elevation of around 4,700 feet above mean sea level. The neighborhood features modest, one- and two-story houses. This property is situated on the northwest corner of West 12th and West streets. Running parallel to West 12th Street is a sidewalk of pink-colored sandstone. A grass-covered strip separates the sidewalk from the street. Surrounding the house is a planted-grass yard, with mature landscaping.
