COLORADO CULTURAL RESOURCE SURVEY

Architectural Inventory Form

- 1. Resource number: **5PE.5624** Parcel number(s):
- 2. Temporary resource number: **051** **525311015**
- 3. County: **Pueblo**
- 4. City: **Pueblo**
- 5. Historic building name: **Unfug, Charles O., House**
- 6. Current building name: **Russell-Perkins Apartments**
- 7. Building address: **711 W 12th Street**
- 8. Owner name: **Michael P. Russell and Delores S. Perkins**
- Owner organization:
- Owner address: **865 Bayfield Dr**
Colorado Springs, CO 80906

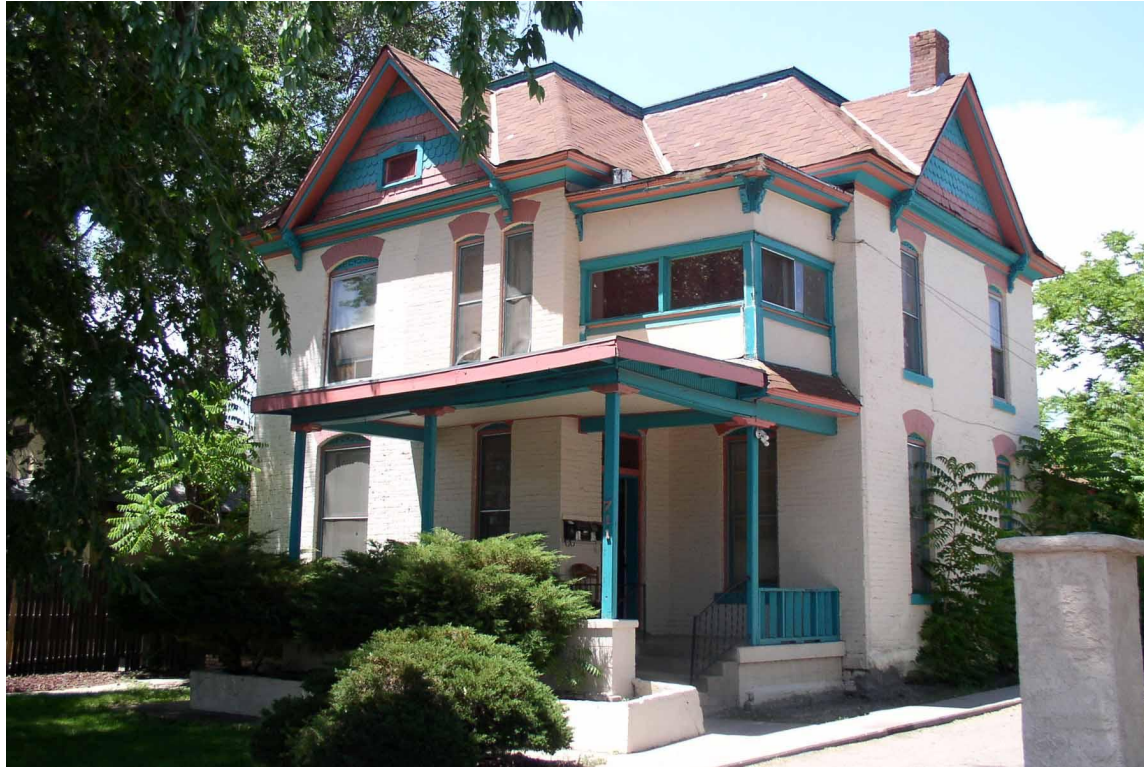
20. Special features: **Fence**
Chimney
Porch
Ornamentation/Decorative Shingles
Window/Segmental Arch
21. General architectural description:
Oriented to the south, this house rests on a sandstone foundation, largely concealed behind cream-painted concrete. A cream-painted brick veneer clads the exterior walls of the original house. Cream-painted stucco covers an addition to the rear (north) of the building. Variegated wood shingles, painted in bands of mauve and teal, cover the gables. Windows are generally 1-over-1-light, double-hung sash, with green- or white-painted wood frames and aluminum-frame storm windows. Windows open between teal-painted, dressed sandstone sills and segmental arches, highlighted in mauve. Between the top sash and the bottom of the arch is a wood panel engraved with a symmetrical, ornamental pattern. The gabled addition to the rear (north) elevation has 4-light, sliding-sash; single-light awning; and 1-over-1-light, double-hung sash windows. A porch extends from the inside (southeast-facing) corner of the house and across the eastern portion of the front (south) façade. It has a concrete floor, concrete-block kneewall, and a combination of wrought-iron railings and simple, wood balustrades. A concrete planter extends southward from the front (south) of the porch. The porch has a shed roof and simple, mauve-painted, square wood supports. The porch provides access to the principal doorway, which opens in the east face of the inside corner. It hosts a 2-panel, 1-light door. Beneath the protruding locking rail are a row of 3, engraved rosettes. A single-light transom appears above

the door. A sleeping porch is above the main porch. Fixed-frame and sliding-sash windows enclose the porch. Teal-painted scroll brackets appear beneath the eaves. These brackets also appear beneath the corners of the pedimented gables. Another doorway opens near the center of the rear (north) elevation. Interlocking, brown asphalt shingles cover the truncated hipped roof. Wood fascia and soffit box the coved eaves. The soffit is painted teal and the fascia is mauve, with a protruding cornice. A louvered attic vent pierces the front (south-facing) gable. Around it is a teal-painted, pedimented architrave, with a rosette beneath the pediment. Brick chimneys emerge from the ridges of the east-facing and west-facing gables and the ridge of the single-story addition.

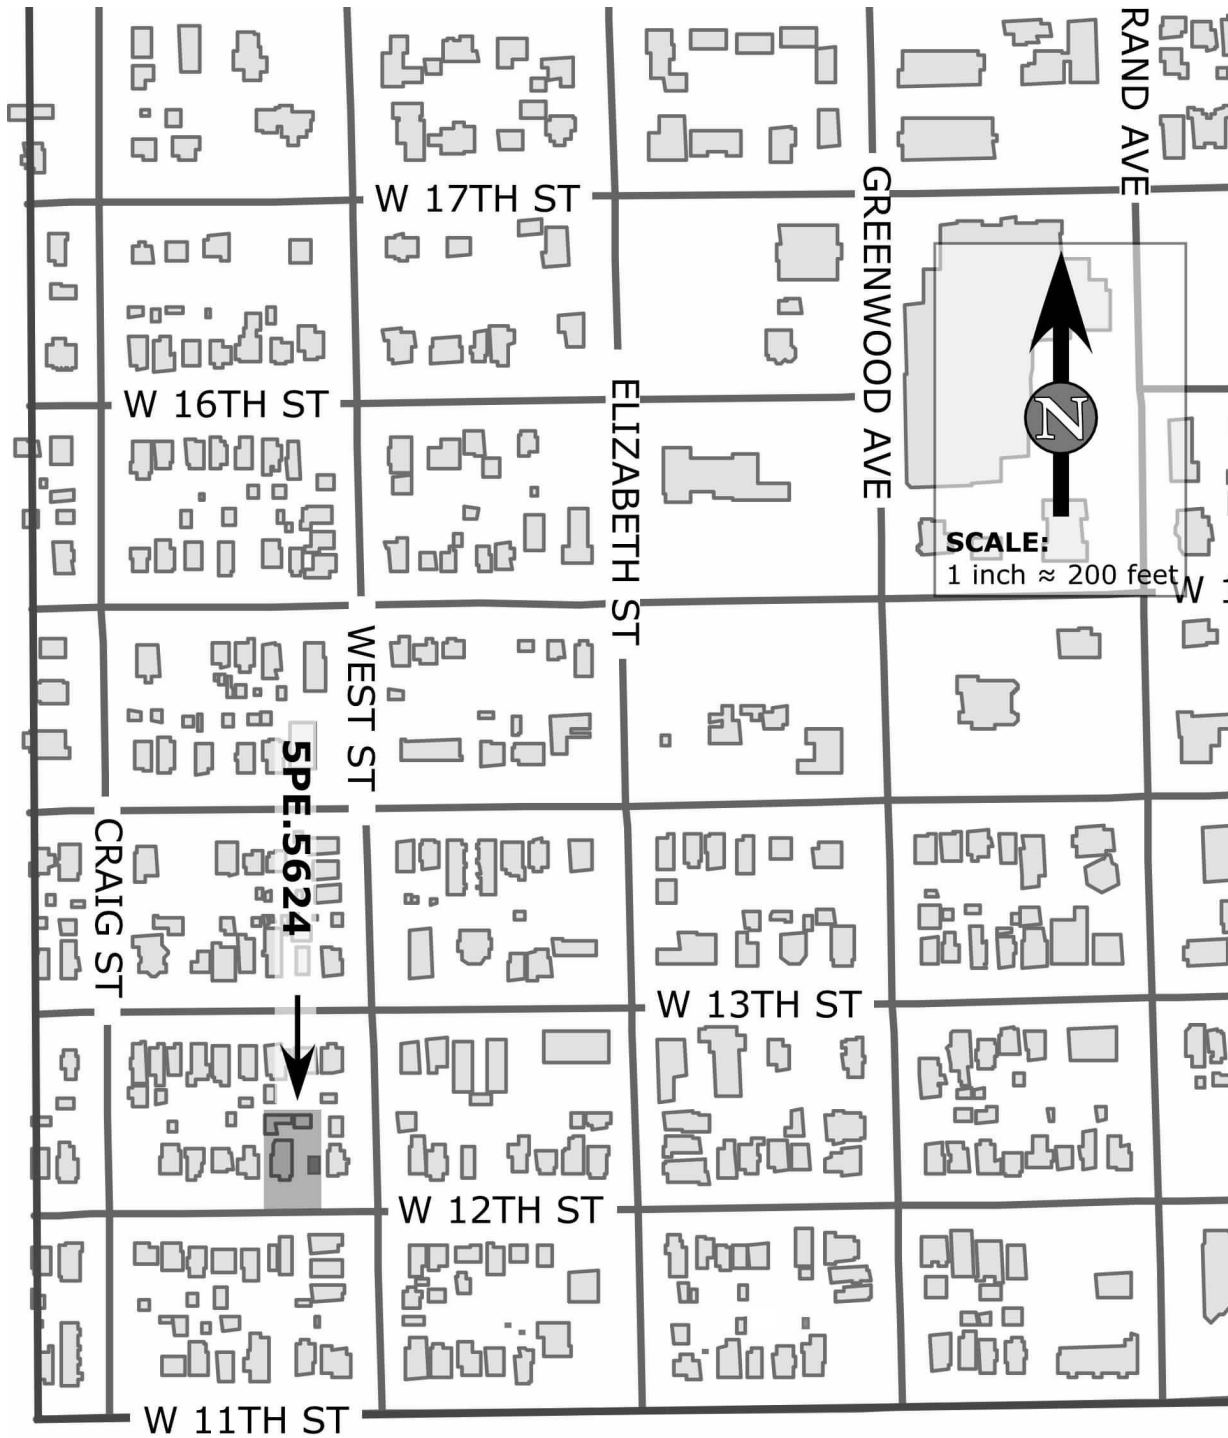
SITE SKETCH MAP

This property is located on terrain sloping downward from north to south, with an elevation of around 4,700 feet above mean sea level. The neighborhood features modest, one- and two-story houses. This property is located on the north side of West 12th Street, an east-west-oriented thoroughfare. It is situated between 1203 West Street, to the east, and 715 West 12th Street, to the west. A grass strip separates the sidewalk from the street. Surrounding the house is a planted-grass yard, with mature landscaping. Remnants of a concrete, 2-track driveway extend from West 12th Street, along the west side of the house, to what was a garage on the northwest corner of the property. A large parking lot is located east of the house, partially surrounded by a stucco-covered wall.

1: Type: **Apartment-Garage Complex (northwest)**

2: Type: **Garage (east)**

3: Type: **Apartment-Garage Complex (northeast)**
