COLORADO CULTURAL RESOURCE SURVEY

Architectural Inventory Form

- 1. Resource number: **5PE.5626** Parcel number(s):
- 2. Temporary resource number: **052** **525319002**
- 3. County: **Pueblo**
- 4. City: **Pueblo**
- 5. Historic building name: **Thompson Grocery Store**
- 6. Current building name: **Sullivan, Michael Sean, House**
- 7. Building address: **714 W 12th Street**
- 8. Owner name: **Michael Sean Sullivan**
- Owner organization:
- Owner address: **714 W 12th St**  
**Pueblo, CO 81004**

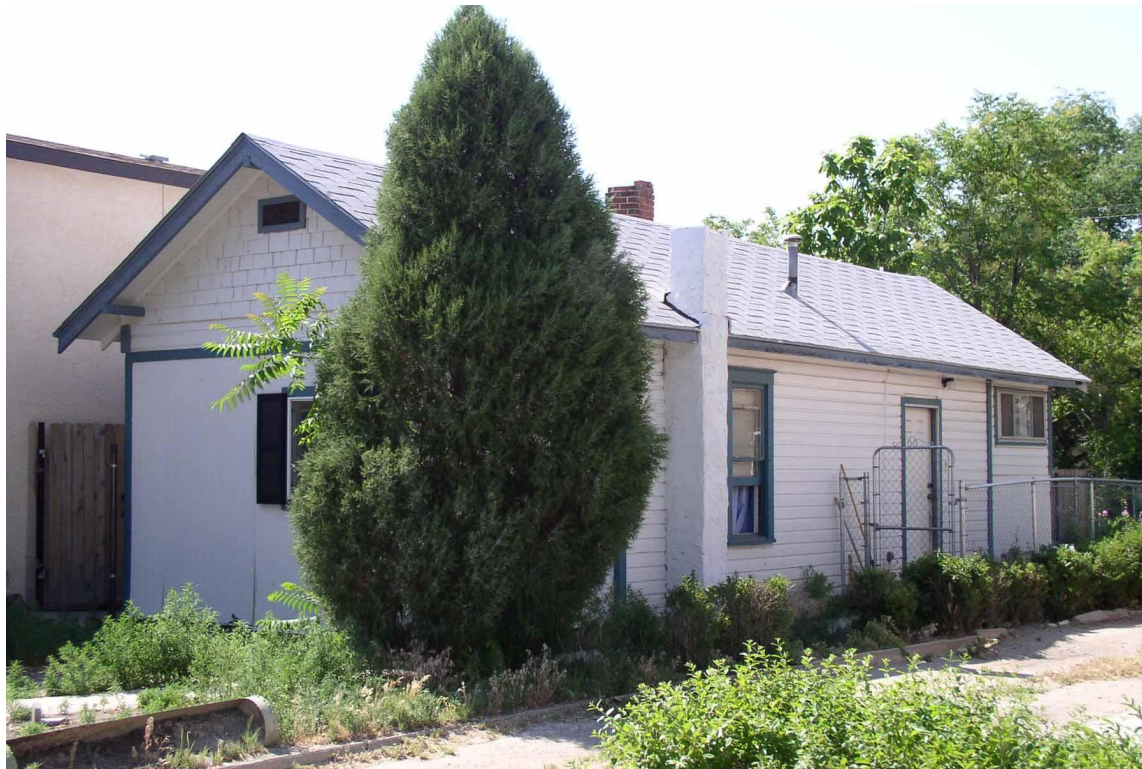
**While this house is situated on the south side of West 12th Street, it is actually oriented to the west and rests on a concrete slab. White-painted wood weatherboard, with 1-by-4-inch cornerboards, clads the exterior walls. White-painted, square-cut wood shingles cover the gables. White-painted plywood sheets entirely enclose a front-gabled porch across the north elevation. Windows are generally 1-over-1-light, double-hung sash, with blue-painted wood frames and surrounds. Other windows are 1-beside-1-light, sliding sash, with ether white vinyl or natural aluminum frames. The south elevation hosts a 6-light casement window, opening behind an aluminum-frame storm window. A doorway opens south of center in the front (west) façade. It hosts a 6-panel, white, metal door. A single, concrete step approaches the door. Gray, interlocking asphalt shingles cover the side-gabled roof. The shaped perlin ends are exposed. However, a fascia board, painted blue, caps the exposed rafter ends. A white-painted, stucco-covered, engaged chimney protrudes near the north end of the façade. Another brick chimney protrudes from the center of the roof's east-facing slope, near the roof ridge.**

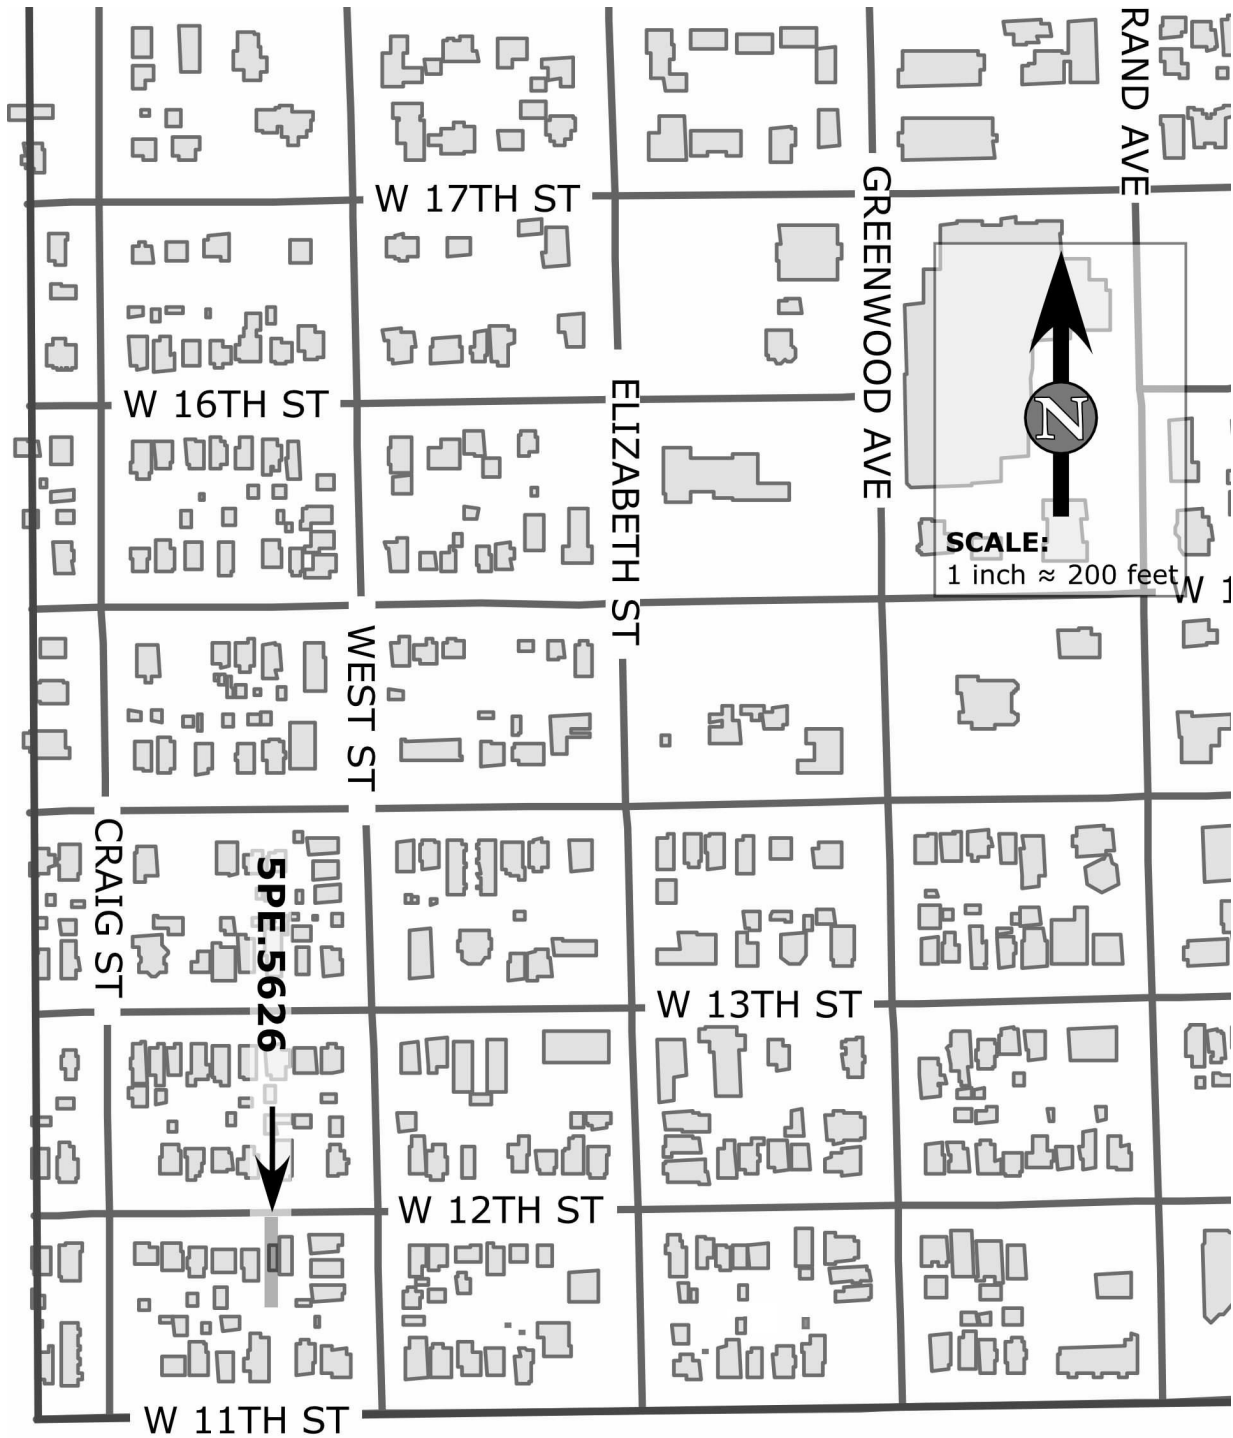
#### SITE SKETCH MAP

This property is located on terrain sloping downward from north to south, with an elevation of around 4,700 feet above mean sea level. The neighborhood features modest, one- and two-story houses. This property is located on the south side of West 12th Street, an east-west-oriented thoroughfare. It is situated between 712 W 12th Street, to the east, and 716 West 12th Street to the west. Running parallel to the street is a sidewalk of pink-colored sandstone slabs. A grass strip separates the sidewalk from the street. Surrounding the house is a small yard. A chain-link fence encloses the narrow backyard.
