COLORADO CULTURAL RESOURCE SURVEY

Architectural Inventory Form

- 1. Resource number: **5PE.517.29** Parcel number(s):
- 2. Temporary resource number: **054** **525319003**
- 3. County: **Pueblo**
- 4. City: **Pueblo**
- 5. Historic building name: **Collins, William H., House**
- 6. Current building name: **Laas, Merrilee V., House**
- 7. Building address: **716 W 12th Street**
- 8. Owner name: **Merrilee V. Laas**
- Owner organization:
- Owner address: **716 W 12th St**  
**Pueblo, CO 81003**

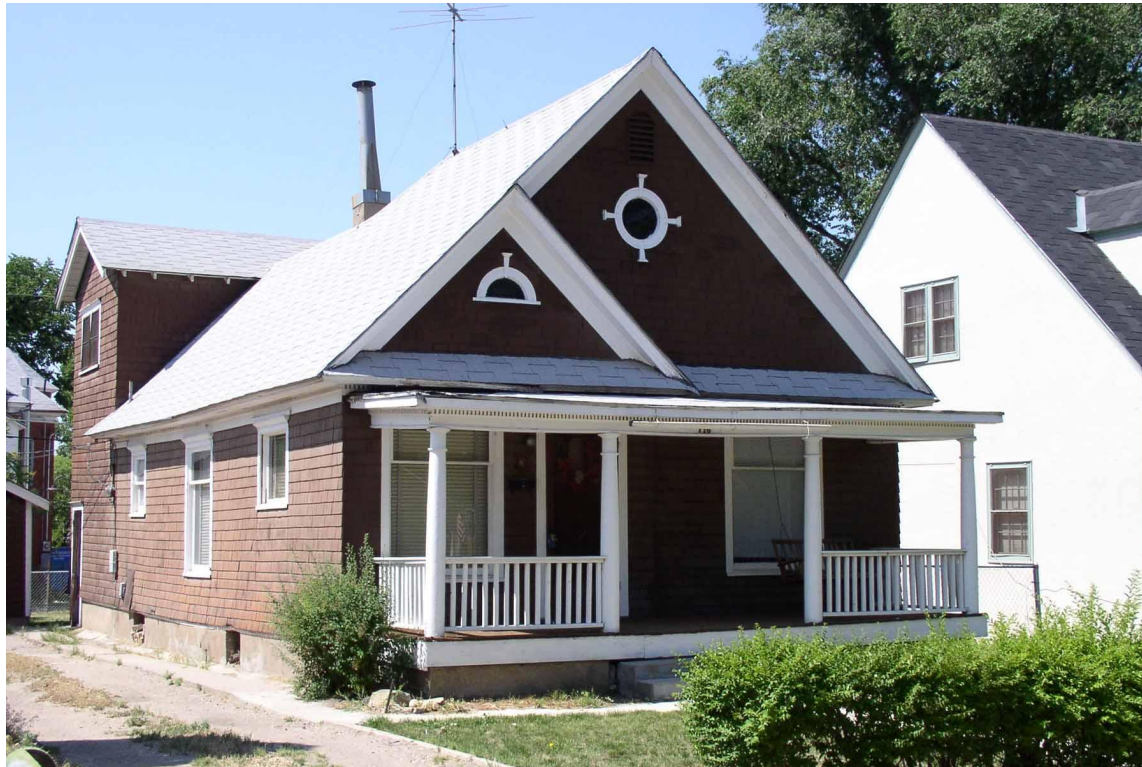
**Oriented to the north, this house rests on a concrete foundation, with 3-light hopper basement windows. Brown-painted, square-cut wood shingles clad the exterior walls. Windows are generally 1-over-1-light, double-hung sash, with white-painted wood frames and surrounds. The surrounds have projecting, dentiled cornices. Those windows opening in the front (north) façade and at the center of the east elevation have narrow upper sashes. Appearing in the upper story of a 2-story addition to the rear (south) elevation are 3-(vertical)-over-1-light, double-hung sash windows. A single-light hopper or awning window opens in the north end of the east elevation. Piercing the center of the front (north-facing) gable is a round window. A pediment is situated within the east corner of this gable. At its center is a half circular window. A hipped-roof porch spans the entire façade. It has a white-painted wood balustrade between wood, Tuscan columns. The porch has a dentiled cornice. Opening east of center in the façade is the principal doorway. It hosts a 3-panel, 3-light, wood door, opening behind a wood-frame screen door. Another doorway opens low in the south end of the east elevation. Gray, interlocking asphalt shingles cover the front-gabled main roof and the side-gabled roof of the 2-story addition. White-painted wood fascia and soffit box the eaves, and the rafter ends are exposed beneath the roof of the 2-story addition.**
