COLORADO CULTURAL RESOURCE SURVEY

Architectural Inventory Form

I. IDENTIFICATION

- 1. Resource number: **5PE.5628** Parcel number(s):
- 2. Temporary resource number: **057** **525319004**
- 3. County: **Pueblo**
- 4. City: **Pueblo**
- 5. Historic building name: **Sun-Ra Apartments**
- 6. Current building name: **Fuss Apartments**
- 7. Building address: **718 W 12th Street**
- 8. Owner name: **Rodney Jay Fuss**
- Owner organization:
- Owner address: **718 W 12th St**
Pueblo, CO 81003

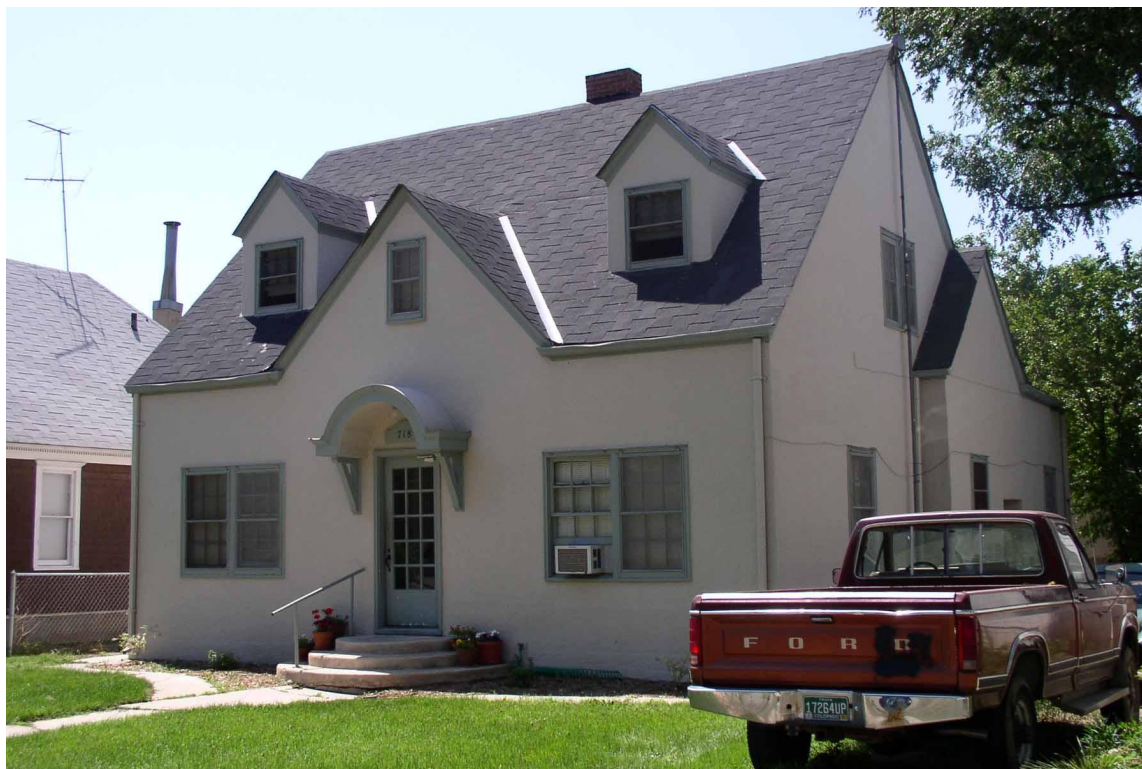
19. Primary external roof material: **Asphalt Roof/Composition Roof**
Other roof materials:
20. Special features: **Chimney**
Roof Treatment/Dormer
21. General architectural description:
Oriented to the north, this house rests on a concrete foundation, covered in cream-painted stucco. Basement window openings have been boarded shut. Cream-painted stucco clads the exterior walls. Windows are generally 6-over-6-light, double-hung sash, with green-painted wood frames, screens, and surrounds. They are paired on either side of the front (south) façade. Smaller window openings are 4-over-4-light. The principal doorway opens in the center of the symmetrical façade. It hosts a 15-light, glass-in-wood-frame door, painted green. A barrel-roofed hood, on simple knee brackets, protects the rounded, 3-step stoop. Two other doorways open in the south ends of both the east and west elevations. They host 3-panel, 9-light, glass-in-wood-frame doors, painted green. Another doorway opens in the second story of the rear (south) elevation, offset east of center. It hosts the same kind of door as the side doorways and is protected beneath a pent roof. It provides access to a green-painted, steel staircase descending to the south. Dark gray, interlocking asphalt shingles cover the cross-gabled roof. Front-gabled dormers protrude from either side of the roof's north-facing slope. The house has no overhanging eaves. A squat, red-brick chimney emerges from the center of the east-west-oriented roof ridge.

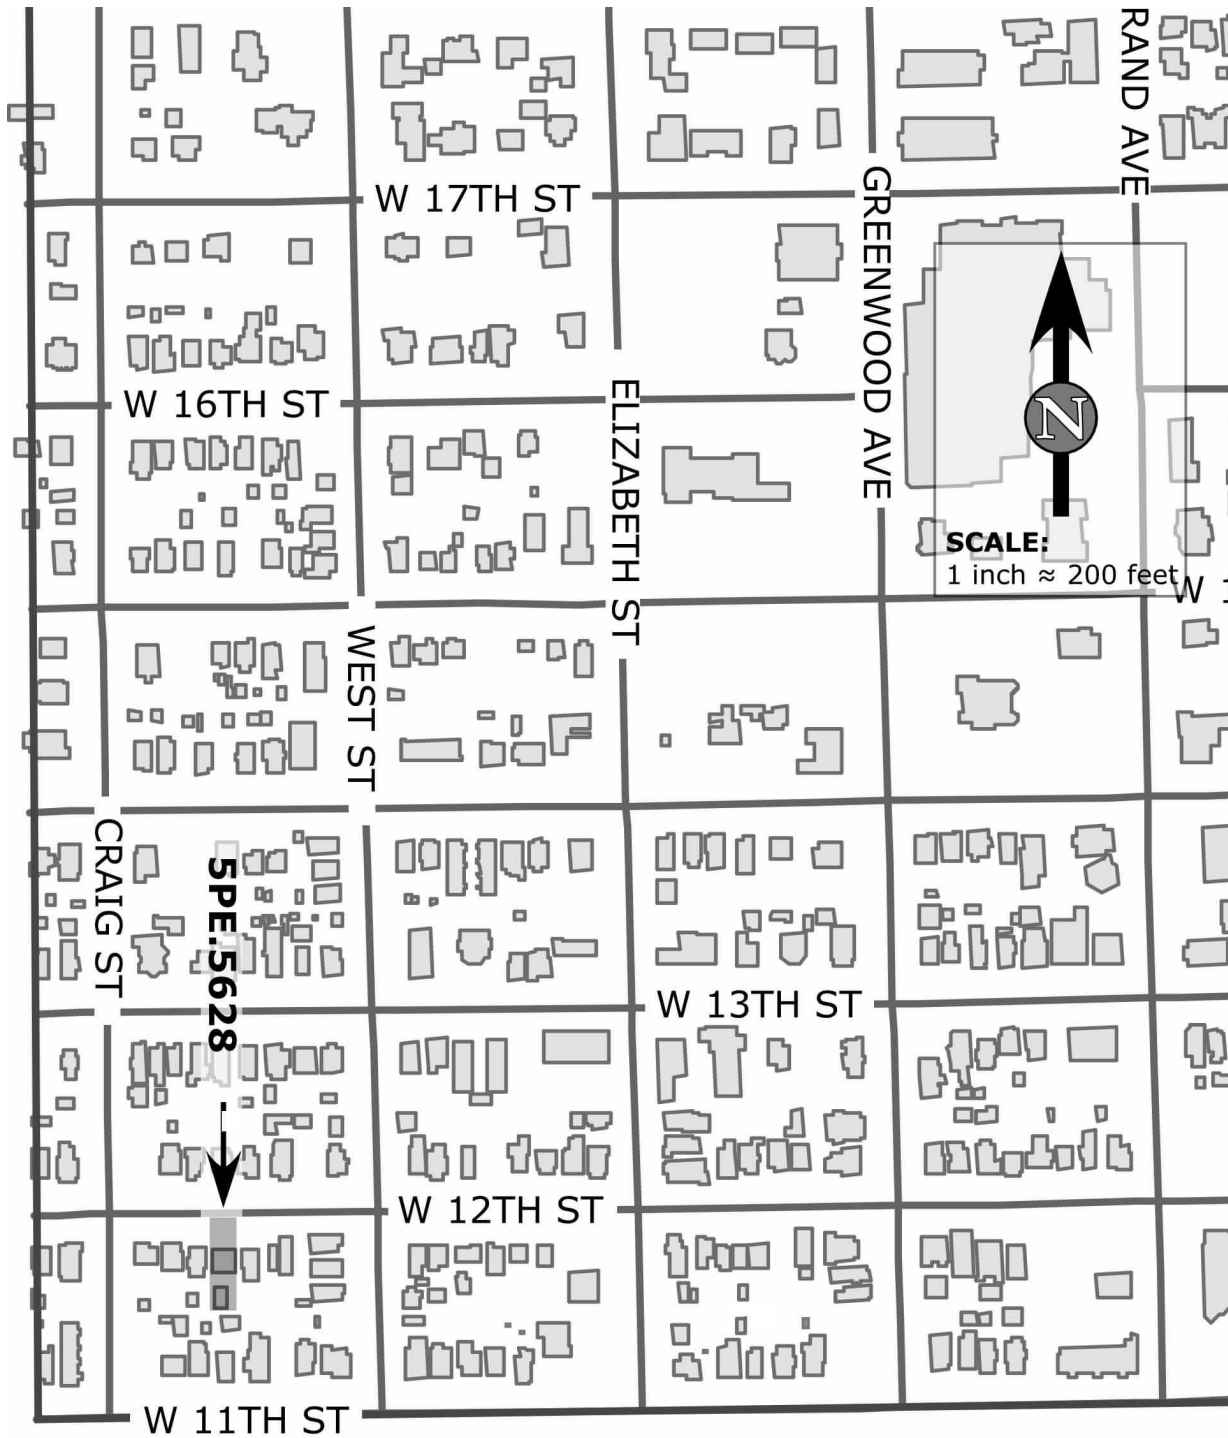
SITE SKETCH MAP

This property is located on terrain sloping downward from north to south, with an elevation of around 4,700 feet above mean sea level. The neighborhood features modest, one- and two-story houses. This property is located on the south side of West 12th Street, an east-west-oriented thoroughfare. It is situated between 716 W 12th Street, to the east, and 720 West 12th Street to the west. A gravel-covered strip separates the sidewalk from the street. Surrounding the house is a planted-grass yard, with mature landscaping. A gravel parking lot is located behind (south of) the house, accessed from the alley.
