COLORADO CULTURAL RESOURCE SURVEY

Architectural Inventory Form

- 1. Resource number: **5PE.5629** Parcel number(s):
- 2. Temporary resource number: **058** **525319005**
- 3. County: **Pueblo**
- 4. City: **Pueblo**
- 5. Historic building name: **Rushmer, Gorton, House**
- 6. Current building name: **Mulvihill, Kelli T.**
- 7. Building address: **720 W 12th Street**
- 8. Owner name: **Kelli T. Mulvihill**
- Owner organization:
- Owner address: **720 W 12th St**
- Pueblo, Colorado 81003**

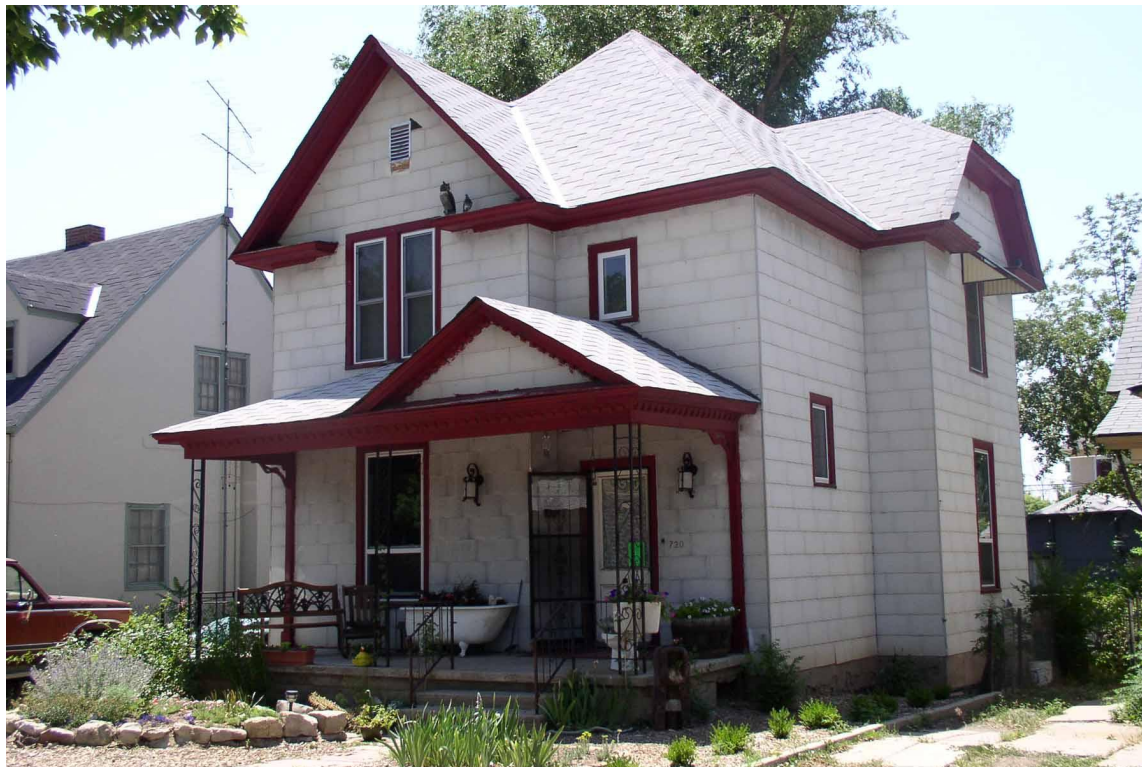
19. Primary external roof material: **Asphalt Roof**
 Other roof materials:
20. Special features: **Fence**
Chimney
Porch
21. General architectural description:
Oriented to the north, this house rests on a sandstone foundation, largely concealed behind concrete stucco. Gray, asbestos shingle siding clads the exterior walls. Windows are 1-over-1-light, double-hung sash, with white vinyl frames and red-painted wood surrounds. The window opening in the first story of the front (north) elevation has a narrow bottom sash. A single-light casement window appears in the west side of the façade's second story and between the stories in the west elevation. A hipped-roof front porch spans the facade. It has a concrete floor, and wrought iron supports and railing. Extending from red-painted, wood pilasters on either end of the porch are elaborate scrolled brackets. A pediment dominates the western half of the porch. The porch fascia and the pediment feature a red-painted, heavy dentiled cornice. Beneath the pediment, approaching the porch, are 2 concrete steps. The principal doorway opens in the west side of the facade, in a recess west of the front-gabled bay that projects forward from the east side of the façade. The doorway hosts a 2-panel, 1-light, glass-in-wood-frame door, painted white, opening behind a back, security storm door. Another doorway opens near the center of the rear (south) elevation. It is a wood slab door with a single, diamond-shaped light. Gray, interlocking asphalt shingles cover the hipped roof. The 2-story bays projecting from the center off the east and west elevations have clipped gables. Red-painted wood soffit and fascia, with projecting cornice, box the broadly overhanging eaves.

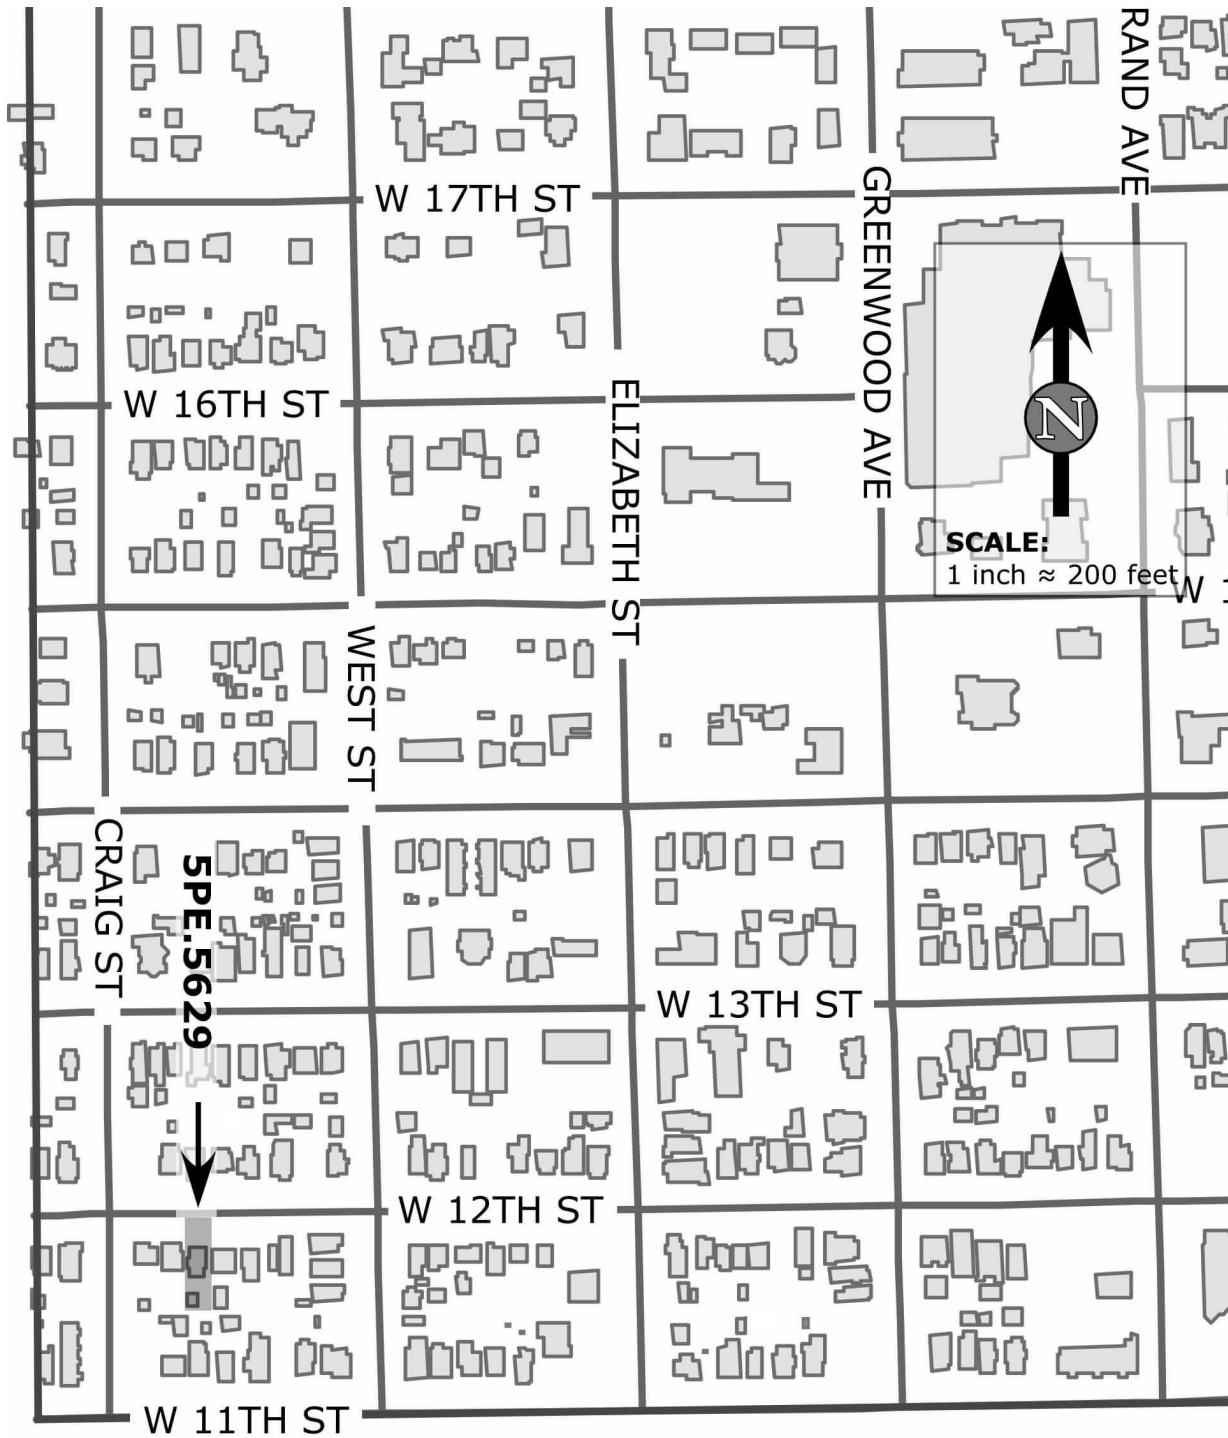
SITE SKETCH MAP

This property is located on terrain sloping downward from north to south, with an elevation of around 4,700 feet above mean sea level. The neighborhood features modest, one- and two-story houses. This property is located on the south side of West 12th Street, an east-west-oriented thoroughfare. It is situated between 718 W 12th Street, to the east, and 722 West 12th Street to the west. A grass strip, planted with a large catalpa tree, separates the sidewalk from the street. Mulch covers the front yard, interspersed by rock-lined flowerbeds. A combination of chain-link and wood privacy fences encircles the planted-grass backyard. Behind (south of) the house is a brick patio.
