COLORADO CULTURAL RESOURCE SURVEY

Architectural Inventory Form

48. Report title: **Pueblo North Side Neighborhood Survey**

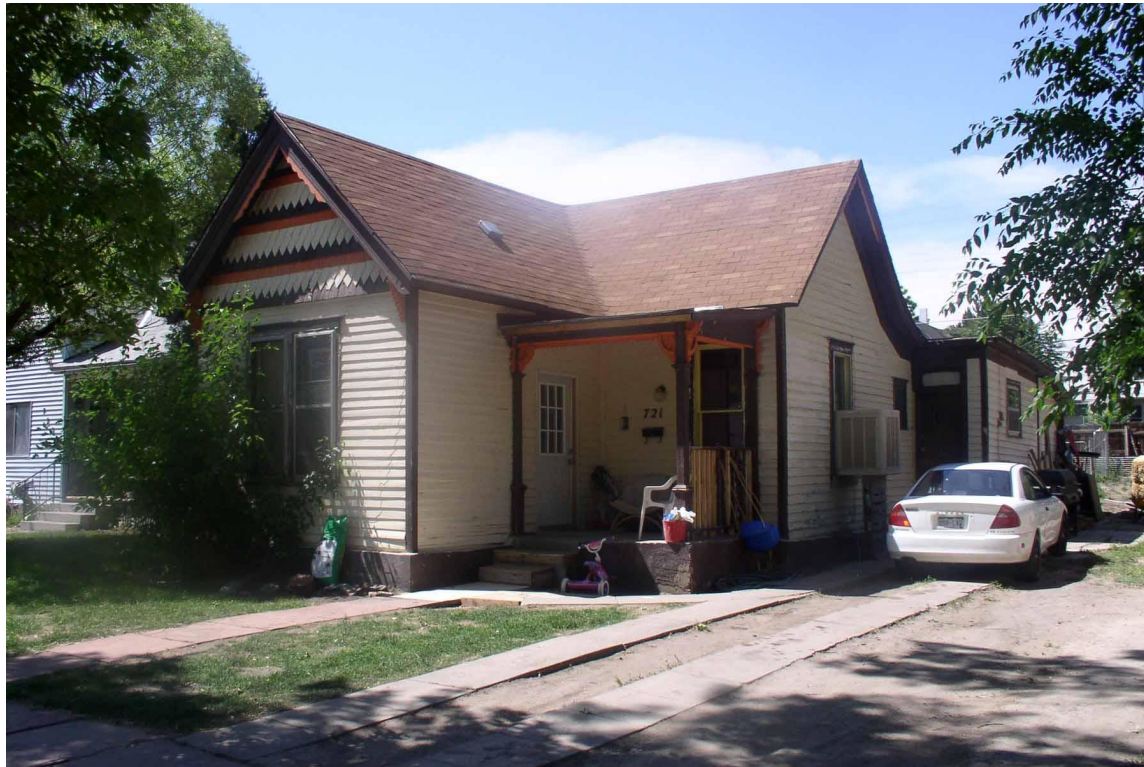
19. Primary external roof material: **Asphalt Roof**
Other roof materials:
20. Special features: **Fence**
Porch
Ornamentation/Decorative Shingles
21. General architectural description:
Oriented to the south, this house appears to rest on a brown-painted concrete foundation (or perhaps a concrete sill installed post-construction). Yellow-painted, horizontal wood siding, with brown-painted, 1-by-4-inch cornerboards, clads the exterior walls. Variegated wood shingles, in brown-, yellow-, and orange-painted bands, clad the exterior walls. Windows are generally 1-over-1-light, double-hung sash, with brown- or yellow-painted wood frames and brown-painted wood surrounds. The surrounds have projecting cornices. Some windows have aluminum-frame storm windows. A pair of single-light hopper, awning, or casement windows opens in the east end of the rear (north) elevation. A shed-roofed porch nearly fills the inside (southeast-facing) corner of the house. The porch has a concrete floor and brown-painted, wood supports, with pedestals and capitals and chamfered edges. A simple, wood balustrade lines the east side of the porch. The porch's decorative features include sunrise brackets and a scalloped frieze. The principal doorway opens in the east face of this inside corner. It hosts a white, 9-light metal door, with faux X-shaped bracing. Opening east of center on the rear elevation is a wood slab door, providing access to an uncovered, concrete patio. A shed-roofed addition protrudes from the rear (north) and east elevations. Another doorway opens in this addition's narrow south elevation. It is a single-light, wood slab door, opening beneath a single-light transom. Approaching it is a single, concrete step. Brown asphalt shingles cover the cross-gabled roof. Brown-painted wood soffit and fascia, with protruding cornice, box the eaves. Brown-painted wood vergeboards and orange-painted, scrolled brackets decorate the gables.

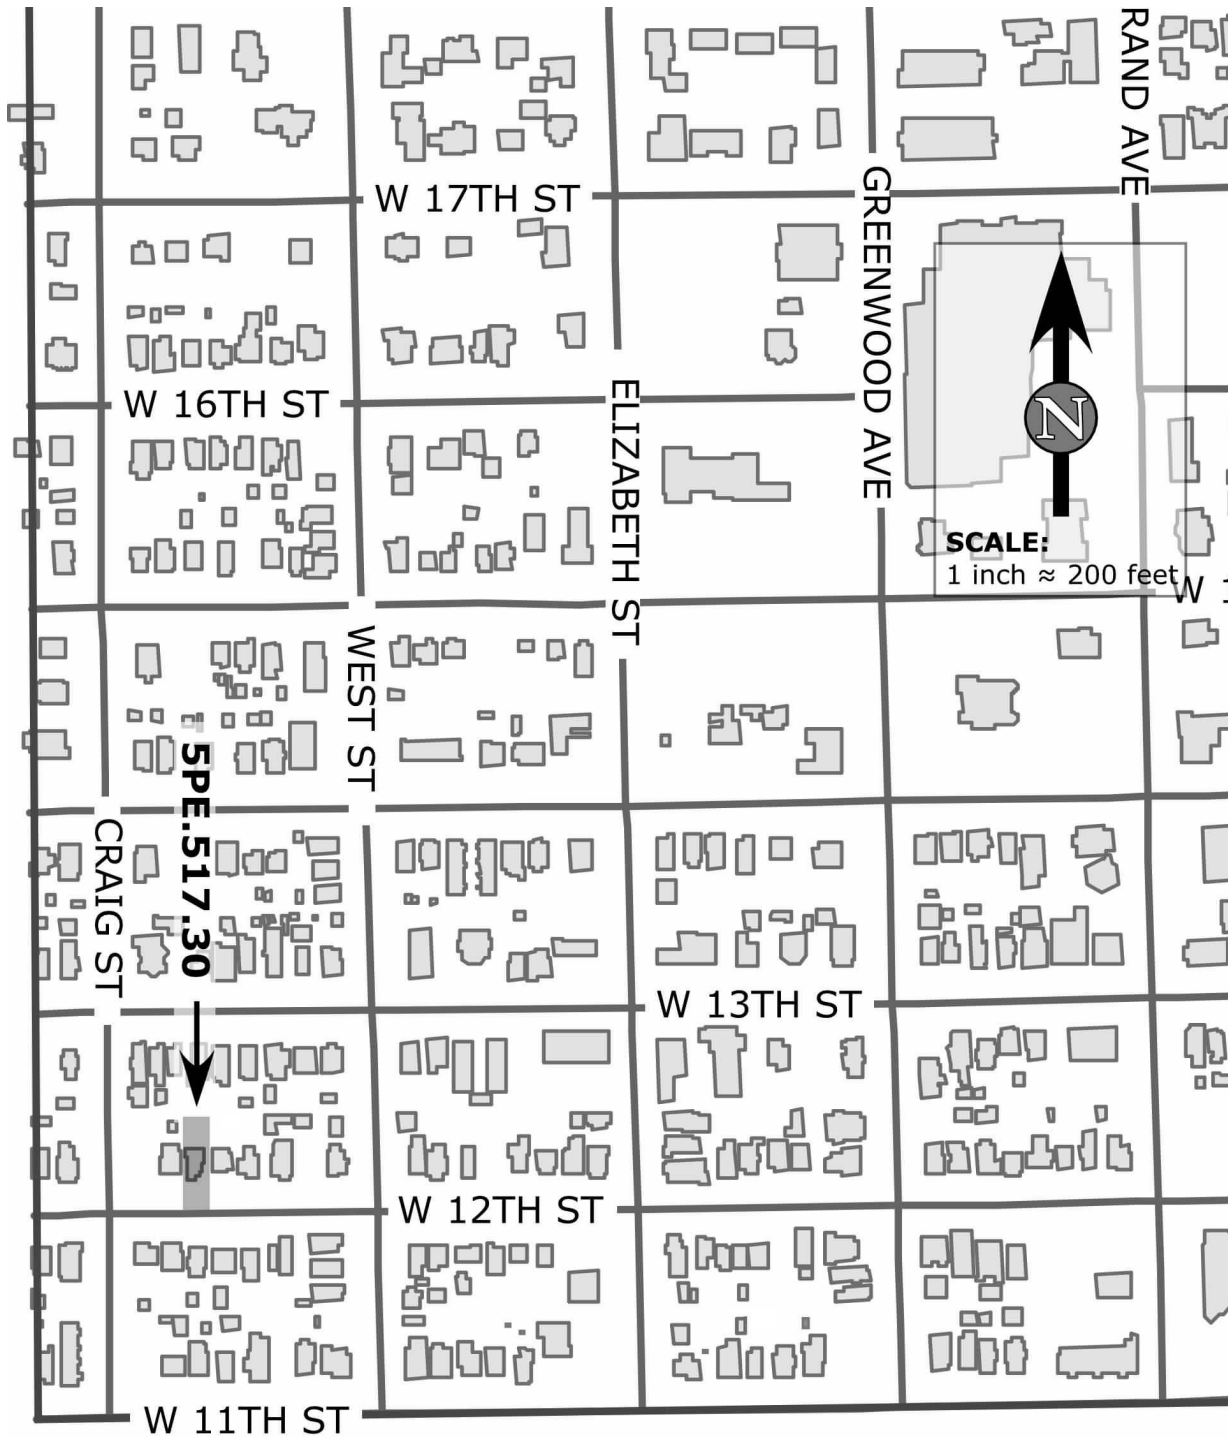
SITE SKETCH MAP

This property is located on terrain sloping downward from north to south, with an elevation of around 4,700 feet above mean sea level. The neighborhood features modest, one- and two-story houses. This property is located on the north side of West 12th Street, an east-west-oriented thoroughfare. It is situated between 717 W 12th Street, to the east, and 725 West 12th Street, to the west. Running parallel to the street is a sidewalk of pink sandstone slabs. A grass strip separates the sidewalk from the street. Surrounding the house is a planted-grass yard, with mature landscaping. A concrete, 2-track driveway runs from West 12th Street along the east side of the house. Encircling a portion of the back yard is a woven-wire fence.
