COLORADO CULTURAL RESOURCE SURVEY

Architectural Inventory Form

- 1. Resource number: **5PE.517.31** Parcel number(s):
- 2. Temporary resource number: **061** **525319007**
- 3. County: **Pueblo**
- 4. City: **Pueblo**
- 5. Historic building name: **Gregory, Gilbert D., House**
- 6. Current building name: **Abeyta, Gerald A. and Linda C., House**
- 7. Building address: **724 W 12th Street**
- 8. Owner name: **Gerald A. and Linda C. Abeyta**
- Owner organization:
- Owner address: **724 W 12th St**
Pueblo, CO 81003

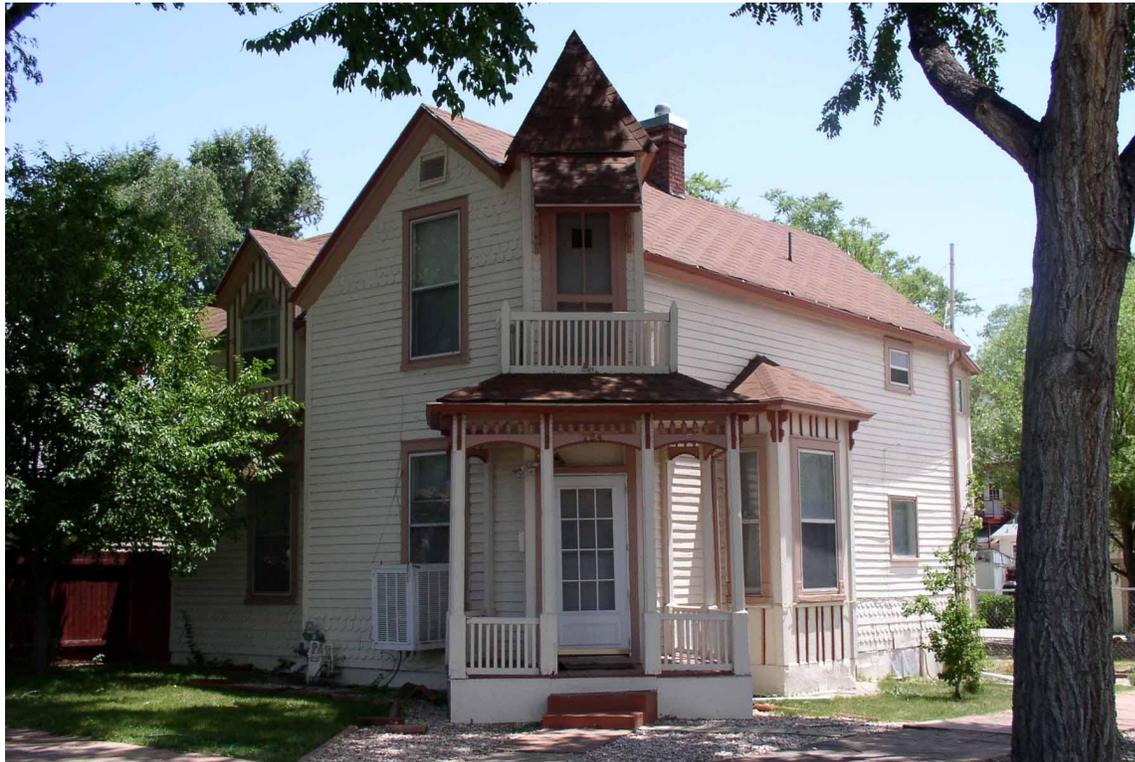
21. General architectural description:
Oriented to the northwest, this house appears to rest on a sandstone foundation encased in cream-painted concrete. Basement windows are three-light hopper. Cream-painted, horizontal wood siding, with 1-by-4-inch cornerboards, clads most of the exterior walls. However, a band of variegated wood shingles extends upward to approximately 3 feet above the foundation. These same variegated shingles cover the gables. Cladding the surface of some bay windows is vertical board-and-batten siding. Windows are generally 1-over-1-light, double-hung sash, with cream-painted wood frames and pink surrounds. The surrounds have projecting cornices and, at their bottoms, rosettes. A window piercing a slightly projecting, front-gabled wall dormer, has a three-sided transom. The south end of the west elevation's first story has a single-light, fixed frame window. A

similar window opens in the center of the same elevation, both horizontally and vertically, most likely corresponding to an interior staircase. It hosts an elaborate stained-glass window with a fleur-de-lis pattern. A hipped-roof bay window projects from the first story, just north of the stained-glass window. This bay has scrolled brackets beneath the eaves. A hipped-roof porch extends northwestward from a tower at the northwest corner of the house. The porch features a simple, wood balustrade and elaborate, turned friezes spanning between the porch supports. The supports are square, with chamfered edges and, at their tops, brackets. Approaching the porch more from West 12th Street than Craig Street, are two concrete steps. The principal doorway opens in the northwest corner of the house. It hosts a 6-panel, white, metal door, opening behind a white, aluminum-frame storm door. Another doorway opens above it, providing access to a small balcony. It has a 1-light, white-painted wood slab door, opening behind a wood-frame storm door. A two-story, shed-roofed porch extends across the western portion of the south elevation. Cream-painted beadboard and bands of single-light windows enclose the porches, which obscure any doorway that might provide access to them. Brown, interlocking asphalt shingles cover the cross-gabled roof. Pink-painted wood soffit and mauve-painted wood fascia, with a projecting cornice, box the eaves. A red-brick chimney, with corbelled cap, protrudes near the center of the north-south oriented roof ridge.

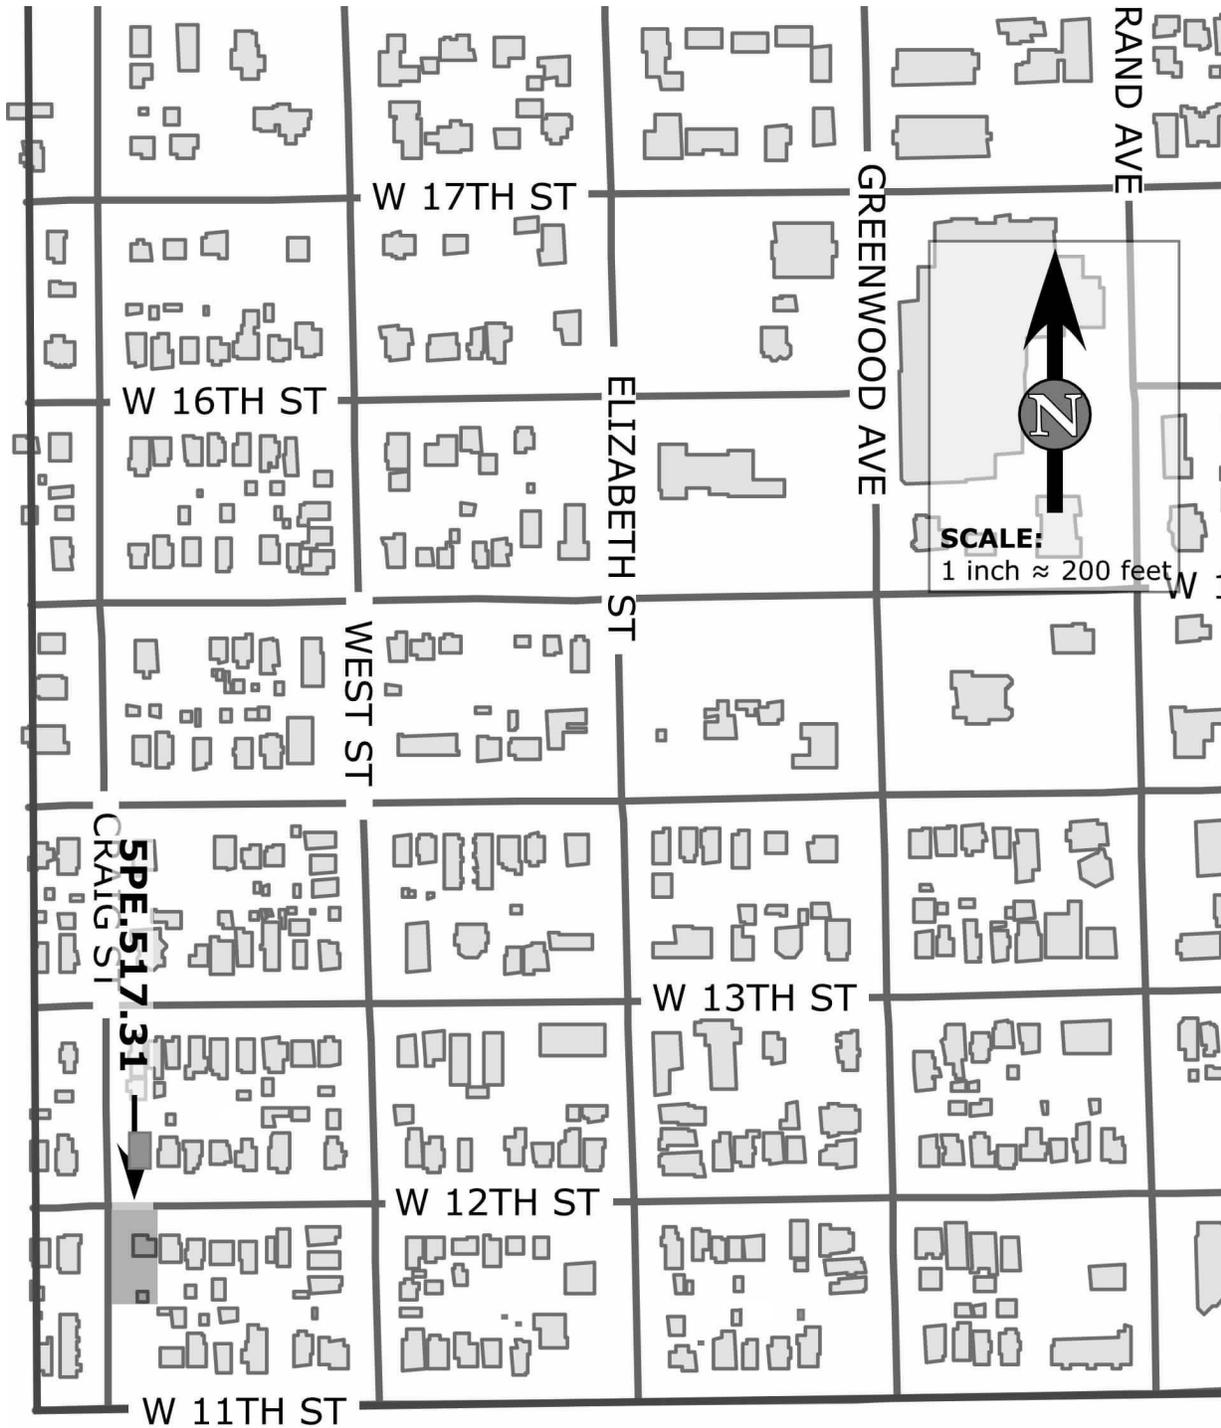
SITE SKETCH MAP

This property is located on terrain sloping downward from north to south, with an elevation of around 4,700 feet above mean sea level. The neighborhood features modest, one- and two-story houses. This property is situated on the southeast corner of West 12th and Craig streets. Running parallel to both streets is a sidewalk of pink-colored sandstone. A grass-covered strip separates the sidewalk from 12th Street, while the strip is gravel-covered along Craig Street. Surrounding the house is a planted-grass yard, with mature landscaping. Encircling the backyard is a chain-link fence.
