COLORADO CULTURAL RESOURCE SURVEY

Architectural Inventory Form

- 1. Resource number: **5PE.5631** Parcel number(s):
- 2. Temporary resource number: **062** **525311014**
- 3. County: **Pueblo**
- 4. City: **Pueblo**
- 5. Historic building name: **Rouen, Timothy, House**
- 6. Current building name: **Valdez, Timio S. and Fedalina, House**
- 7. Building address: **725 W 12th Street**
- 8. Owner name: **Timio S. and Fedaline Valdez**
- Owner organization:
- Owner address: **725 W 12th St**  
**Pueblo, CO 81003**

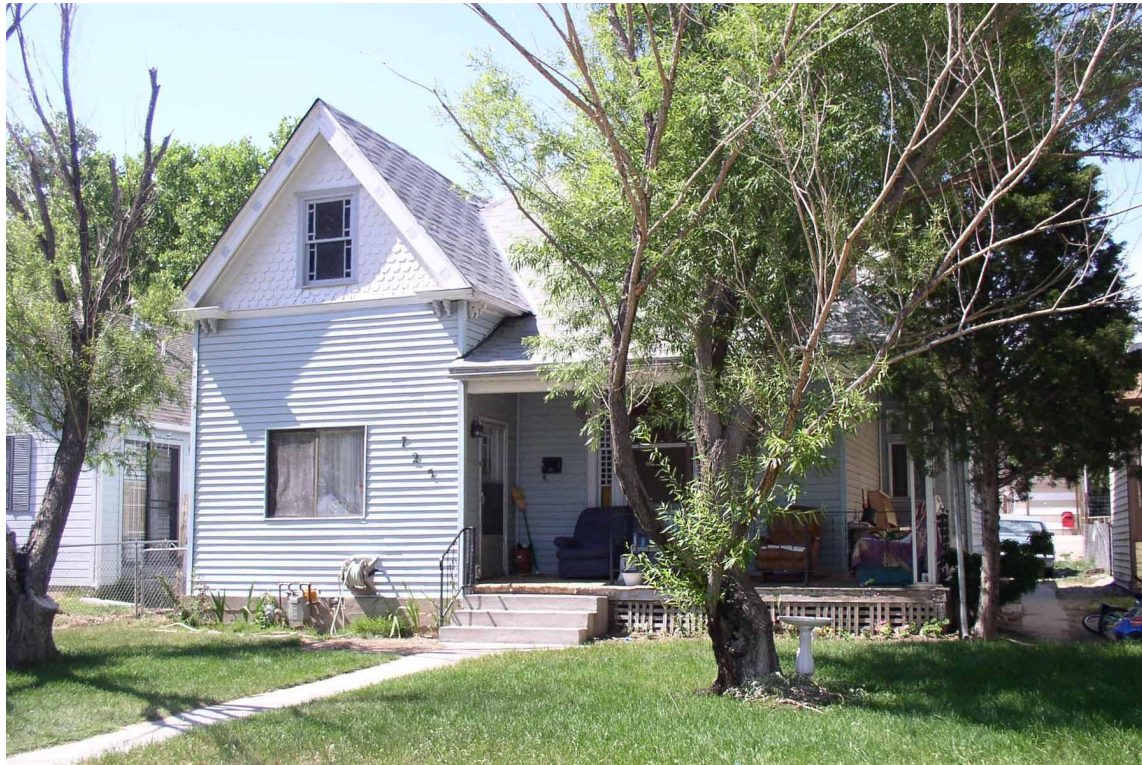
**Roof Treatment/Dormer**  
**Window/Stained Glass**
21. General architectural description:  
**Oriented to the south, this house rests on a concrete foundation (or a concrete sill poured sometime after construction). Blue vinyl siding clads the exterior walls. White-painted, octagon wood shingles covers the gables. Windows are generally 1-beside-1-light, sliding sash, with brown aluminum frames. Dominating the front (south) façade is a 1-over-1-light, double-hung sash window, with a round-arch top sash and flanking, stained-glass, single-hung sidelights. Another double-hung sash window, with stained glass, pierces the center of the front (south-facing) gable. It has a broad, blue-painted, fluted architrave, with projecting cornice. A similar-styled hopper or awning window appears in a shed-roofed dormer protruding from the center of the main, hipped-roof's south-facing slope. A hipped-roof porch wraps around the southeast corner of the house. It has a wood floor and white, aluminum supports. Three concrete steps approach the porch on its west end. The principal doorway actually opens in the east elevation of a front-gabled bay protruding from the west end of the front façade. It hosts a 3-panel, 1-light door, with stained-glass, diamond-shaped glazing. It opens behind an aluminum-frame storm door. Another doorway opens in the center of a hipped-roof bay projecting from the rear (north) elevation. It hosts a 4-panel, 1-light, glass-in-wood-frame door, opening behind an aluminum-frame storm door. Gray, interlocking asphalt shingles cover the cross-gabled roof. White-painted**

**wood soffit and fascia, with projecting cornice, box the eaves. The gables feature decorative verge boards and eave returns. Paired scroll brackets appear beneath the eave returns.**

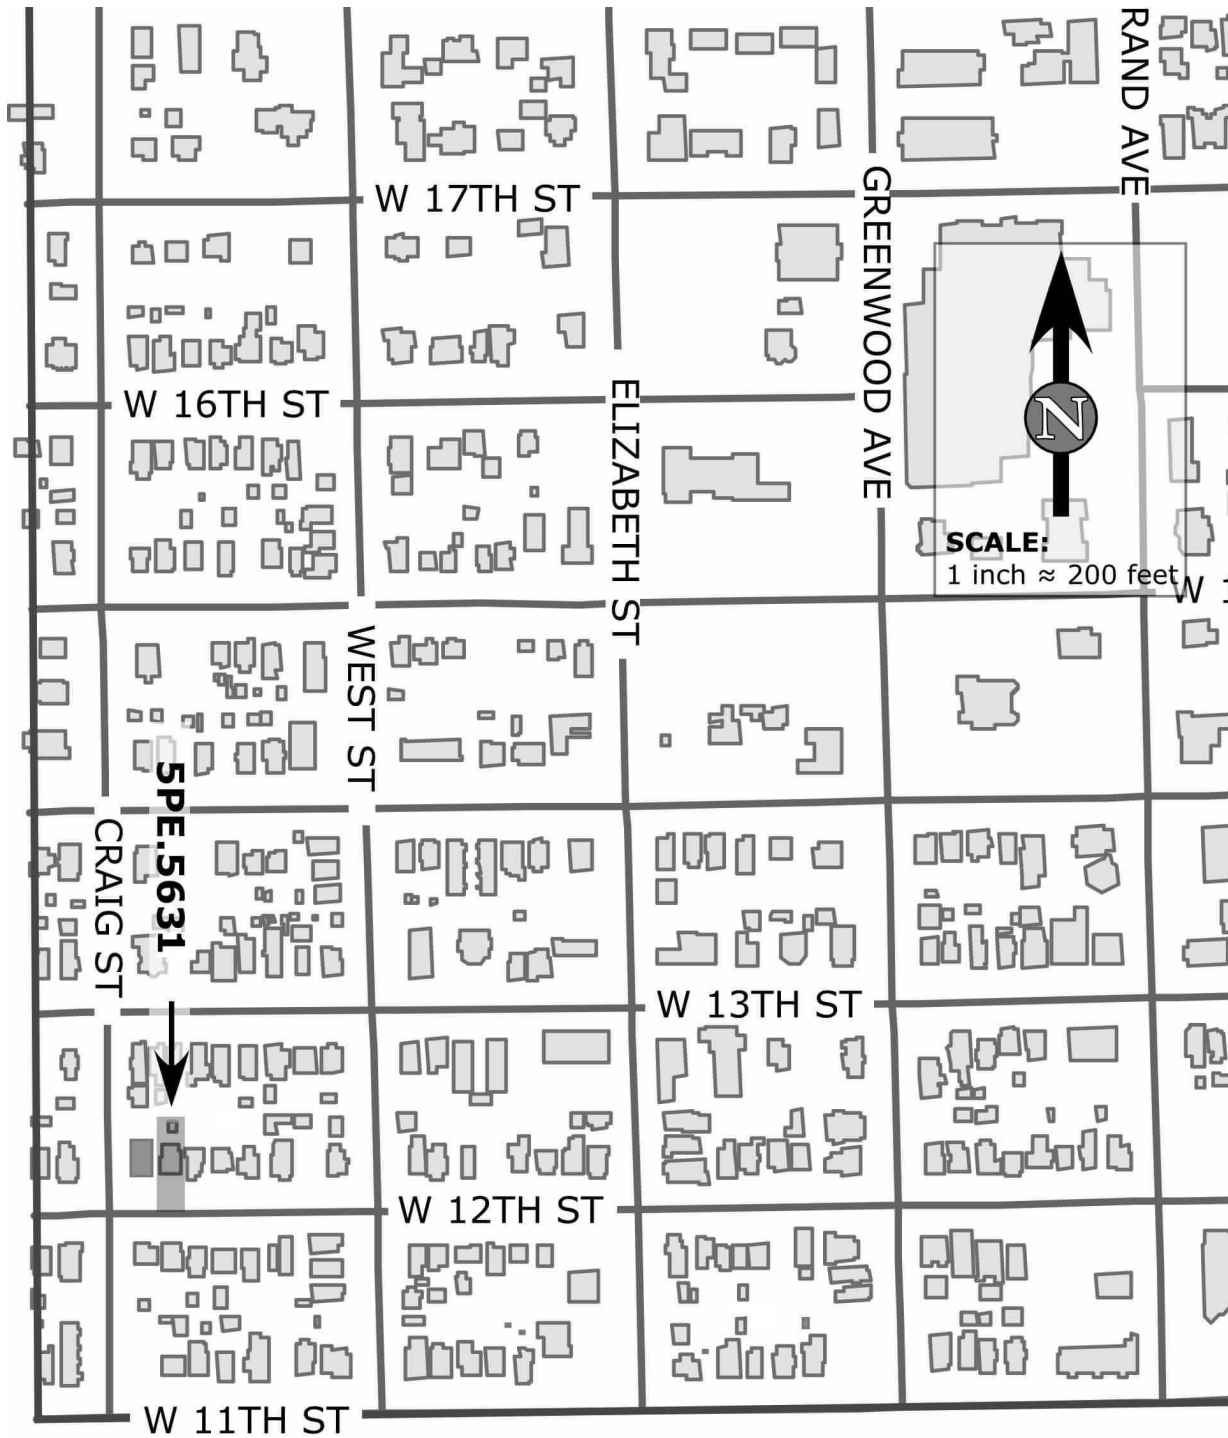
#### SITE SKETCH MAP

**This property is located on terrain sloping downward from north to south, with an elevation of around 4,700 feet above mean sea level. The neighborhood features modest, one- and two-story houses. This property is located on the north side of West 12th Street, an east-west-oriented thoroughfare. It is situated between 721 W 12th Street, to the east, and 727 West 12th Street, to the west. A grass strip separates the sidewalk from the street. Surrounding the house is a planted-grass yard, with mature landscaping. A gravel parking area is located on the northeast corner of the lot. Encircling portions of the back yard is a chain-link fence.**

Describe: **Located directly north of the house is a 1-car garage. Oriented to the south, the building rests on a concrete slab. The walls consist of unusually thin concrete blocks. Dominating the front (south) elevation are paired, plywood doors, opening on metal strap hinges. The same doors open in the rear (north) elevation. Sheet of asphalt cover the shed roof, which a parapet surrounds.**

Describe: **A modular or prefabricated storage shed is located northwest of the house and west of the garage. Oriented to the south, the building rests on a wood sill. The walls consist of white-painted sheet metal. Dominating the front (south) elevation are paired, sheet-metal, sliding doors. The front-gabled roof also consists of sheet metal.**
