COLORADO CULTURAL RESOURCE SURVEY

Architectural Inventory Form

- 1. Resource number: **5PE.5632**
- 2. Temporary resource number: **063**
- 3. County: **Pueblo**
- 4. City: **Pueblo**
- 5. Historic building name: **727 West Twelfth Street**
- 6. Current building name: **727 West Twelfth Street**
- 7. Building address: **727 W 12th Street**
- 8. Owner name: **Housing Authority of Pueblo**
- Owner organization:
- Owner address: **1414 N Santa Fe Ave**
Pueblo, CO 81003

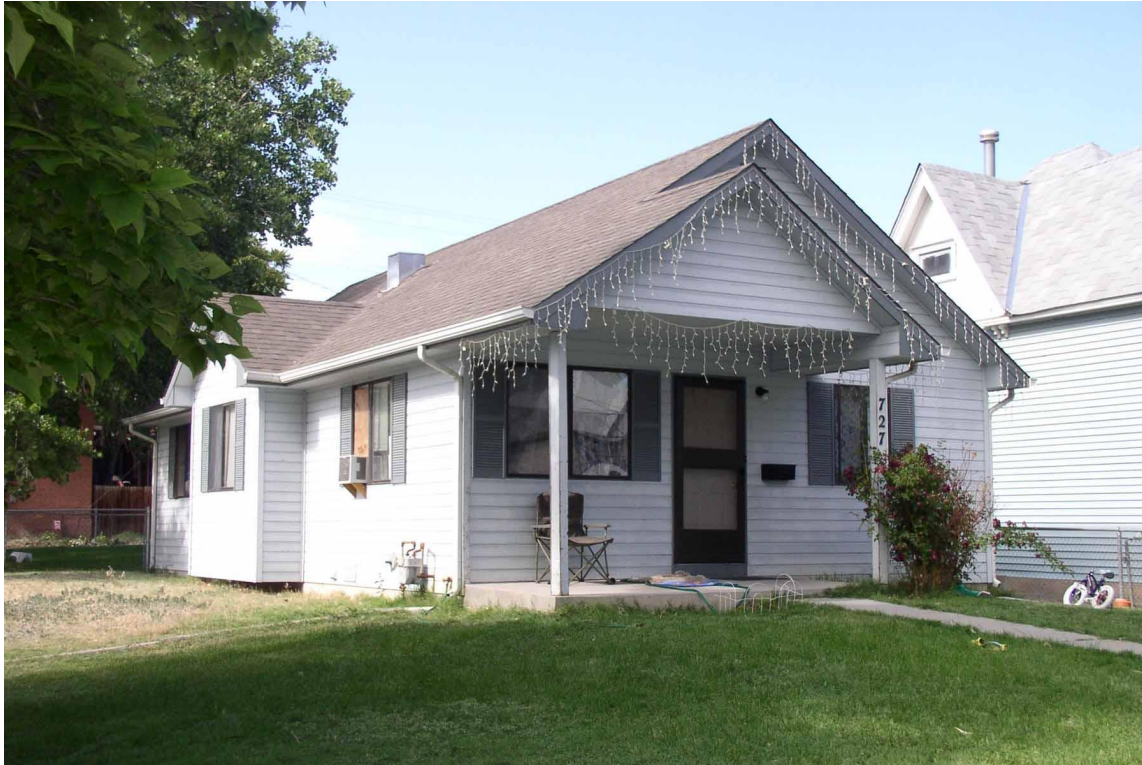
19. Primary external roof material: **Asphalt Roof/Composition Roof**
Other roof materials:
20. Special features: **Fence**
Porch
21. General architectural description:
Oriented to the south, this house rests on a concrete foundation. A front-gabled bay, cantilevered over the foundation, protrudes from the center of the west elevation. Blue-painted, horizontal, wooden-composition weatherboard, with 1-by-4-inch cornerboards, clads the exterior walls. Windows are 1-beside-1-light, sliding-sash, with brown aluminum frames. Dark-blue, vinyl, louvered shutters flank most windows. A front-gabled porch protrudes from the west half of the front (south) façade. It has a concrete floor and simple, blue-painted, square wood supports. Beneath the porch roof is a white, 6-panel, metal door, opening behind a brown, aluminum-frame storm door. A plate-glass sliding door, with a brown, aluminum-frame, opens on the south end of the east elevation. Approaching it is a single, concrete stoop. Gray asphalt shingles cover the front-gabled main and porch roofs. Blue-painted wood fascia and soffit box the eaves.

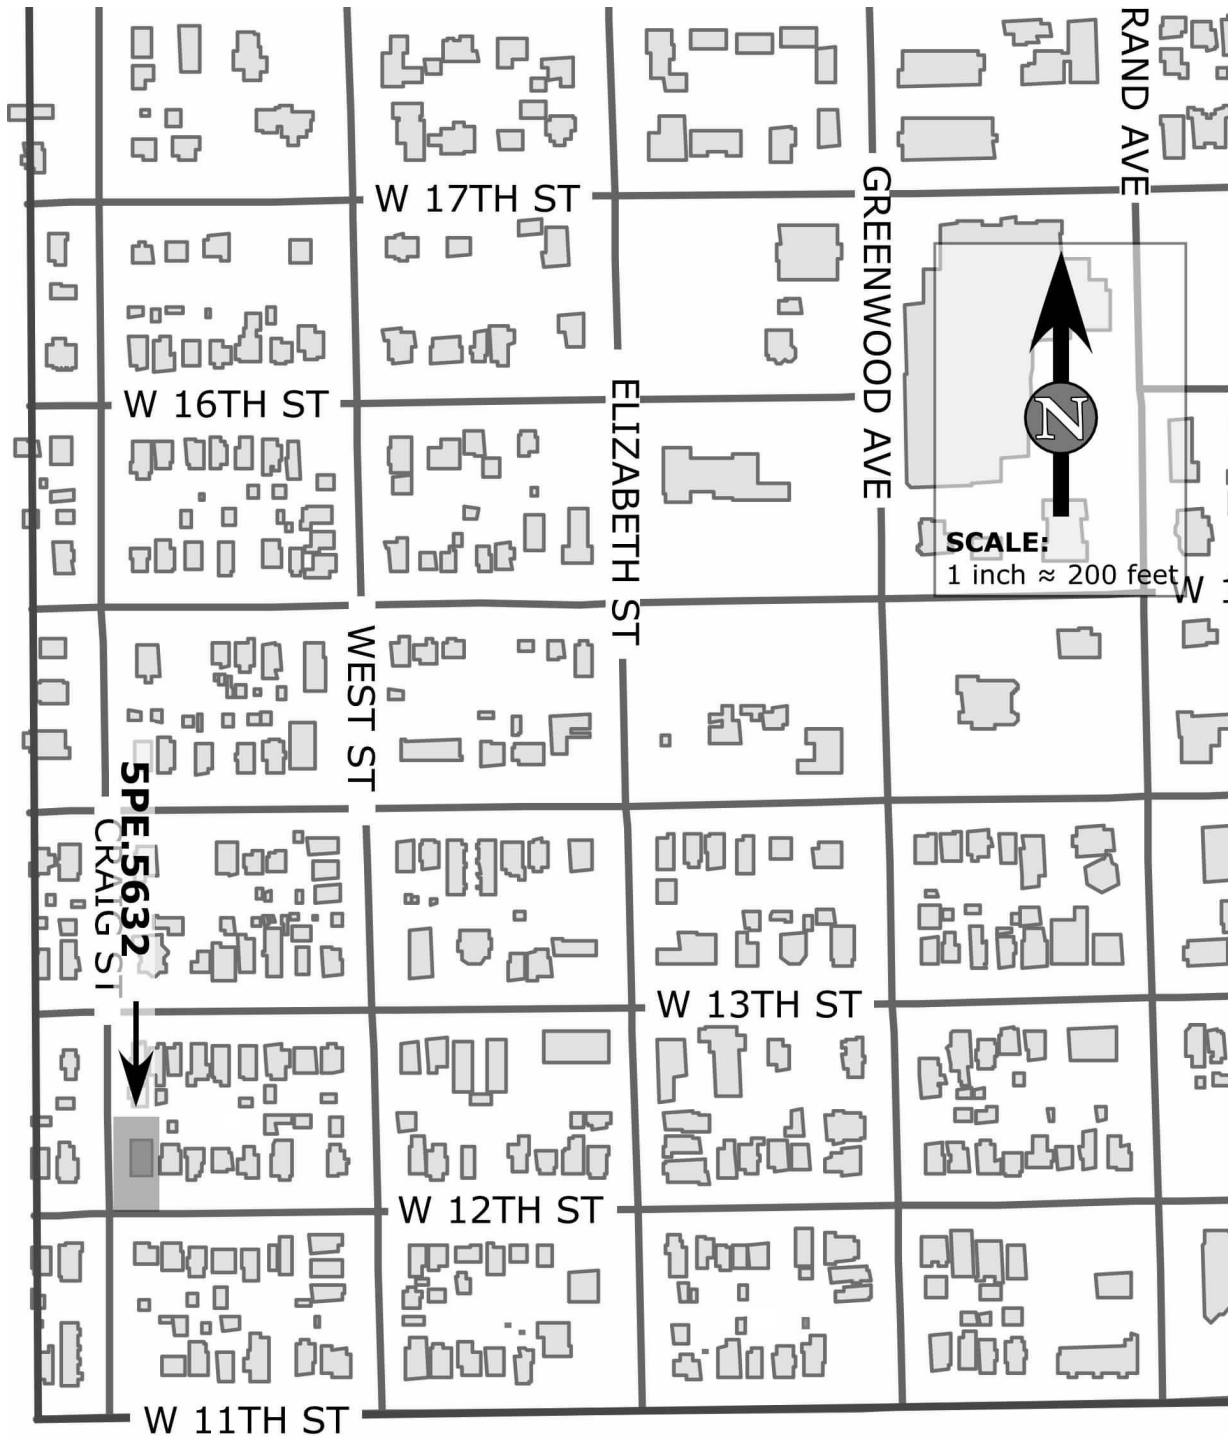
SITE SKETCH MAP

This property is located on terrain sloping downward from north to south, with an elevation of around 4,700 feet above mean sea level. The neighborhood features modest, one- and two-story houses. This property is situated on the northeast corner of West 12th and Craig streets. A grass-covered strip separates the sidewalk from the Street. Surrounding the house is a planted-grass yard, with mature landscaping. Encircling the backyard is a chain-link fence.
