COLORADO CULTURAL RESOURCE SURVEY

Architectural Inventory Form

- 1. Resource number: **5PE.517.32**
- 2. Temporary resource number: **064**
- 3. County: **Pueblo**
- 4. City: **Pueblo**
- 5. Historic building name: **Morrow, John, House**
- 6. Current building name: **Trujillo, Victor, Jr., and Kelly A., House**
- 7. Building address: **801 W 12th Street**
- 8. Owner name: **Victor Trujillo, Jr., and Kelly A. Trujillo**
- Owner organization:
- Owner address: **801 W 12th St**
Pueblo, CO 81003

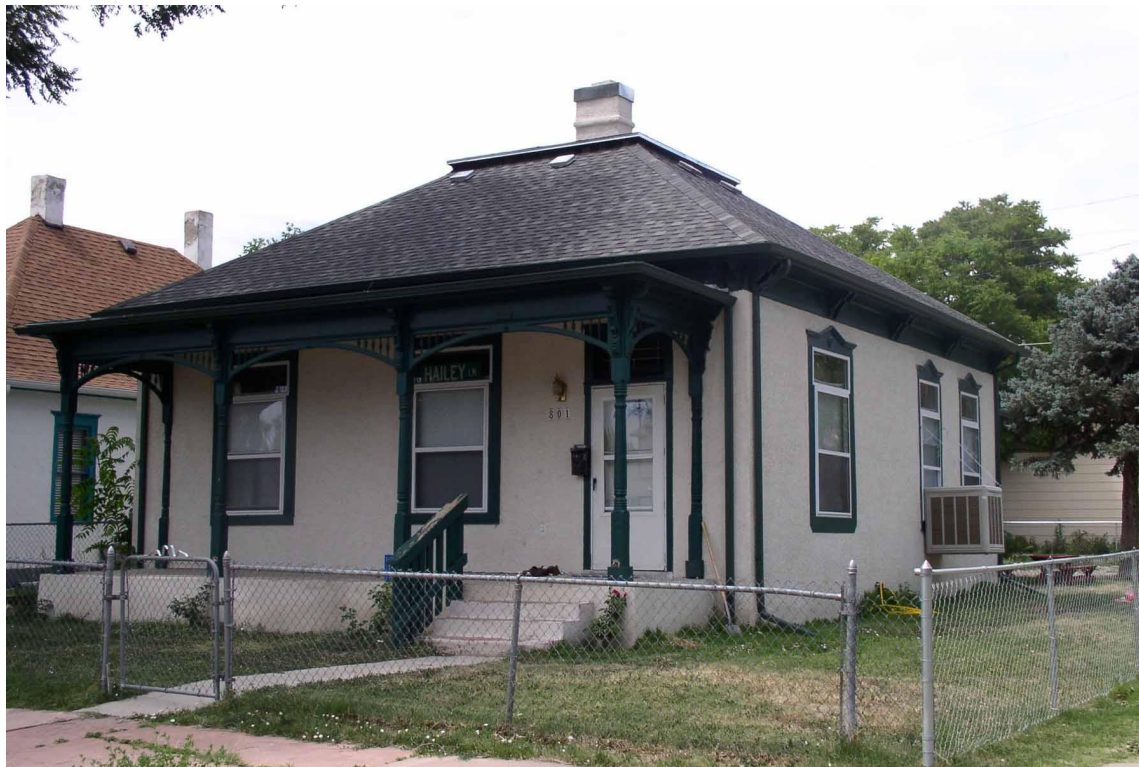
21. General architectural description:
This house is oriented to the south. A buff-white-tinted stucco entirely conceals the foundation. The same stucco clads the exterior walls. Windows are generally 1-over-1-light, double-hung sash, with white vinyl frames and aluminum-frame storm windows. Those opening in the southern portion of the house have transoms. Windows in the front (south) facade and southern half of the east elevation have green-painted wood surrounds. The surrounds on the east elevation are pedimented. The southernmost window in the east elevation has a rosette carved into the pediment. A vertical band of glass blocks pierces the east side of rear (north) elevation. A hipped-roof porch spans nearly the entire front (south) façade. It has a concrete floor. The turned, green-painted porch supports culminate in elaborate, scrolled brackets. Arched, spindlework friezes span between the porch supports. Three concrete steps, with a wood railing to the west, approach the porch on its west side. The principal doorway opens in the east end of the asymmetrical façade. It hosts a white, 4-panel metal door, with a fanlight. It opens behind a vinyl-frame storm door. A stained-glass transom appears above the door. A nearly identical porch fills the inside (northeast-facing) corner created at the junction of the southern portion of the house and a hipped roof wing to the west end of the rear (north) elevation. Opening in the north face of this inside corner is another doorway. It hosts a green-painted wood slab door,

opening behind a white vinyl-frame storm door. Green-gray asphalt shingles cover the truncated hipped roof. The peak of the central, hipped roof is flat. Green-painted wood soffit and fascia box the eaves. Paired, scrolled brackets appear beneath the eaves. A stucco-covered chimney protrudes from the center of the main, hipped roof.

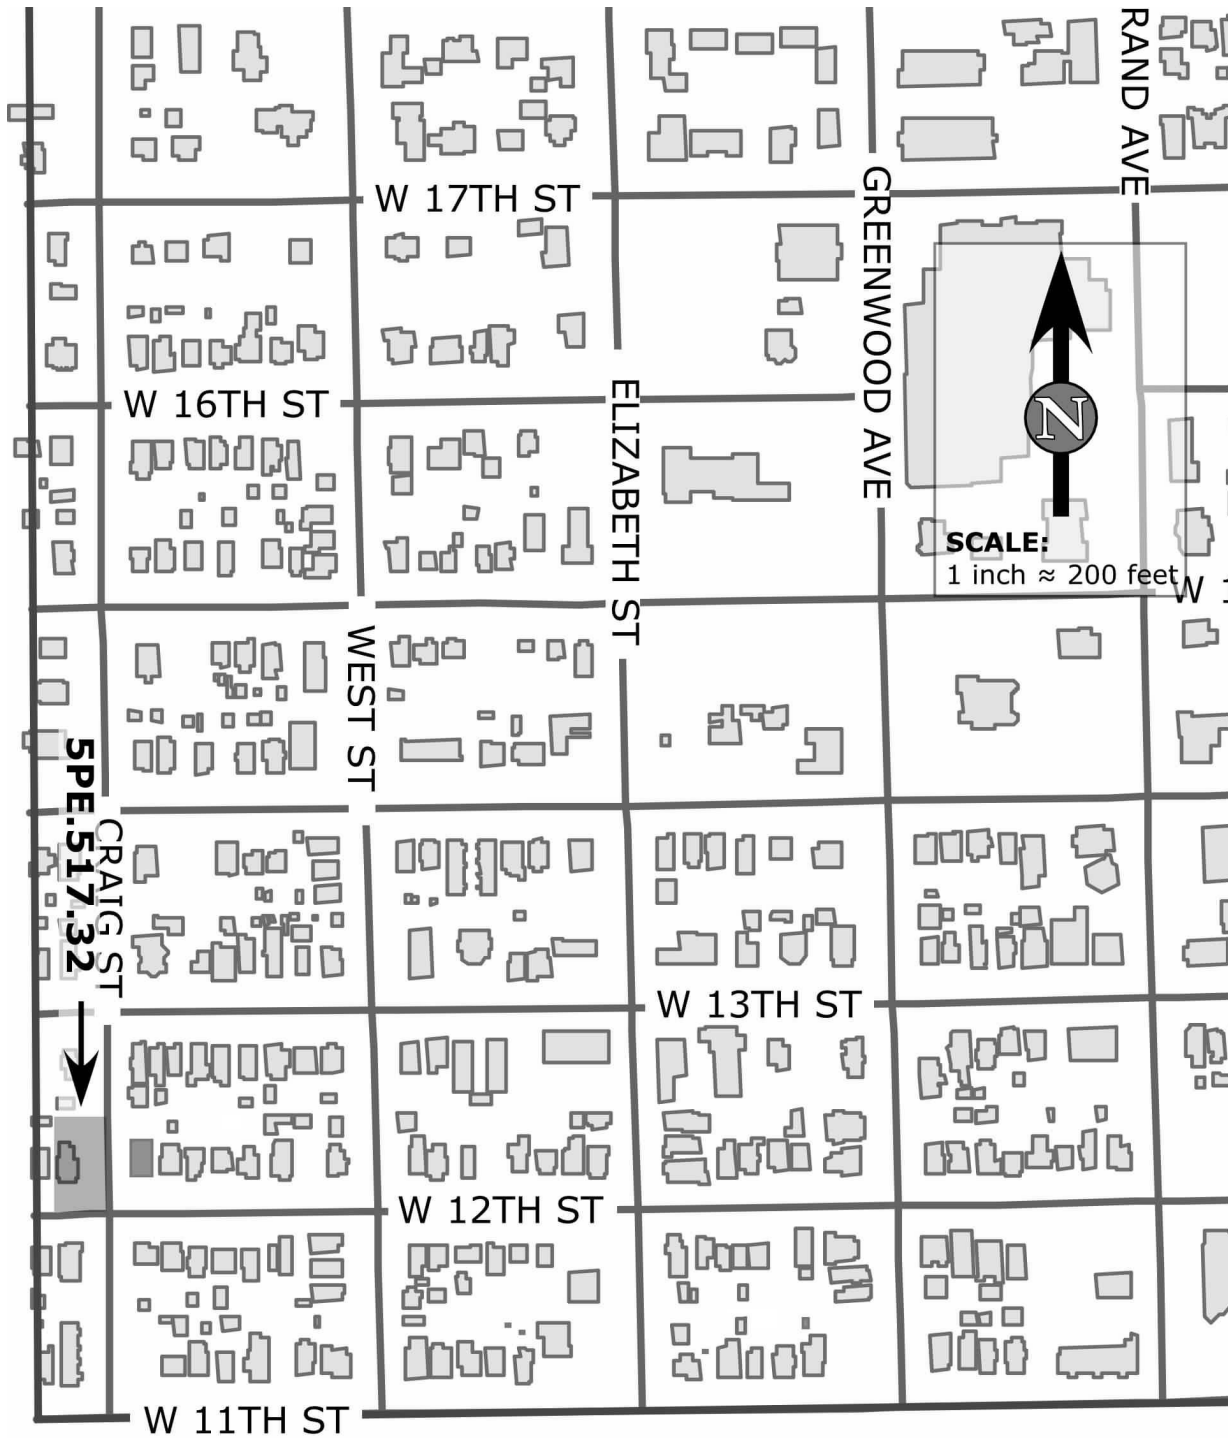
SITE SKETCH MAP

This property is located on terrain sloping downward from north to south, with an elevation of around 4,700 feet above mean sea level. The neighborhood features modest, one- and two-story houses. This property is situated on the northwest corner of West 12th and Craig streets. Running parallel to West 12th Street is a sidewalk of pink sandstone slabs. A grass-covered strip separates the sidewalk from the Street. Surrounding the house is a planted-grass yard, with mature landscaping. Encircling the entire property is a chain-link fence.

- 1: Type: **Shed**
- Describe: **IA shed is located north of the house, along the west edge of the property. Oriented to the east, this building's foundation is concealed, if present at all. Cream-colored stucco clads the exterior walls. Opening in the center of the front (east) elevation is a green-painted plywood door. Asphalt sheets cover the shed roof, and the rafter ends are exposed by capped by a fascia board.**
