COLORADO CULTURAL RESOURCE SURVEY

Architectural Inventory Form

- 1. Resource number: **5PE.1179**
- 2. Temporary resource number: **065**
- 3. County: **Pueblo**
- 4. City: **Pueblo**
- 5. Historic building name: **James, Joseph A., House**
- 6. Current building name: **Pineda-Mondragon**
- 7. Building address: **802 W 12th Street**
- 8. Owner name: **Paula Regina Pineda and Stephanie Carmen Mondragon**

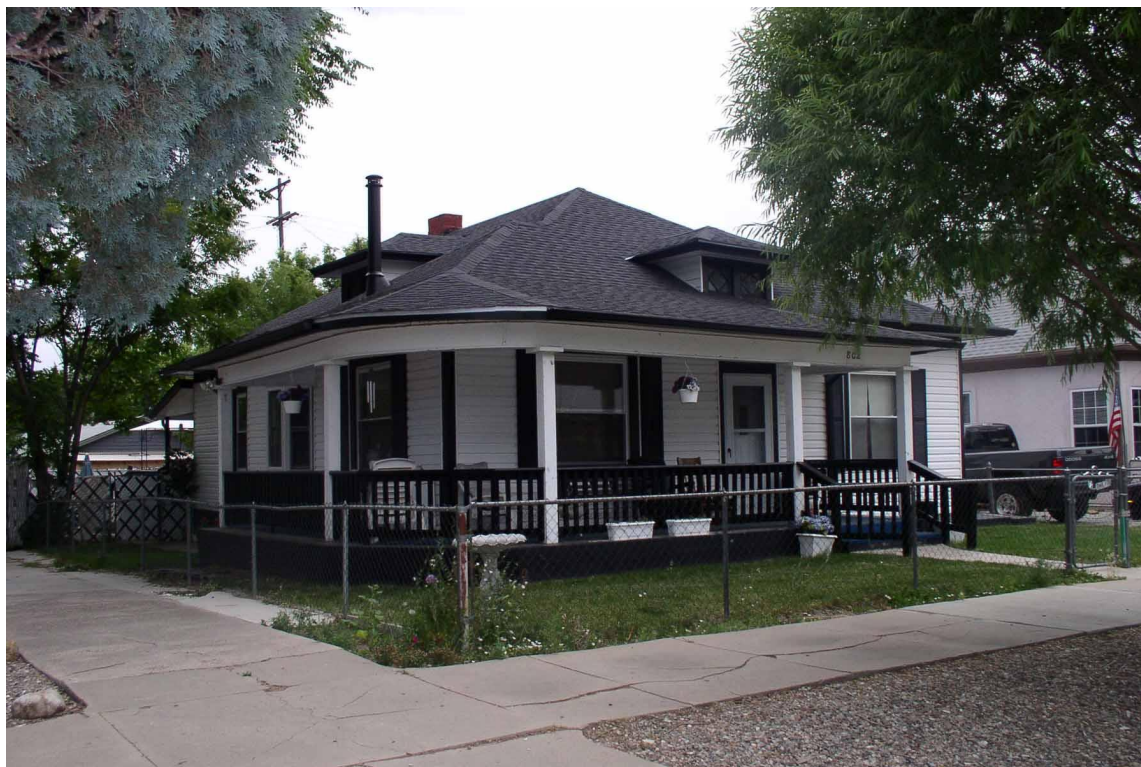
21. General architectural description:
Oriented to the north, this house rests on a black-painted, concrete foundation, with single-light, hopper basement windows. White, vinyl siding, with black-painted, wood cornerboards, clads the exterior walls. Windows are 1-over-1-light, double-hung sash, with white vinyl frames. Windows in the front (north) façade have black-painted wood surrounds, and those in the façade and north end of the east elevation have black, louvered, vinyl shutters. A 3-sided bow window protrudes from near the center of the east elevation. Hipped roof dormers, which emerge from the roof's east- and north-facing slopes, have paired hopper, awning, or casement windows, with diamond-shaped glazing. A rounded, hipped-roof porch wraps around the northeast corner of the house. The porch has a concrete floor and white-painted, square, wood supports. A single step approaches the porch at its west end. The principal doorway opens in the center of the façade, which would be symmetrical except for the offset of the porch. The doorway hosts a white, 8-panel, metal door, with a single light. A white, aluminum-frame storm door protects this door. Above the door is a single-light transom. A small, shed-roofed porch is located in the inside (southeast-facing) corner. Beneath it is another doorway. It hosts a 3-panel, 1-light, glass-in-wood-frame door, painted white. A shed-roofed addition is attached to the west side of the rear (south) elevation. The addition's east elevation hosts sliding, plate-glass doors. Black

asphalt shingles cover the hipped-roof. White vinyl soffit and black-painted wood fascia box the flared eaves. A red-brick chimney emerges at the apex of the roof's south-facing slope.

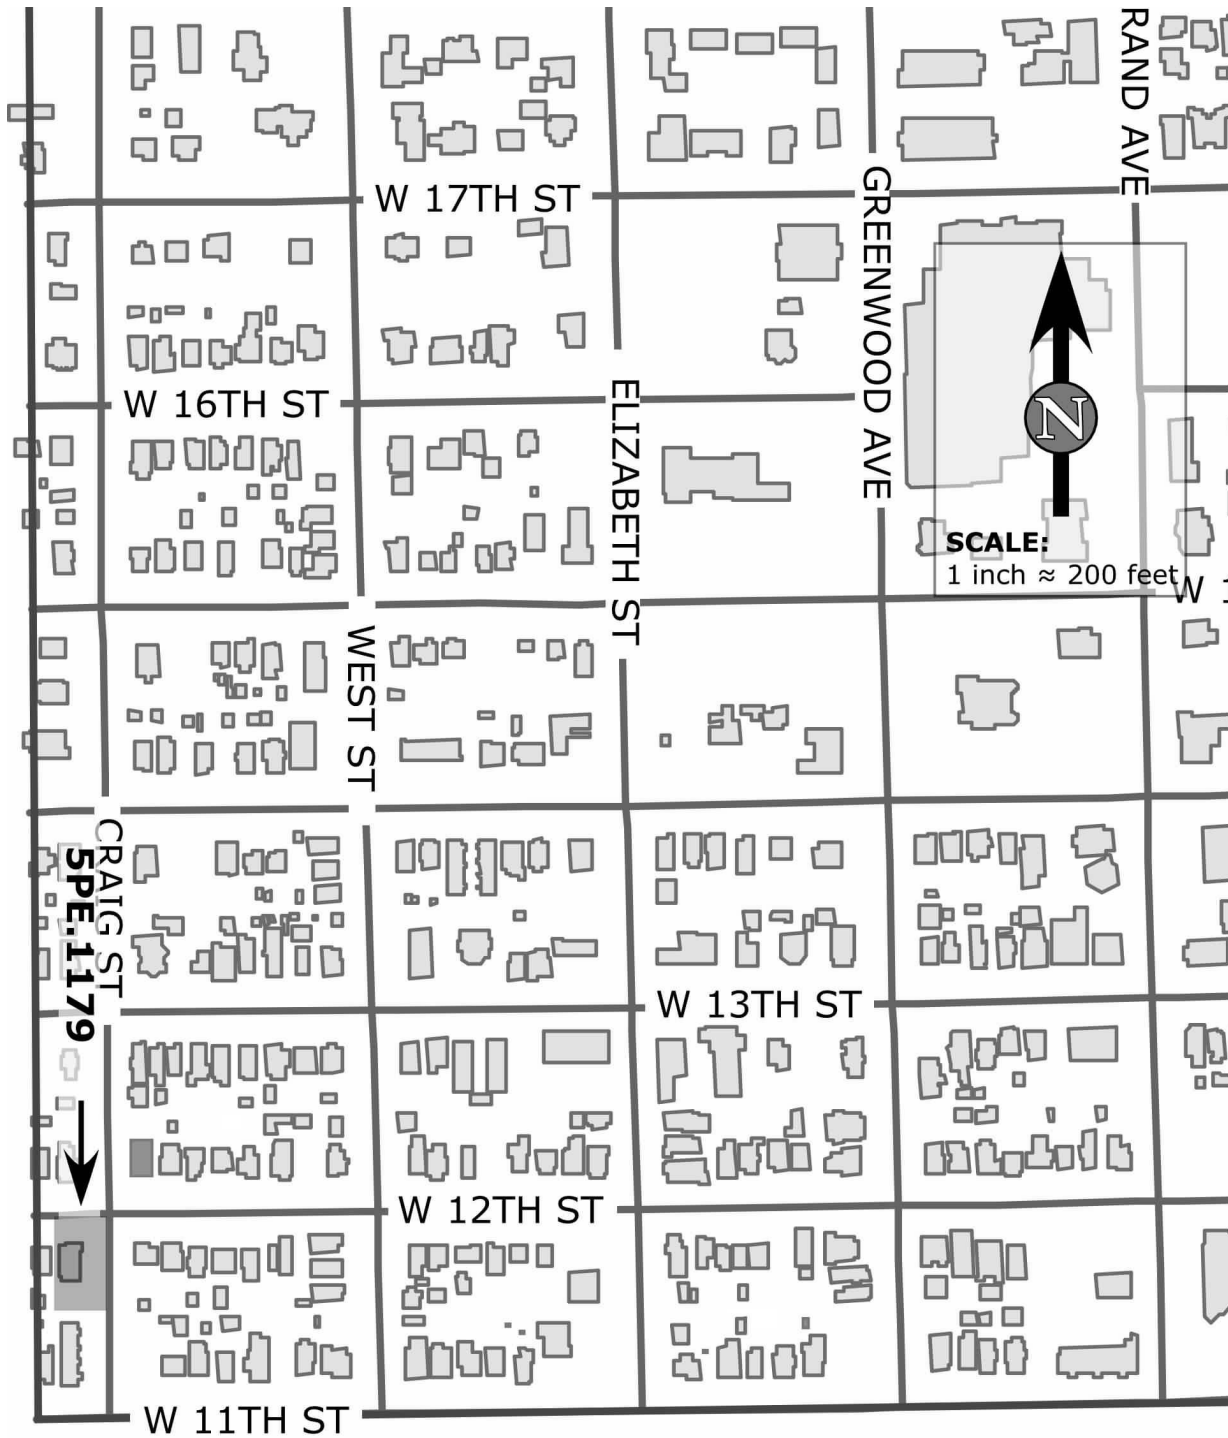
SITE SKETCH MAP

This property is located on terrain sloping downward from north to south, with an elevation of around 4,700 feet above mean sea level. The neighborhood features modest, one- and two-story houses. This property is situated on the southwest corner of West 12th and Craig streets. A gravel-covered strip separates the sidewalk from the street. Surrounding the house is a planted-grass yard, with mature landscaping. A chain-link fence encircles the property.
