COLORADO CULTURAL RESOURCE SURVEY

Architectural Inventory Form

- 1. Resource number: **5PE.5636**
- 2. Temporary resource number: **068**
- 3. County: **Pueblo**
- 4. City: **Pueblo**
- 5. Historic building name: **Ross-Whistler House**
- 6. Current building name: **Parsons, Thomas, House**
- 7. Building address: **410 W 13th Street**
- 8. Owner name: **Thomas Parsons**
- Owner organization:
- Owner address: **410 W 13th St**
Pueblo, CO 81003

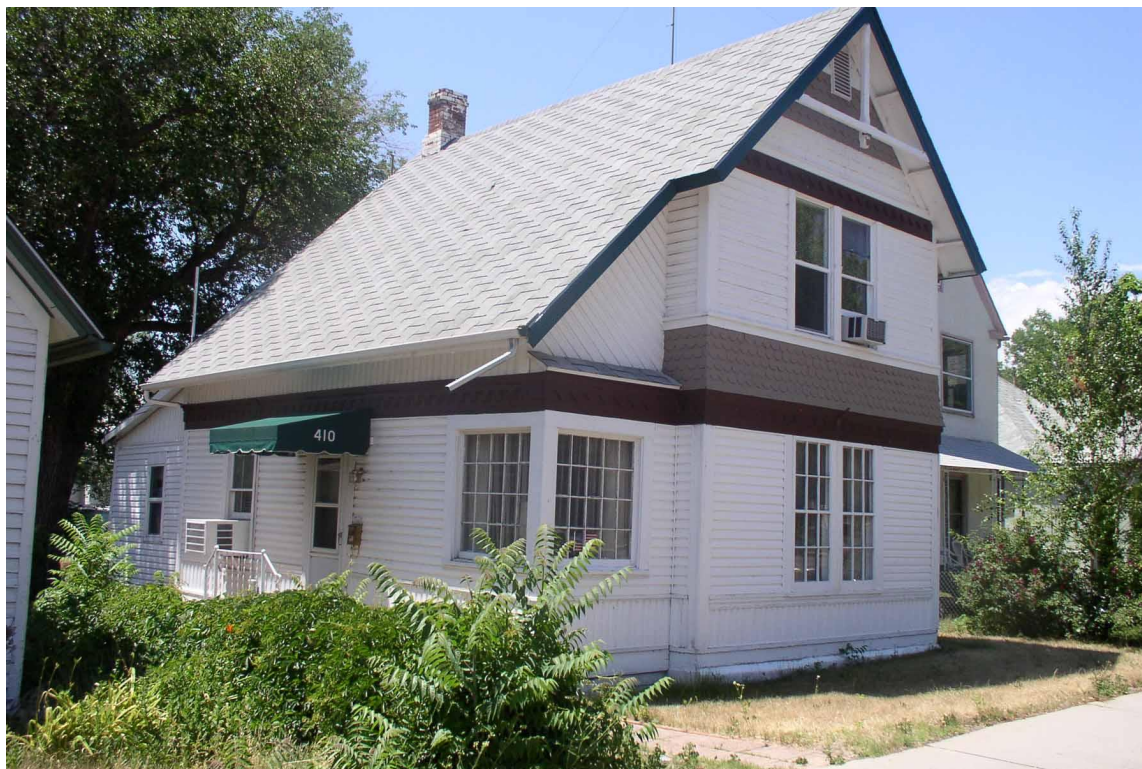
21. General architectural description:
Oriented to the north, this house rests on a white-painted concrete foundation. White vinyl siding, with white-painted, 1-by-4-inch cornerboards, clads most of the exterior walls of the first story. The wall cladding of the second story generally features white-painted wood weatherboard. A brown-painted, dentiled frieze separates the first and second stories. Variegated wood shingles, painted in bands of light brown, white, and dark brown, cover the gables. A pendant is suspended in the north-facing gable. White-painted, square-cut wood shingles cover a shed-roofed dormer protruding from the roof's west-facing slope. Windows are generally 1-over-1-light, double-hung sash, with either white-painted wood frames or white vinyl frames. The windows have white-painted wood surrounds. Those opening in the center of the front (north) façade's first story have 12-light, wood-frame storm windows. The main roof has been lowered to cover an integral porch across the east elevation, giving the house's main gable an asymmetrical appearance. White vinyl siding and 20-light, fixed-frame windows enclose this porch. The principal doorway opens near the center of the east elevation. It hosts a glass-in-wood-frame door, opening behind a white, aluminum-frame storm door. Approaching it from the north and south is a 2-step, brick-and-concrete stoop, flanked on its east side by a white, aluminum railing. A green canvas awning shelters the stoop. Another doorway opens near the center of the rear (south) elevation. It hosts a paneled, 1-light, glass-in-wood-frame door, opening behind a white, aluminum-frame storm

door. This doorway provides access to an unsheltered wood deck. Green-gray, interlocking asphalt shingles cover the main front-gabled roof and all other roof surfaces. The rafter ends are exposed but capped by a green-painted fascia board. A red-brick chimney protrudes from the south end of the north-south-oriented roof ridge.
