COLORADO CULTURAL RESOURCE SURVEY

Architectural Inventory Form

- 1. Resource number: **5PE.5637** Parcel number(s):
- 2. Temporary resource number: **069** **525411009**
- 3. County: **Pueblo**
- 4. City: **Pueblo**
- 5. Historic building name: **Latshaw, William D., House**
- 6. Current building name: **Serna, Yolanda Espinoza, Apartments**
- 7. Building address: **411 W 13th Street**
- 8. Owner name: **Yolanda Alise Espinoza Serna**
- Owner organization:
- Owner address: **411 W 13th St**  
**Pueblo, CO 81003**

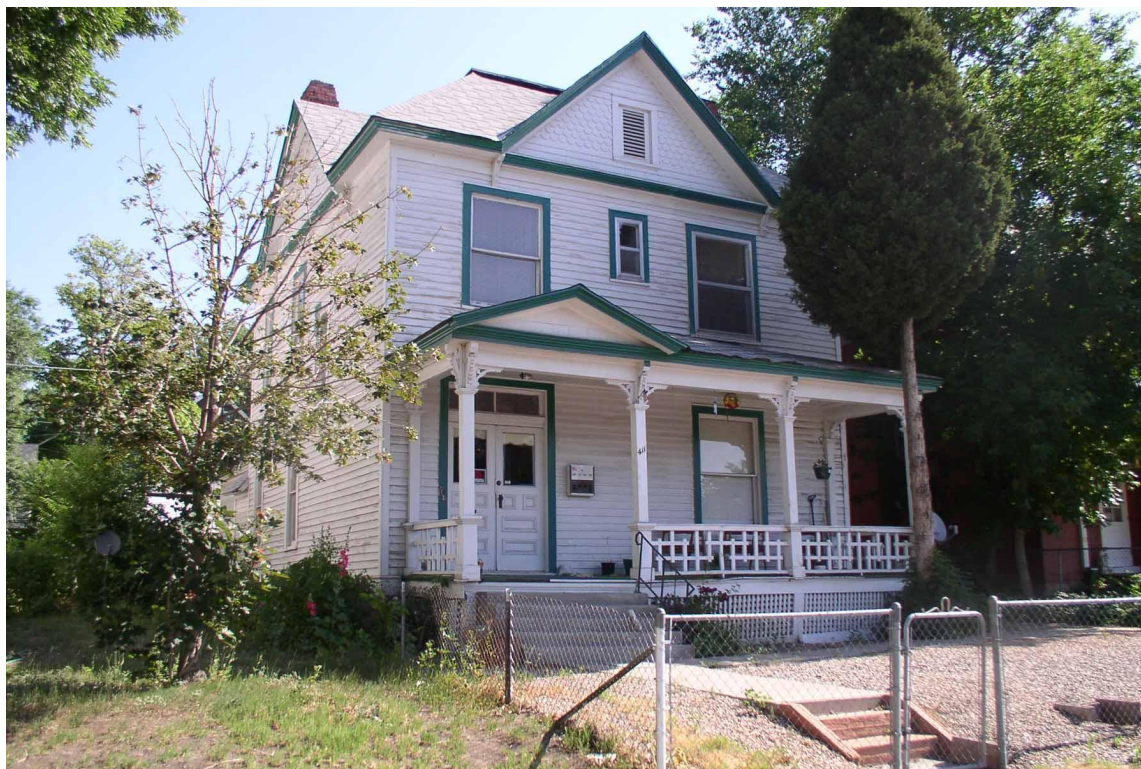
21. General architectural description:  
**Oriented to the south, this house rests on a buff-colored, rock-faced sandstone foundation arranged as coursed ashlar. White-painted, horizontal wood siding, with 1-by-4-inch cornerboards, clads the exterior walls. Variegated wood shingles, also painted white, cover the pedimented gables, which face east, south, and west. Windows are 1-over-1-light, double-hung sash, with white-painted wood frames and green-painted wood surrounds. Some windows have aluminum-frame storm windows. Piercing the gable of a single-story structure attached to the rear (north) elevation is a 2-over-2-light window. A rectangular, single-story, hipped-roof bay window protrudes from the north side of the east elevation. A hipped-roof porch spans the entire front (south) facade. White-painted, square latticework fills the area between the ground and the wood porch floor. The porch features square, wood supports, with formal pedestals and capitals. Elaborate scrolled brackets spring from the capitals to the east, south, and west. Between the supports is a stickwork balustrade. A pediment rises above the westernmost third of the porch. White-painted, square-cut shingles cover the face of the pediment. Approaching the porch, beneath the pediment, are 5 concrete steps, flanked on the east by a wrought-iron railing. The principal doorway opens on the west side of the otherwise symmetrical façade. It hosts paired, 5-panel, 1-light, glass-in-wood-frame doors, painted white. The glass is beveled. Above both doors is a 2-light transom. A small, shed-roof porch fills the inside (northeast-facing) corner created by the junction of the**
