COLORADO CULTURAL RESOURCE SURVEY

Architectural Inventory Form

- 1. Resource number: **5PE.5640** Parcel number(s):
- 2. Temporary resource number: **072** **525418005**
- 3. County: **Pueblo**
- 4. City: **Pueblo**
- 5. Historic building name: **Johnson, J. Will, House**
- 6. Current building name: **Hipp-Hinders House**
- 7. Building address: **414 W 13th Street**
- 8. Owner name: **Roy L. Hipp and Donna J. Hinders**
- Owner organization:
- Owner address: **611 W 22nd St**  
**Pueblo, CO 81003**

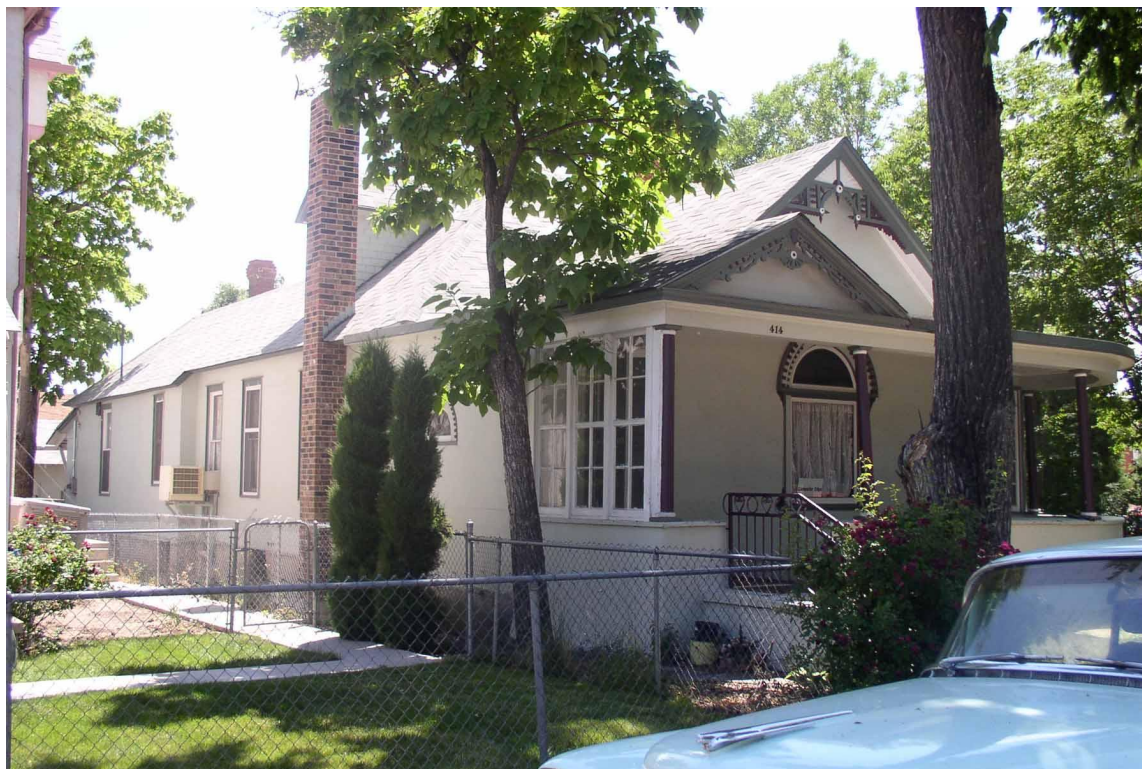
**Chimney**  
**Porch**  
**Window/Stained Glass**
21. General architectural description:  
**Oriented to the south, this house rests on a combination of low sandstone and concrete foundations. Light-green-painted stucco clads the exterior walls. The same color, square-cut wood shingles cover the dormers. Windows are generally 1-over-1-light, double-hung sash, with white-painted wood frames; white-painted, wood-frame screens; and dark-green-painted wood surrounds. A 3-sided, hipped-roof bay protrudes from north of center on the west elevation. Dominating the center of the front (north) façade is a large, fixed-frame window, with round-arch transom. An elaborate wood architrave surrounds the window. It features scroll brackets and 2 levels of dentil molding. A half-round, stained-glass window pierces the north end of the east elevation. Enclosing the western portion of the front, wraparound porch is a band of 15-light windows. A rounded, hipped-roof porch spans the entire façade and wraps around the northwest corner of the house. The porch features a stucco-covered kneewall and round supports. A pediment rises above the porch's easternmost quarter. The pediment features an elaborately carved bargeboard. A 4-step concrete stoop approaches the porch beneath the pediment. The principal doorway opens in the east end of the façade. It hosts a 5-panel, 1-light, oak door. The glass is beveled. It opens behind a white-painted, wood-frame screen door. Above the doorway is a single-light transom. Another doorway opens near the center of the rear (south) elevation.**

It hosts a 4-panel, white-painted wood door, opening behind and white-painted, wood-frame screen door. It provides access to a wood stoop, protected beneath a shed roof. An identical doorway-stoop combination exists on the rear (south) elevation of a hipped-roof addition to the east end of the original core's south elevation. Gray-green asphalt shingles cover the main roof and all other roof surfaces. Green-painted wood fascia and soffit box the eaves. Front-gabled dormers emerge from the east- and west-facing roof slopes. Elaborate stickwork fills the main, north-facing gable, and the gables of the dormers. An elaborately corbelled, red-brick chimney emerges between the north-facing gable and the central, hipped roof. Simpler chimneys protrude from the east elevation and near the south end of the roof ridge.

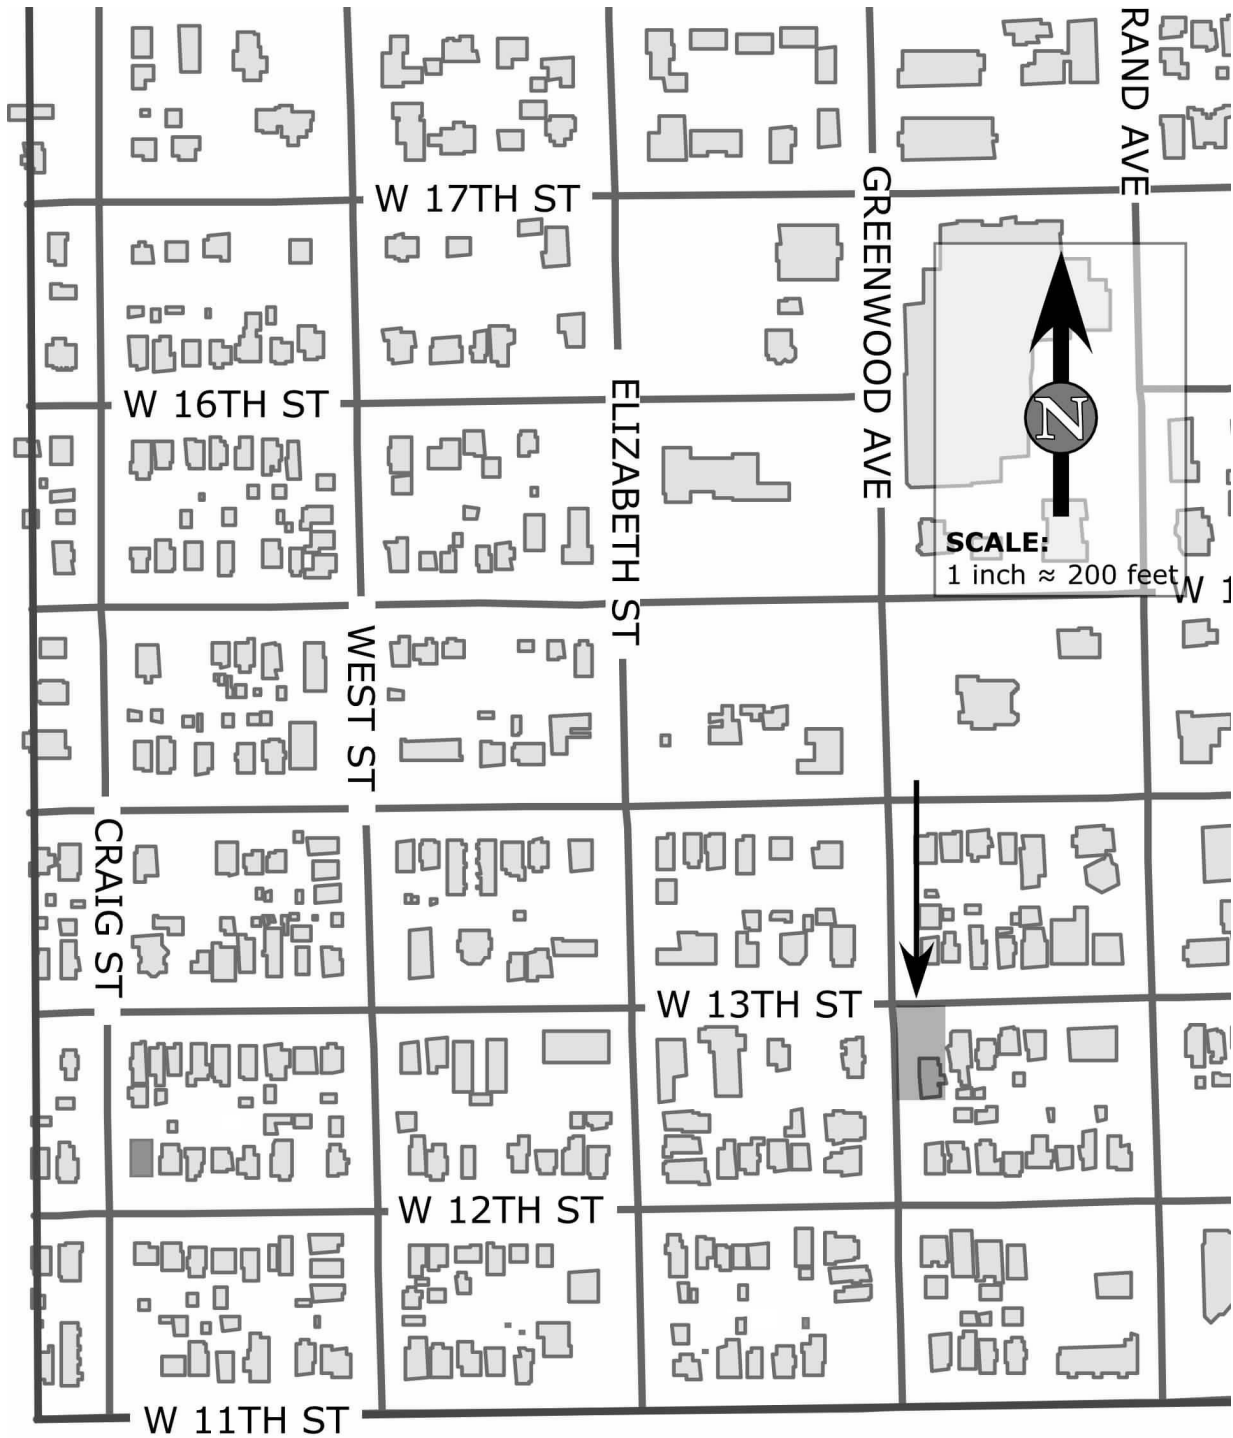
SITE SKETCH MAP

**This property is located on terrain sloping downward from north to south, with an elevation of around 4,700 feet above mean sea level. The neighborhood features modest, one- and two-story houses. Most of the houses here have an unusually shallow setback from West 13th Street, the busy, principal east-west thoroughfare through this area. This property is situated on the south side of West 13th Street, between 412 West 13th Street to the east and 416 West 13th Street to the west. A planted-grass yard, with mature landscaping, surrounds the building. Encircling a portion of the backyard is a chain-link fence. A gravel parking area is situated at the southwest corner of the lot.**

Describe: **A single-car garage is located on the southeast corner of the lot. Oriented to the west, the building rests on a concrete slab. Light-green-painted stucco clads the exterior walls. The unusual garage doorway is actually located on the southwest corner of the building, with door itself folding to enclose the corner. It is of wood construction, painted light green. A window opening in the center of the south elevation has been boarded shut with light-green-painted beadboard. Gray-green asphalt shingles cover the front-gabled roof, and the rafter ends are exposed.**
