COLORADO CULTURAL RESOURCE SURVEY

Architectural Inventory Form

- 1. Resource number: **5PE.5644** Parcel number(s):
- 2. Temporary resource number: **075** **525410009**
- 3. County: **Pueblo**
- 4. City: **Pueblo**
- 5. Historic building name: **Duke, Thomas A., House; Flutcher, Charles A. Jr., House**
- 6. Current building name: **Chapman, Theadus C. and Laura E., House**
- 7. Building address: **511 W 13th Street**
- 8. Owner name: **Theadus C. & Laura E. Chapman**
- Owner organization:
- Owner address: **511 W 13th St**
Pueblo, CO 81003

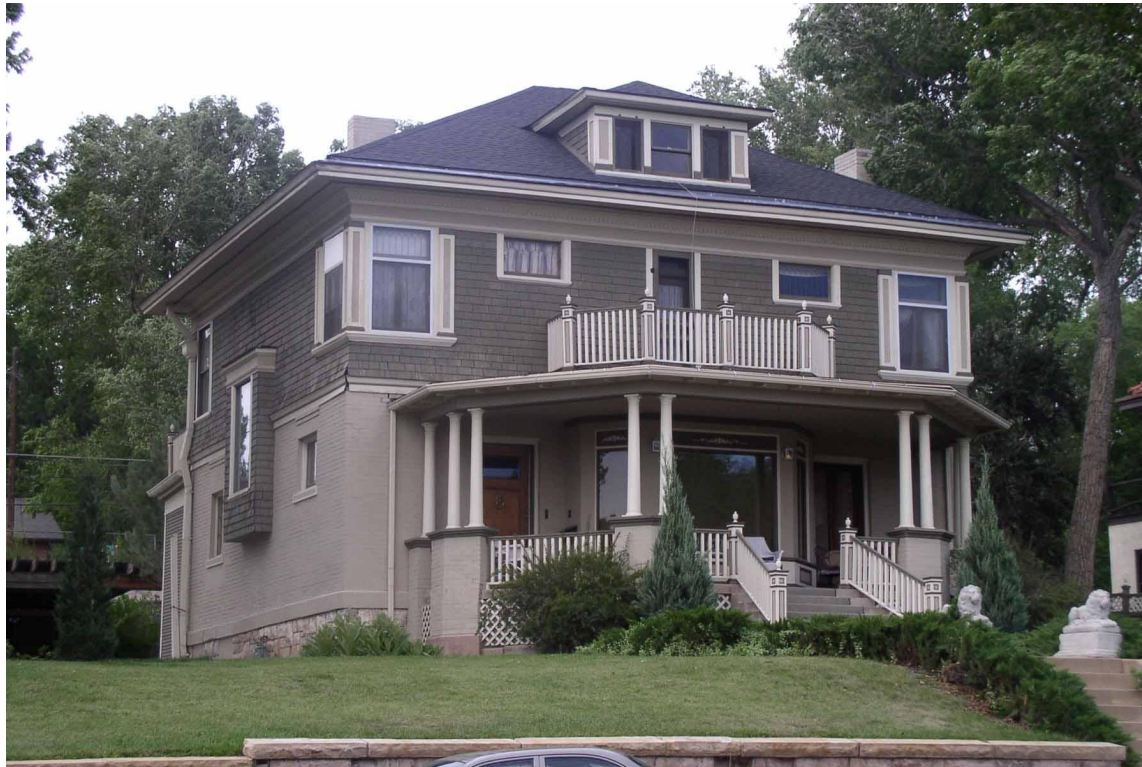
21. General architectural description:
Oriented to the south, this house rests on a high, buff-colored, rock-faced sandstone foundation arranged as coursed ashlar, with raised and beaded mortar. The basement windows are 2-light hopper and open beneath brick segmental arches. Approached by a concrete stairwell, a doorway opens in the basement, near the center of the rear (north) elevation. A protruding, dressed sandstone watertable marks the junction of the foundation and exterior walls. A khaki-painted brick veneer clads the exterior walls of the first story. Green-painted, square-cut wood shingles cover the second story. Narrow, green-painted wood siding covers an enclosed porch protruding from the west end of the east elevation. Windows are generally 1-over-1-light, double-hung sash, with green-painted wood frames. Those windows opening in brick portions of the house usually appear between sandstone sills and flat arches. Those in shingle-sided portions have cream-painted wood surrounds. Protruding from the center of the front (south) façade's first story is a 5-sided, canted bay. The bay features large, fixed-frame windows. Above the windows are rectangular panels framing swags. Windows opening in both faces of the southeast and southwest corners consist of paired, 1-light casement windows. Above them are leaded-glass transoms, with diamond-shaped glazing. Awning or hopper windows with similar glazing open in the south end of the east elevation's first story; near the

middle of the façade's second story; and in the south end of the west elevation's first story. Similarly glazed casement windows open in the hipped-roof dormer protruding from the roof's south slope. They flank a 1-over-1-light, double-hung sash window. A similar dormer protrudes from the north-facing slope. A rectangular bow window protrudes from the center of the west elevation. It corresponds to a window seat located on the landing of an interior staircase. A broad, octagonal, hipped-roof porch, following the same angles as the protruding bay, dominates the façade. Brick pedestals support the paired Doric columns. Between the pedestals is a simple wood balustrade. Approaching the porch at its center are 6 concrete steps, flaked by a wood balustrade. Urn-like finials cap the newel. More concrete steps, guarded on either side by concrete lions, lead to street level. Two doorways open on either end of the porch. The principal doorway is opens in the west side of the facade. It hosts a large, 1-panel, 1-light, oak door, with beveled glass and a large, brass knocker. The doorway on the opposite side has paired, narrow glass doors. Above the porch is an octagonal balcony. It has a simple, wood balustrade with the same newels as the front steps. It is accessed via a doorway opening in the center of the facade. It is a paneled, 1-light door, with leaded transom. An enclosed porch protrudes from the west end of the north elevation. Opening in the center of this porch is another doorway. A 4-step concrete stoop approaches the doorway. Another doorway opens above this one, proving access to a balcony above the rear porch. The balustrade is identical to the front balcony. Asphalt shingles cover the hipped roof. Khaki-painted wood soffit and green-painted fascia box the broadly overhanging eaves. A dentiled cornice marks the junction of the wall and roof. A tan-painted brick chimney protrudes from the roof's west-facing slope.

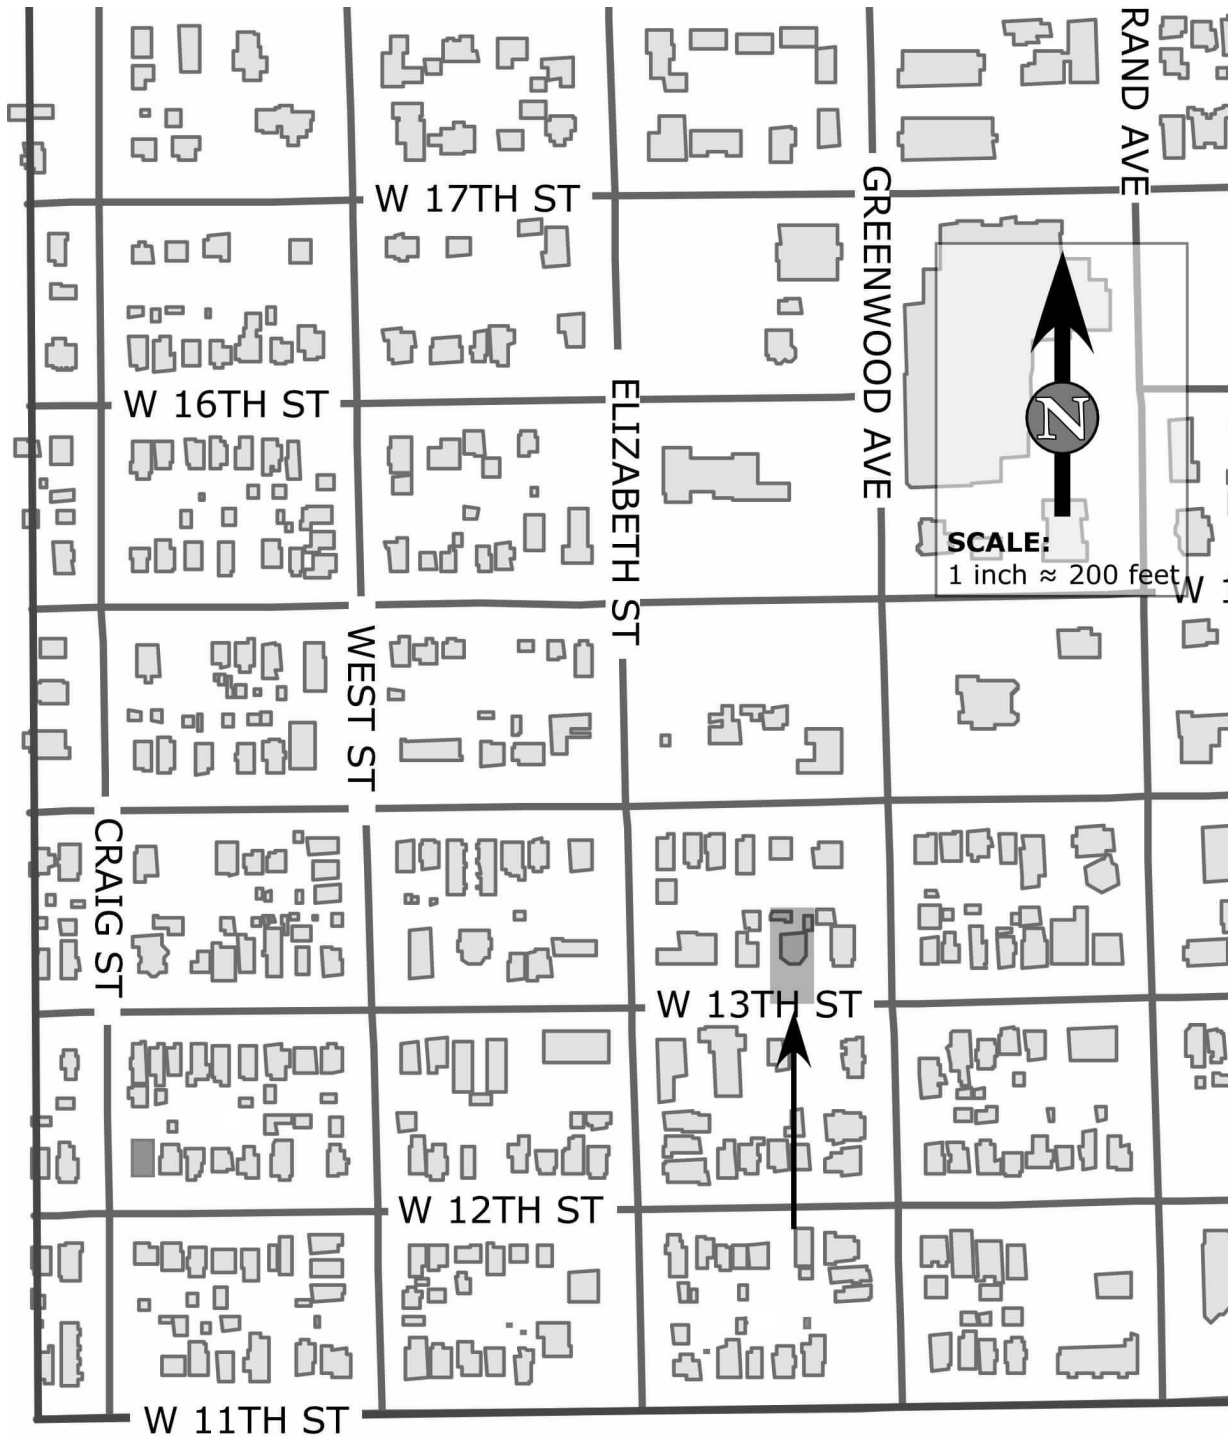
SITE SKETCH MAP

This property is located on terrain sloping downward from north to south, with an elevation of around 4,700 feet above mean sea level. The neighborhood features modest, one- and two-story houses and commercial buildings. Most of the houses here have an unusually deep setback from West 13th Street, the busy, principal east-west thoroughfare through this area. This property is situated on the north side of West 13th Street, between 1311 North Greenwood Street to the east and 515 West 13th Street to the west. A planted-grass yard, with mature landscaping, surrounds the house. Lining the west side of the property is a chain-link fence, and a tongue-and-groove wood privacy fence delimits the north edge of the parcel. Because the terrain slopes downward steeply to the south, a buff- and pink-colored, rock-faced, coursed sandstone ashlar retaining wall lines the sidewalk parallel to West 13th Street. A covered patio is located along the north edge of the property, while a concrete parking area is situated west of the garage.
