COLORADO CULTURAL RESOURCE SURVEY

Architectural Inventory Form

- 1. Resource number: **5PE.5645** Parcel number(s):
- 2. Temporary resource number: **076** **525410008**
- 3. County: **Pueblo**
- 4. City: **Pueblo**
- 5. Historic building name: **Nash, Herman Woodworth, House**
- 6. Current building name: **Archuleta, Jimmy R. and Diana, House**
- 7. Building address: **515 W 13th Street**
- 8. Owner name: **Jimmy R. and Diana Archuleta**
- Owner organization:
- Owner address: **515 W 13th St**
Pueblo, CO 81003

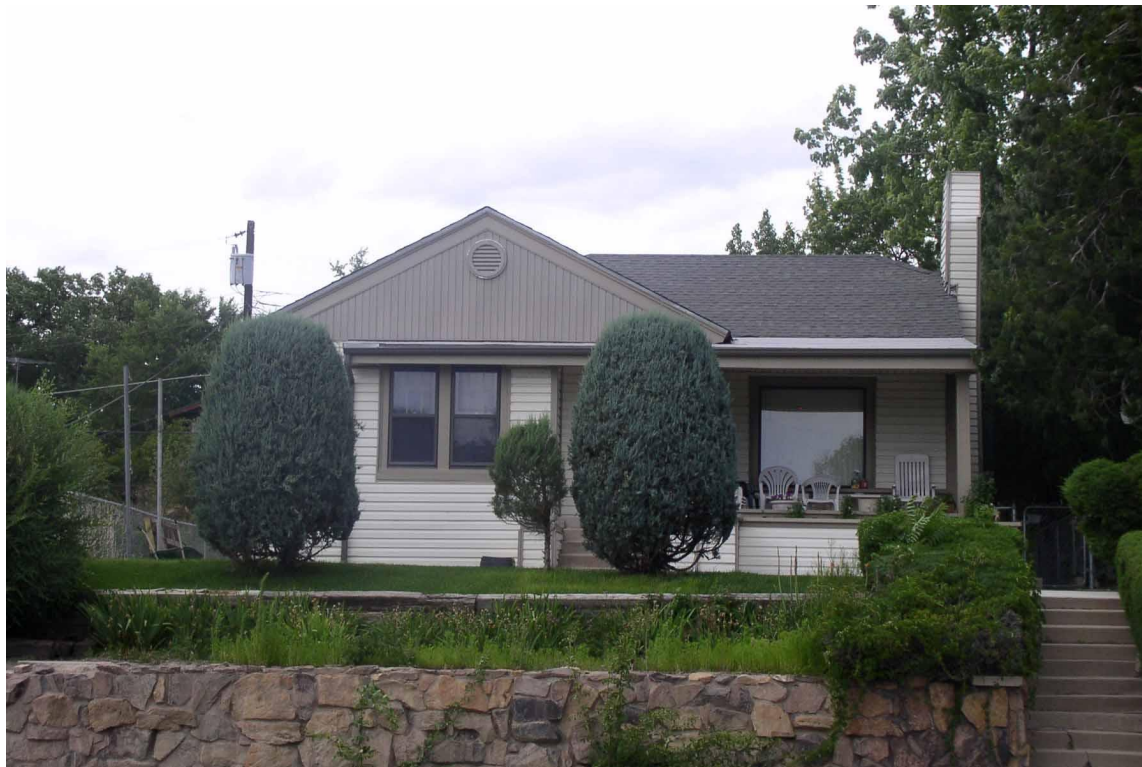
19. Primary external roof material: **Asphalt Roof/Composition Roof**
Other roof materials:
20. Special features: **Fence**
Chimney
Porch
21. General architectural description:
Oriented to the south, this house rests on a foundation entirely concealed behind cream-colored vinyl siding. The same vinyl siding, with tan vinyl cornerboards, clads the exterior walls. Tan, vertically oriented siding covers the gables. Windows are generally 6-over-1-light, double-hung sash, with cream-painted wood frames and brown, aluminum-frame storm windows. All windows have tan, vinyl surrounds. The east end of the front (south) elevation hosts a single-light picture window. Another picture window pierces the north end of the east elevation. The south end of the same elevation has a single-light hopper or awning window. A shed-roofed porch extends across the eastern half of the front (south) façade. It has a concrete floor and simple, tan-painted supports. Concrete steps approach on the west side of the north elevation and at its east end. The principal doorway opens near the center of the asymmetrical façade. It hosts a white, 4-panel metal door, with fanlight. Gray-green asphalt shingles cover the cross-gabled roof, and the eaves are boxed with cream vinyl soffit and tan vinyl fascia. The east-facing gable is clipped. An engaged hearth and chimney, also covered in vinyl siding, protrudes south of center on the east elevation.

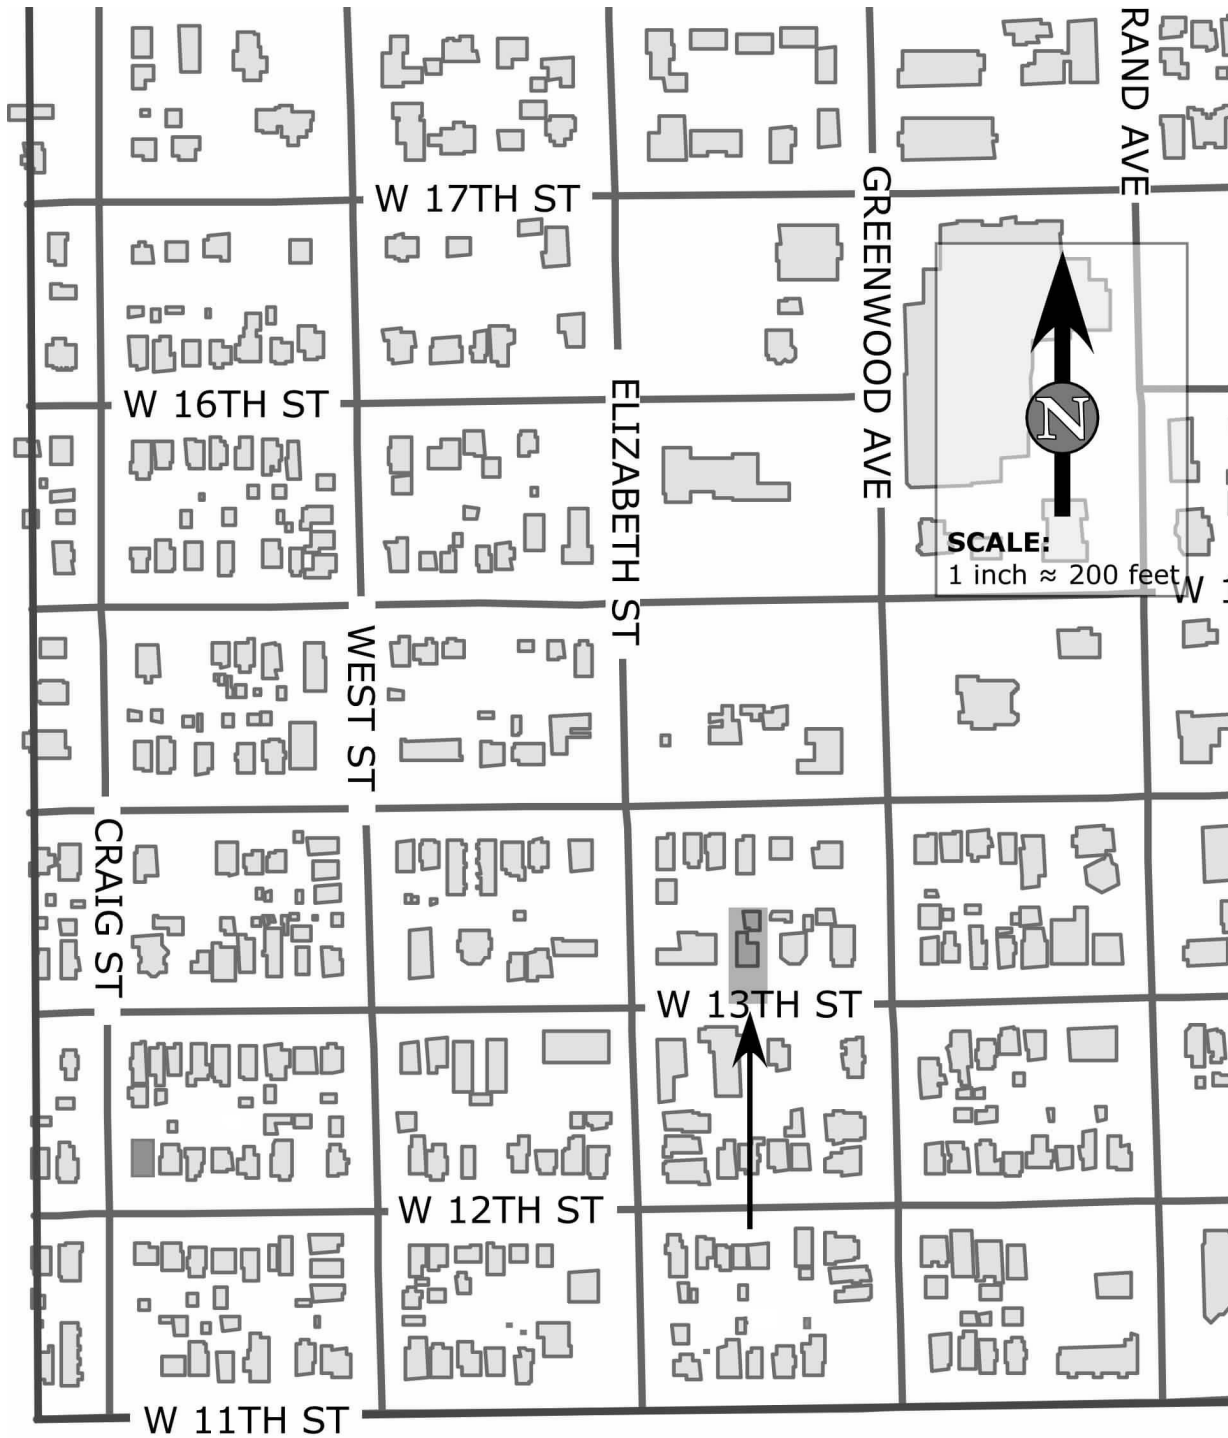
SITE SKETCH MAP

This property is located on terrain sloping downward from north to south, with an elevation of around 4,700 feet above mean sea level. The neighborhood features modest, one- and two-story houses and commercial buildings. Most of the houses here have an unusually deep setback from West 13th Street, the busy, principal east-west thoroughfare through this area. This property is situated on the north side of West 13th Street, between 511 West 13th Street to the east and 1300 North Elizabeth Street to the west. A planted-grass yard, with mature landscaping, surrounds the house. Lining much of the property is a chain-link. A random-coursed sandstone retaining wall lines the sidewalk parallel to West 13th Street. Because the property immediately west is at street level, a massive concrete retaining wall delimits the western edge of the property.

Describe: **A 2-car garage is located north of the house, on the northern edge of the property. Oriented to the west, the building rests on a concrete slab. Cream-colored vinyl siding clads the exterior walls. Covering the gables is tan, vertically oriented vinyl siding. Offset north of center in the front (west) elevation is a 32-panel, steel, overhead-retractable garage door, painted white. Gray-green asphalt shingles cover the front-gabled roof, and vinyl boxes the eaves.**
