COLORADO CULTURAL RESOURCE SURVEY

Architectural Inventory Form

- 1. Resource number: **5PE.5648**
- 2. Temporary resource number:
- 3. County: **Pueblo**
- 4. City: **Pueblo**
- 5. Historic building name: **LeCompte, L.E., House**
- 6. Current building name: **Post, Betty Joan, House**
- 7. Building address: **611 W 13th Street**
- 8. Owner name: **Betty Joan Post**
- Owner organization:
- Owner address: **105 Pioneer Rd**
Monte Vista, CO 81144

47. Photograph numbers): **CD-ROM Photo Disc: North Side Photos
File Name(s): 13thstw611**
- Negatives filed at: **Special Collections
Robert Hoag Rawlings Public Library
100 East Abriendo Avenue
Pueblo, CO 81004-4290**
48. Report title: **Pueblo North Side Neighborhood Survey**
49. Date(s): **06/27/05**
50. Recorder(s): **Adam Thomas**
51. Organization: **Historitecture, L.L.C.**
52. Address: **PO Box 419
Estes Park, CO 80517-0419**
53. Phone number(s): **(970) 586-1165**

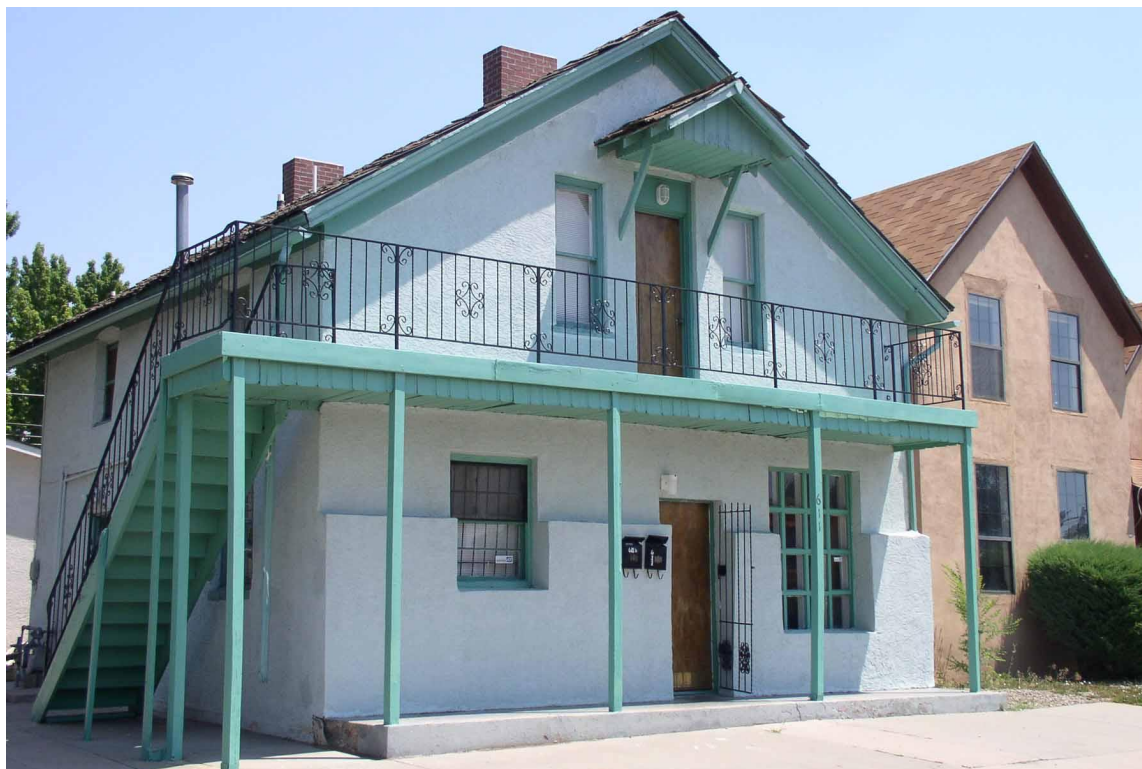
19. Primary external roof material: **Wood Roof/Shake Roof**
 Other roof materials:
20. Special features: **Balcony**
Chimney
Porch
21. General architectural description:
Oriented to the south, this house rests on a low, sandstone foundation, almost entirely obscured behind blue-painted stucco. The same stucco covers the exterior walls. Windows are generally 1-over-1-light, double-hung sash, with blue-green-painted wood frames. The east end of the front (south) façade's first story has a 12-light, fixed-frame window. The south ends of the side elevations' second story have 2-over-2-light windows. Beneath this window on the west elevation is the 2-over-2-light window, with the lights arranged horizontally. A 1-beside-1-light, sliding-sash window, with an aluminum frame, appears in the center of a single-story, shed roof addition across the eastern three-quarters of the rear (north) elevation. The principal doorway opens just east of center in the otherwise symmetrical facade. It hosts a wood slab door, opening behind a wrought-iron grate. Above it, centered in the gable, opens another doorway. It also hosts a wood slab door. The door provides access to a balcony spanning the entire front façade. The balcony has a decorative, wrought-iron railing. Wood steps approach the balcony ascending from north to south, along the west elevation. A front-gabled hood, on simple knee brackets, shelters the doorway only. Another doorway opens in the north end of the west elevation. It also hosts wood slab door and wrought-iron grate. Wood shakes cover the front-gabled roof, and blue-green-painted wood soffit and fascia, with projecting cornice, box the eaves. A pair of red-brick chimneys protrudes from the roof ridge.
