COLORADO CULTURAL RESOURCE SURVEY

Architectural Inventory Form

- 1. Resource number: **5PE.5650** Parcel number(s):
- 2. Temporary resource number: **525409006**
- 3. County: **Pueblo**
- 4. City: **Pueblo**
- 5. Historic building name: **Housing Authority of Pueblo Apartments**
- 6. Current building name: **Housing Authority of Pueblo Apartments**
- 7. Building address: **615-619 W 13th Street**
- 8. Owner name: **Housing Authority of Pueblo**
- Owner organization:
- Owner address: **1414 N Santa Fe Ave**
Pueblo, CO 81003

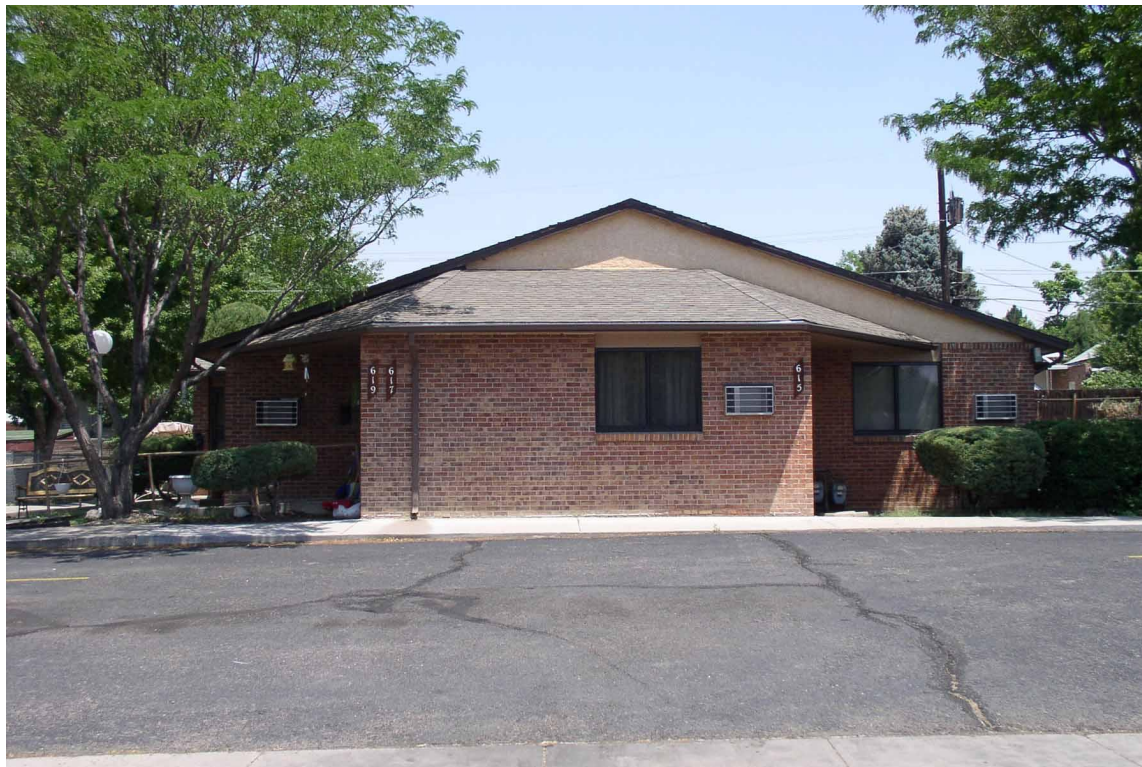
19. Primary external roof material: **Asphalt Roof/Composition Roof**
 Other roof materials:
20. Special features: **Fence**
Porch
21. General architectural description:
Oriented to the south, this triplex rests on a concrete foundation. A brown-brick veneer clads the exterior walls. Tan stucco covers the gables. Windows are 1-beside-1-light, sliding-sash, with aluminum-frames. They open above brick sills. Doorways open in the south elevation of gabled wings projecting from near the centers of the east and west elevations. Another opens in the west elevation of a hipped-roof structure protruding from the center of the front (south) façade. These doorways provide access to the units addressed (from east to west) 615, 617, and 619 West 13th Street. Each hosts a tan-painted, 6-panel metal door, opening behind an aluminum-frame storm door. Low concrete stoops, flanked by tan-painted pipe railings, approach each of the doorways. Three sets of sliding, plate-glass doors open across the rear (north) elevation. The easternmost and westernmost doorways open in projecting, front-gabled structures. A shallow pent roof shelters the middle doorway. All 3 provide access to concrete patios. Brown-gray asphalt shingles cover the main, front-gabled roof and all other roof structures. Boxing the eaves are brown-painted wood fascia and soffit.
