COLORADO CULTURAL RESOURCE SURVEY

Architectural Inventory Form

- 1. Resource number: **5PE.5651**
- 2. Temporary resource number:
- 3. County: **Pueblo**
- 4. City: **Pueblo**
- 5. Historic building name: **Colburn, U. Grant, House**
- 6. Current building name: **Maestas-Espinoza House**
- 7. Building address: **618 W 13th Street**
- 8. Owner name: **Fidel Maestas and Judy Espinoza**
- Owner organization:
- Owner address: **146 MacNeil Rd**
Pueblo, CO 81004

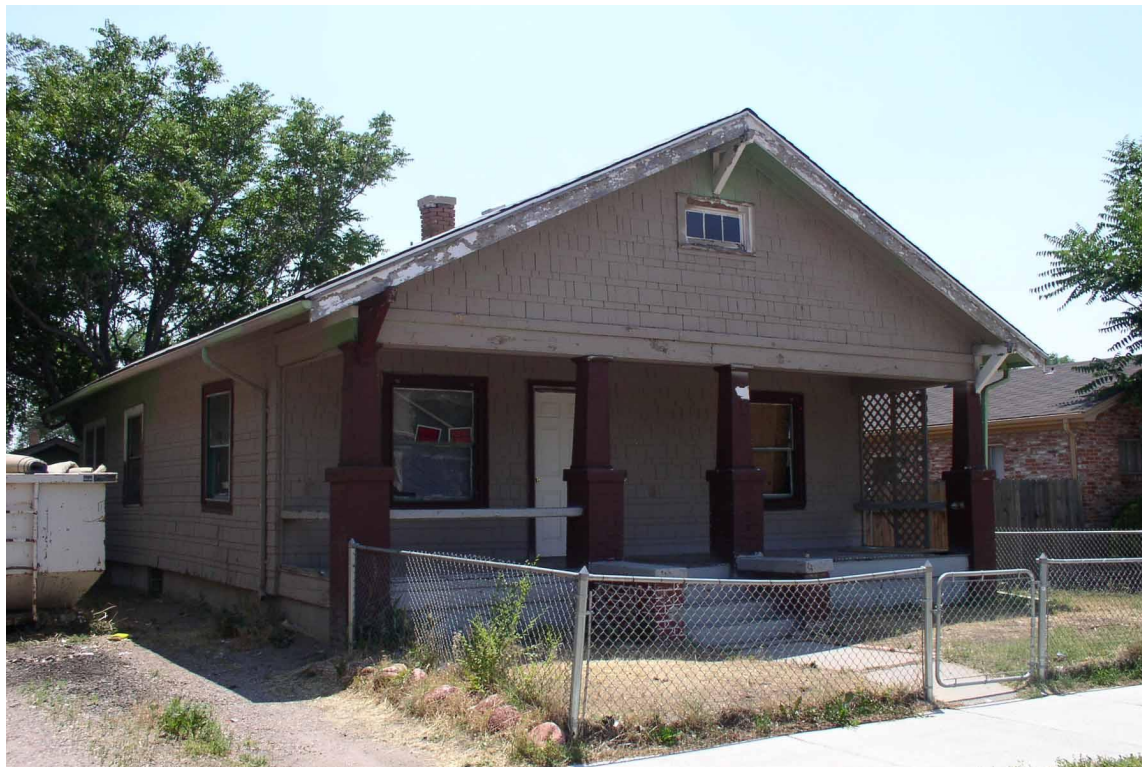
19. Primary external roof material: **Asphalt Roof/Composition Roof**
Other roof materials:
20. Special features: **Fence**
Chimney
Porch
21. General architectural description:
Oriented to the north, this house rests on a tan-painted concrete foundation, with 2-light hopper basement windows. Tan-painted, square-cut wood shingles clad the exterior walls. Windows are generally 1-over-1-light, double-hung sash, with green-painted wood frames and aluminum-frame storm windows. They have broad, dark-red-painted wood surrounds. A 3-light hopper or awning window opens in the front (north-facing) gable. An integral porch spans the entire front (north) façade. It features a wood floor and beadboard porch. The porch supports consist of dark-red-painted brick pedestals and battered, wood piers. Three concrete steps approach the porch, offset east of center. The principal doorway opens east of center in the façade. It hosts a 6-panel, white, metal door. Two doorways open in the rear (south) elevation. One opens low in the west end of the elevation, apparently providing access to a basement stairwell. The other opens west of center. Both are 3-panel, 1-light, glass-in-wood-frame-doors, painted green. They open beneath a simple, shed-roofed structure consisting of wood posts and a corrugated, sheet-metal roof. A brick planter lines the south edge of this structure. Gray asphalt shingles cover the front-gabled roof, and the rafter ends are exposed. Simple knee brackets appear beneath the eaves, within the gables. A red-brick chimney protrudes from the roof ridge, south of center.

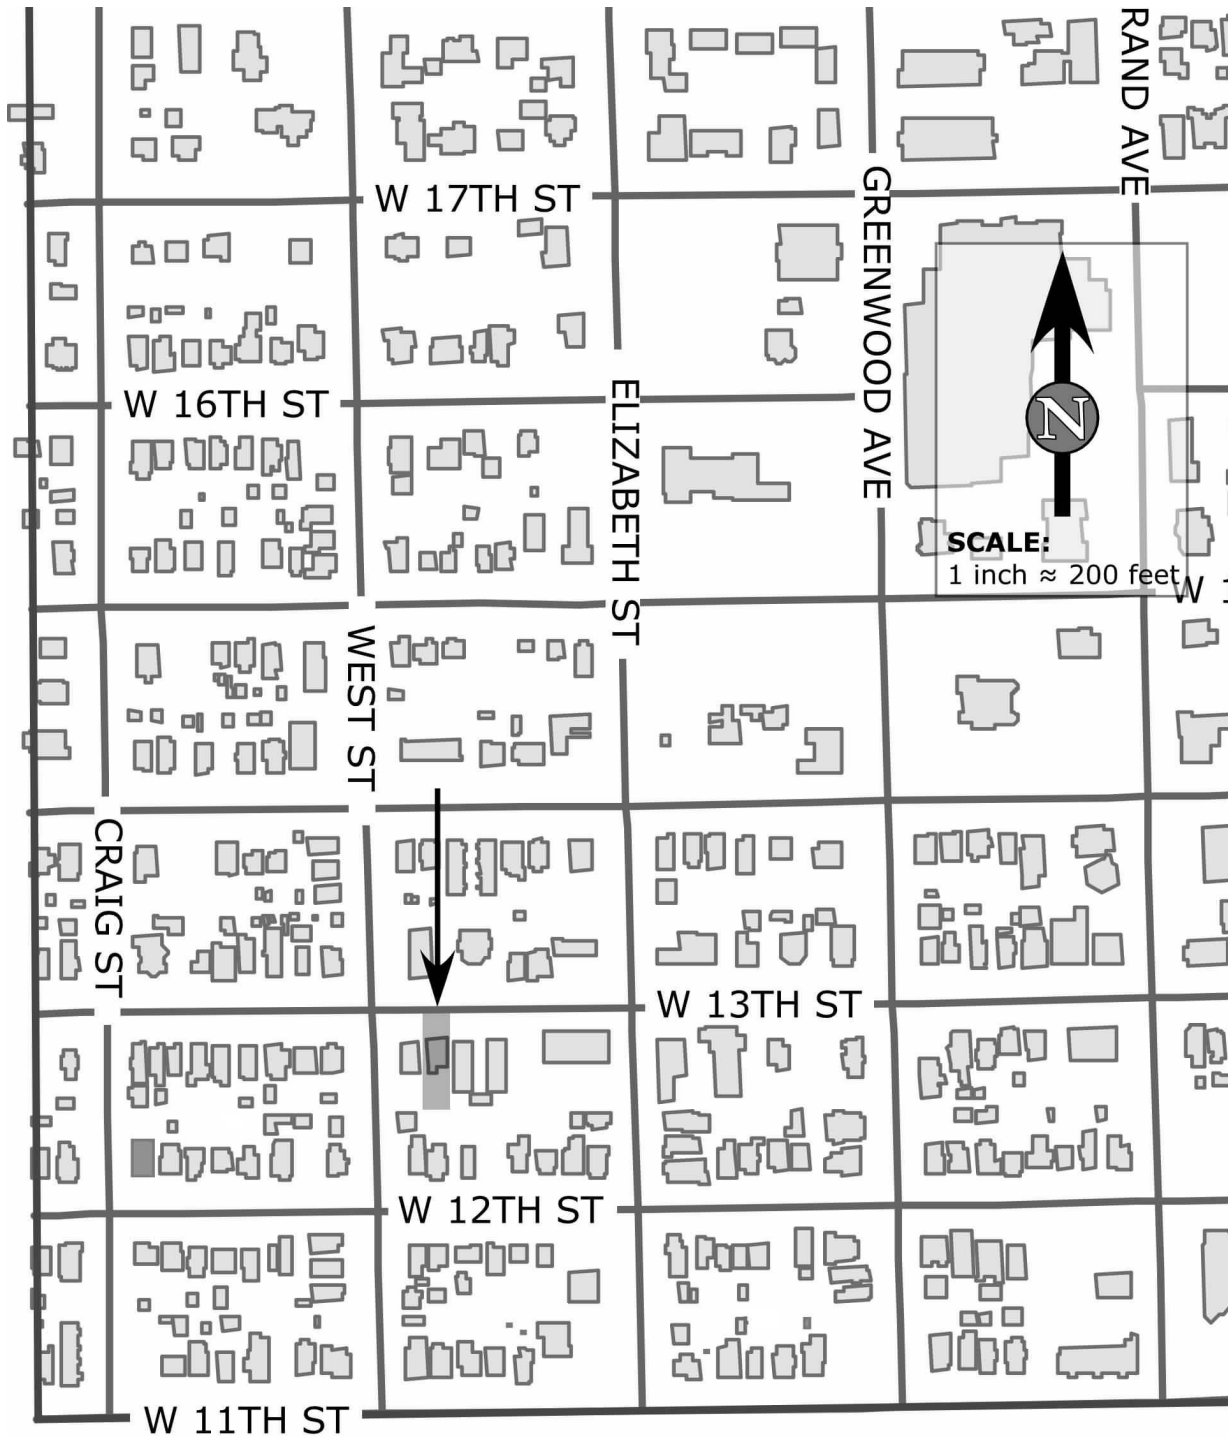
SITE SKETCH MAP

This property is located on terrain sloping downward from north to south, with an elevation of around 4,700 feet above mean sea level. The neighborhood features modest, one- and two-story houses and commercial buildings. Setbacks from West 13th Street, the busy, principal east-west thoroughfare through this area, vary widely on this block. This property is situated on the south side of West 13th Street, between 614-616 West 13th Street to the east and 1216-1218 West Street to the west. Grass covers the strip separating the sidewalk from the street. A planted-grass yard, with mature landscaping, surrounds the house. While a chain-link fence encircles the front yard, a combination of chain-link and wood privacy fences, as well as a concrete-block wall, delimit the back yard. A concrete and gravel driveway runs along the east side of the house, connecting West 13th Street to a garage southeast of the dwelling.
