COLORADO CULTURAL RESOURCE SURVEY

Architectural Inventory Form

- 1. Resource number: **5PE.5653**
- 2. Temporary resource number: **083**
- 3. County: **Pueblo**
- 4. City: **Pueblo**
- 5. Historic building name: **Cowne, Robert, House**
- 6. Current building name: **Aragon, Paul L. and Bernice, House**
- 7. Building address: **702 W 13th Street**
- 8. Owner name: **Paul L. and Bernice Aragon**
- Owner organization:
- Owner address: **383 W Winterhaven Dr  
Pueblo West, CO 81007**

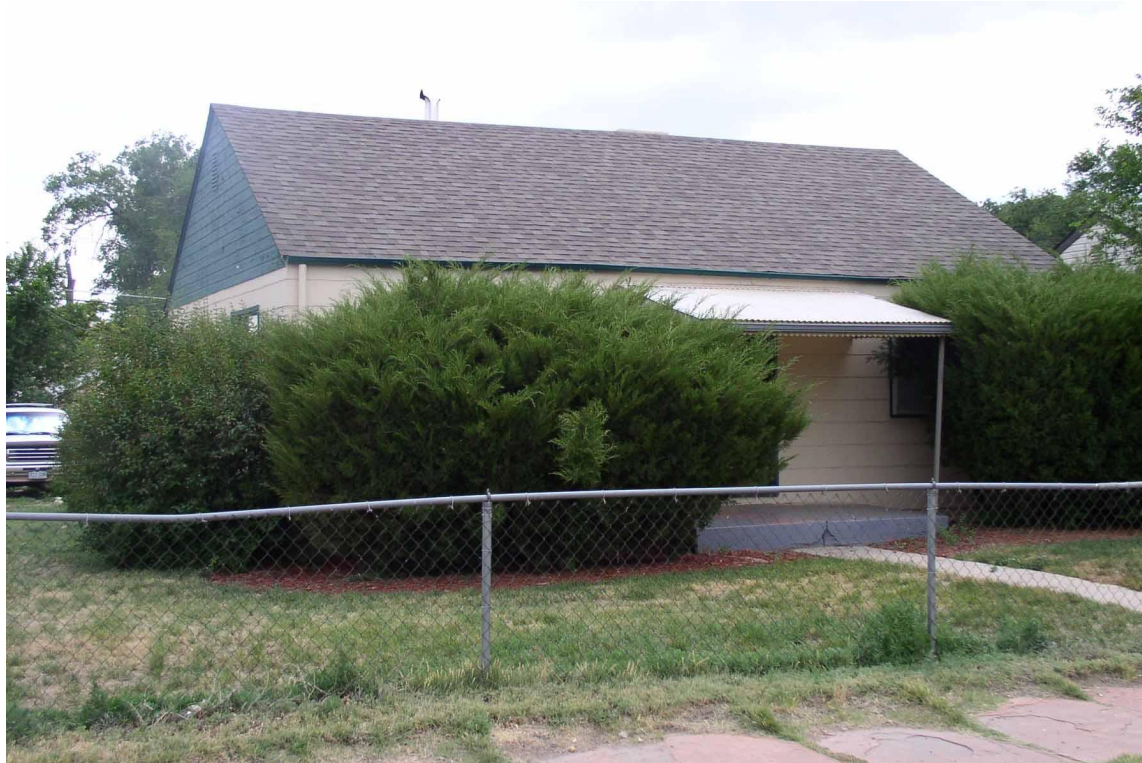
**Oriented to the north, this house rests on a cream-painted concrete foundation. Cream-painted asbestos shingle siding clads the exterior walls. Covering the eaves is green-painted wood weatherboard. Windows are generally single-light picture or 2 (horizontal)-over-2 (horizontal), double-hung sash, with red-painted wood frames and narrow, blue-painted wood surrounds. A 1-beside-1-light, sliding-sash window opens near the center of the rear (south) elevation. The principal doorway opens in the center of the front (north) façade. It hosts a black-painted wood slab door, opening behind a black, security storm door. A single-step concrete stoop approaches the door. Sheltering the stoop is a translucent fiberglass awning on aluminum supports. A shed-roof porch fills the inside (southeast-facing) corner of the house. It has a concrete floor and blue-painted, decorative wrought-iron supports. Two sets of concrete steps approach the porch near the center of its east and south elevations. A doorway opens onto the porch from the rear elevation. It hosts a two-panel, 1-light metal door, opening behind a white, aluminum-frame storm door. Gray asphalt shingles cover the side-gabled roof, and the house lacks overhanging eaves.**
