COLORADO CULTURAL RESOURCE SURVEY

Architectural Inventory Form

- 1. Resource number: **5PE.517.38** Parcel number(s):
- 2. Temporary resource number: **525408004**
- 3. County: **Pueblo**
- 4. City: **Pueblo**
- 5. Historic building name: **Heller-Crow House**
- 6. Current building name: **Miltner, Robert E. and Janet E., House**
- 7. Building address: **705 W 13th Street**
- 8. Owner name: **Robert E. and Janet E. Miltner**
- Owner organization:
- Owner address: **705 W 11th St.
Pueblo, CO 81003**

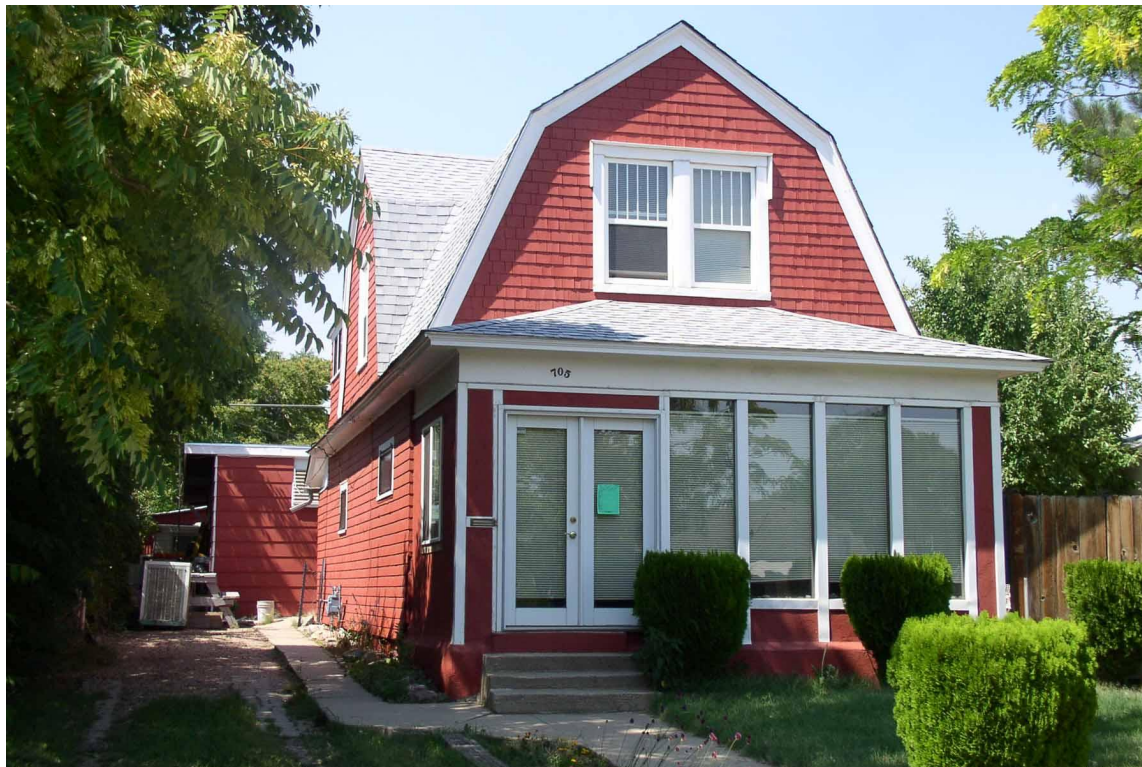
21. General architectural description:
Oriented to the south, this house rests on a red-painted concrete foundation. Red-painted, square-cut wood shingles clad the exterior walls. Stucco, also painted red, covers the exterior wall surfaces of the enclosed front porch. Windows are generally 1-over-1-light, double-hung sash, with white vinyl frames and surrounds. The paired windows dominating the front (south) façade are 6 (vertical)-over-1 light. The surrounding features drip molding. Hopper windows, with cottage-style glazing and beveled glass, are located in the west elevation's first story. Opening in either end of the enclosed front porch and in the north end of the west elevation's second story are 1-beside-1-light, sliding-sash windows, with aluminum frames. A band of tall, 1-light, fixed-frame windows lines the front (south) elevation of the hipped-roof front porch. Single-light French doors open on the west side of the porch, approached by 3 concrete steps. Gray asphalt shingles cover the cross-gambrel roof. White painted wood fascia and soffit box the eaves. A red-brick chimney protrudes at the junction of the roof ridges.

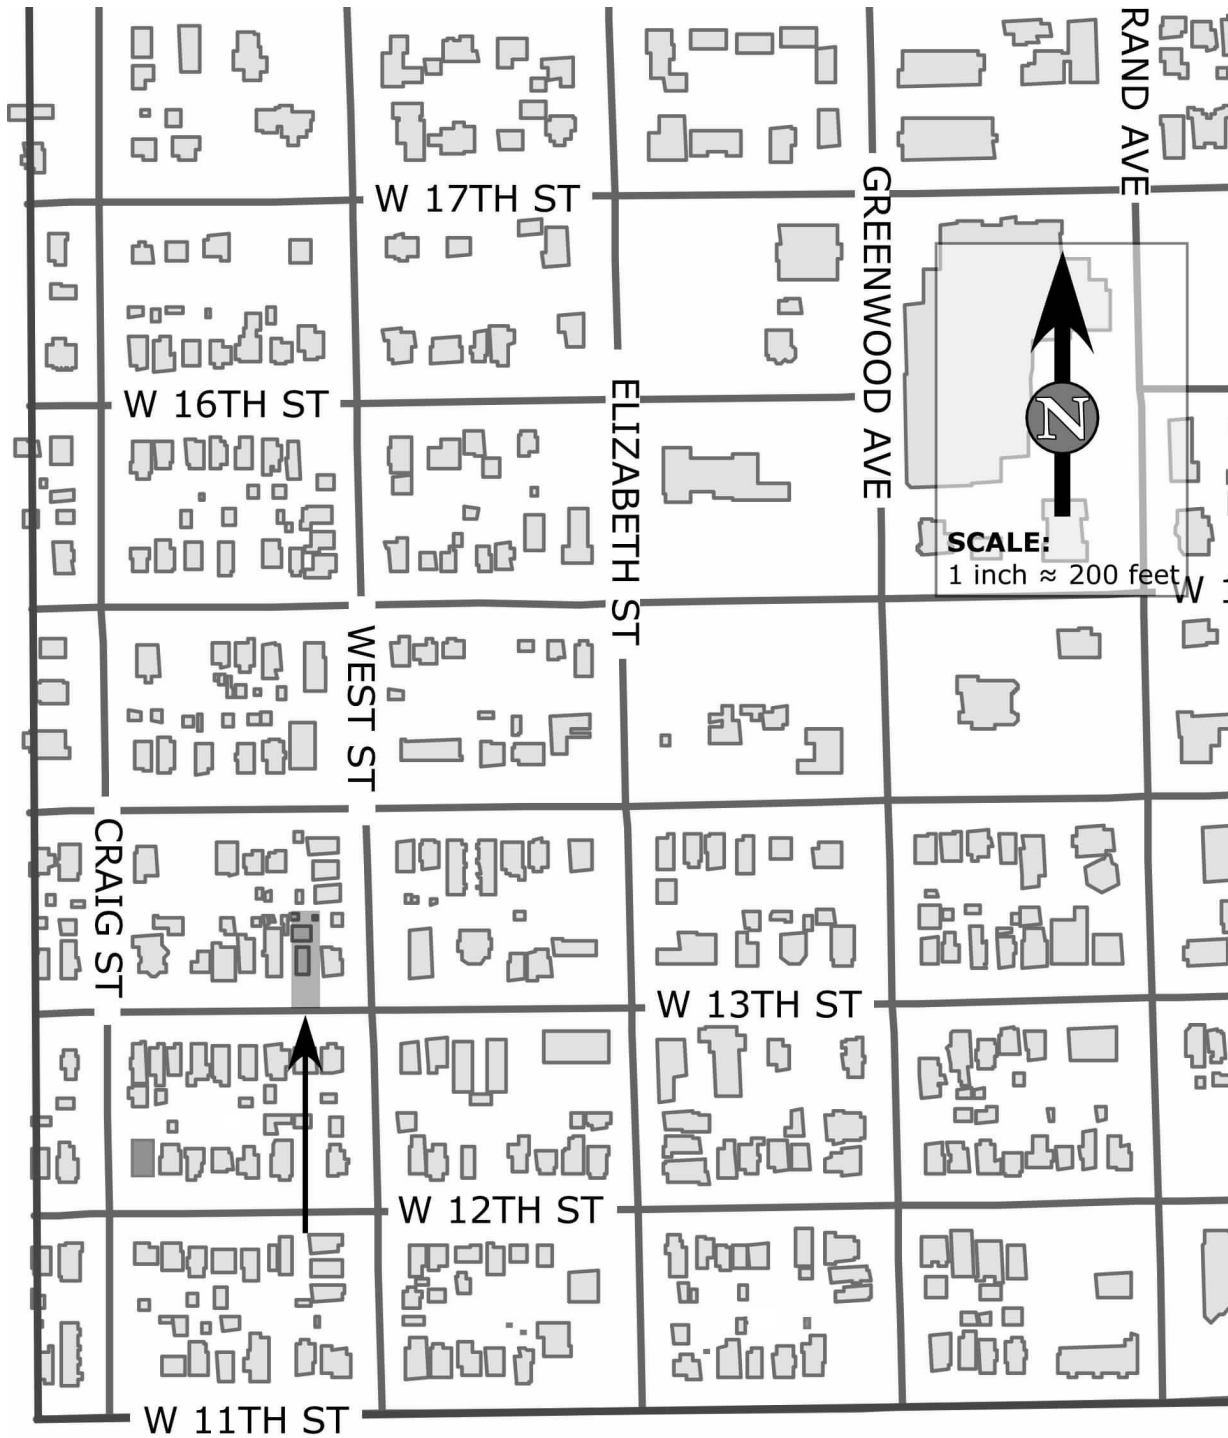
SITE SKETCH MAP

Describe: A 2-car garage is located directly behind (north of) the house. Oriented to the north, the house rests on a concrete slab. Red-painted, asbestos shingle siding clads the exterior walls. Dominating the front (north) elevation and offset to the east is a pair of 12-panel, 4-light, overhead-retractable garage doors, painted white. Sheets of gray asphalt cover the shed roof. A fascia board caps the exposed rafter ends.

Describe: A storage shed is located on the northwest corner of the property. Oriented to the east, the building lacks a formal foundation. Red-painted sheets of corrugated metal clad the exterior walls. This same material covers the door opening in the front (east) elevation. Gray asphalt shingles cover the side-gabled roof.

Describe: A small shed is located on the northeast corner of the property. Oriented to the south, the building rests on concrete blocks. Red-painted sheets of plywood clad the exterior walls. The shed roof consists of sheets of translucent fiberglass.
