COLORADO CULTURAL RESOURCE SURVEY

Architectural Inventory Form

- 1. Resource number: **5PE.5655** Parcel number(s):
- 2. Temporary resource number: **525310009**
- 3. County: **Pueblo**
- 4. City: **Pueblo**
- 5. Historic building name: **Ritchey, Marcellus M., House**
- 6. Current building name: **Providence Unlimited House**
- 7. Building address: **711 W 13th Street**
- 8. Owner name: **Providence Unlimited, LLC**
- Owner organization:
- Owner address: **409 N Main St. #301**
- Pueblo, CO 81003**

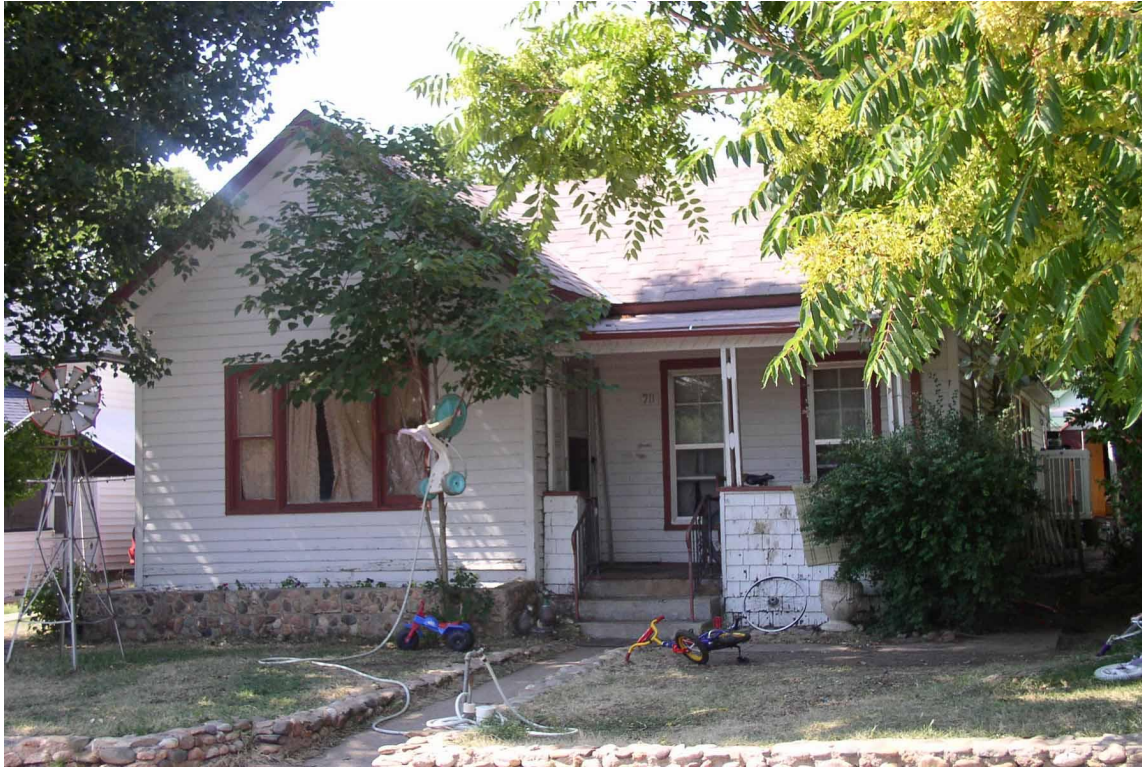
19. Primary external roof material: **Asphalt Roof/Composition Roof**
Other roof materials:
20. Special features: **Porch**
21. General architectural description:
Oriented to the south, this house rests on a concrete foundation. White-painted, horizontal wood siding, with 1-by-4-inch cornerboards, clads the exterior walls. Windows are generally 1-over-1-light or 2-over-2-light, double-hung sash, with white-painted wood frames and mauve-painted wood surrounds. Dominating the front-gabled portion of the front (south) façade is a tripartite picture window. It consists of a central fixed frame flanked by a pair of 1-over-1-light sash windows. The north side of the east elevation contains a pair of 1-beside-1-light, sliding-sash windows. The same type of window appears in the east and west ends of the rear (north) elevation. A shed-roofed porch fills the inside (southeast-facing) corner of the house. It has a wood floor and a kneewall covered in white-painted, square-cut wood shingles. The porch supports consist of paired, white-painted 2-by-4s, with diamond-shaped blocks between them. Two concrete steps, flanked by wrought-iron railings, approach the porch on the west side of its south elevation. The porch has a white-painted, diamond-shaped frieze. The principal doorway opens in the east face of the inside corner. It hosts a 15-light, glass-in-wood-frame door, with a white-painted wood frame. It opens behind an aluminum-frame storm door. Another doorway opens near the center of the east elevation. A flat-roofed carport, on white-painted, square wood supports, spans the entire rear elevation. Red-gray, interlocking asphalt shingles cover the cross-gabled roof. White-painted wood fascia and soffit box the eaves.

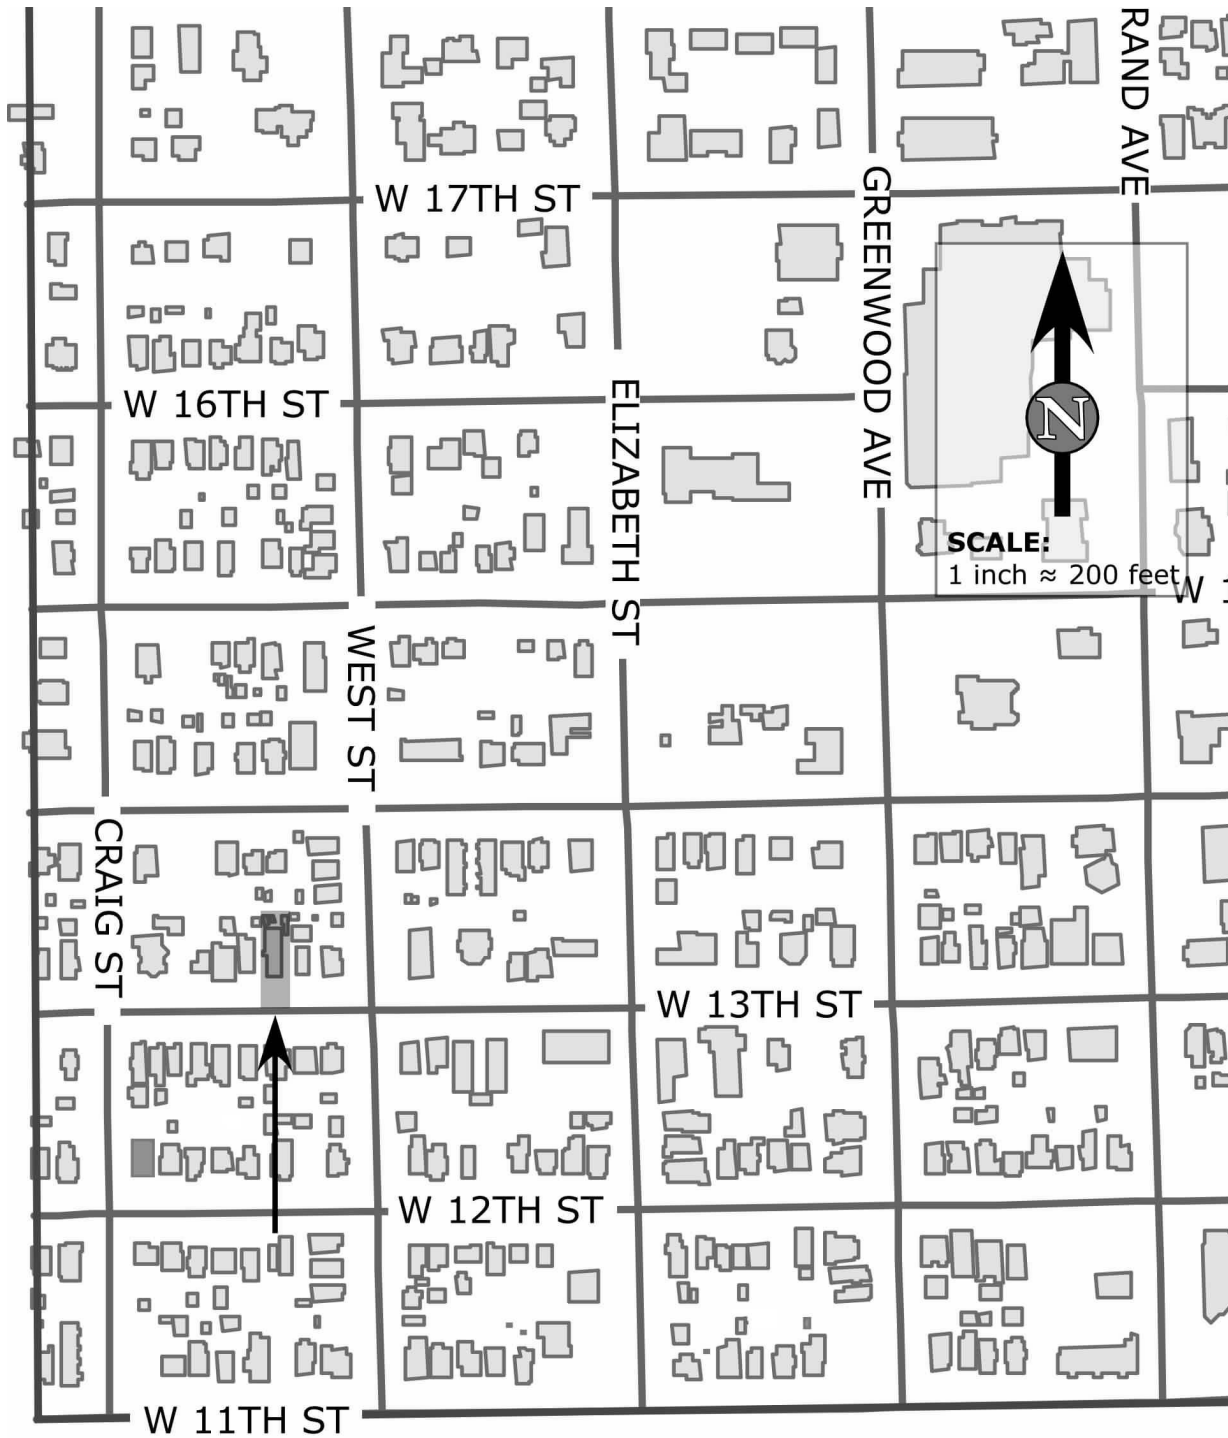
SITE SKETCH MAP

This property is located on terrain sloping downward from north to south, with an elevation of around 4,700 feet above mean sea level. The neighborhood features modest, one- and two-story houses and commercial buildings. Setbacks from West 13th Street, the busy, principal east-west thoroughfare through this area, are generally the same on this block. This property is situated on the north side of West 13th Street, between 705 West 13th Street to the east and 713 West 13th Street to the west. Grass covers the strip separating the pink sandstone sidewalk from the street; a low cobblestone wall flanks the north side of the sidewalk. A planted-grass yard, with mature landscaping, covers the southern portion of the lot. Large cottonwoods shade the southeast and southwest corners of the property. A gravel parking area dominates the backyard.

- 1: Type: **Shed**
Describe: **A standard kit-built shed is located directly northeast of the house. Oriented to the south, the structure lacks a formal foundation. The walls consist of brown-painted sheet metal. Paired, sliding doors of the same description dominate the front (south) elevation. The front-grambreled roof also consists of sheet metal.**
