COLORADO CULTURAL RESOURCE SURVEY

Architectural Inventory Form

- 1. Resource number: **5PE.5656** Parcel number(s):
- 2. Temporary resource number: **525311001**
- 3. County: **Pueblo**
- 4. City: **Pueblo**
- 5. Historic building name: **Footman, Lawrence and John, House**
- 6. Current building name: **Duran, Xavier J., House**
- 7. Building address: **712 W 13th Street**
- 8. Owner name: **Xavier J. Duran**
- Owner organization:
- Owner address: **1630 Moore Ave., Ste. 1**  
**Pueblo, CO 81005**

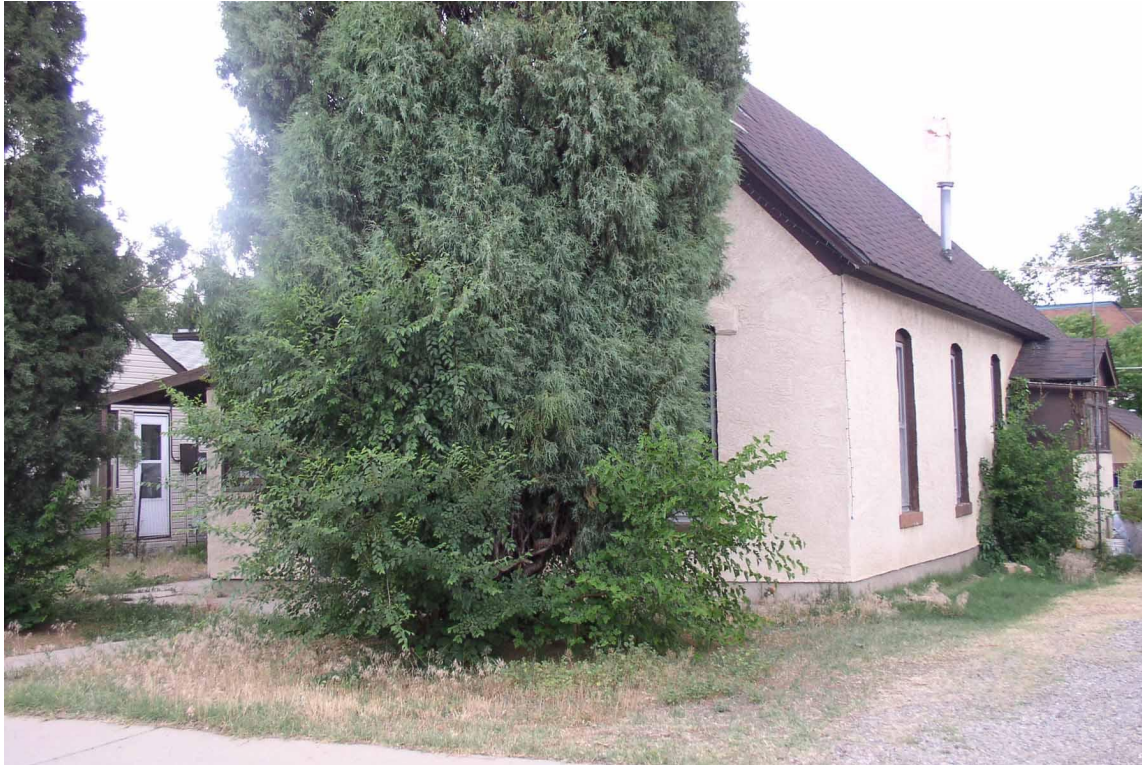
**Chimney**  
**Porch**
21. General architectural description:  
**Oriented to the north, this house rests on a foundation entirely obscured behind concrete and stucco. Tan stucco clads the exterior walls. Windows are generally 1-over-1-light, double-hung sash, with brown-painted wood frames and aluminum-frame storm windows. They open beneath segmental arches, some of which are projecting, and dressed sandstone sills, painted brown. A front-gabled bay protrudes from the south end of the west elevation. It hosts a pair single-light hopper or awning windows, with multi-light sidelights and transoms. Enclosing the front porch is a pair of 1-over-1-light, double-hung sash windows and a band of clerestory windows. The enclosed front porch fills the inside (northeast-facing) corner. It provides access to the principal doorway, which opens in the east face of the corner. It hosts a 4-panel, white-painted wood door, with transom. Another doorway opens in the south elevation of the front-gabled bay projecting from the west elevation. Brown, interlocking asphalt shingles cover the gable-on-hip roof. Boxing the eaves are brown-painted wood fascia and soffit. A stucco-covered chimney protrudes from the roof's west-facing slope.**
