COLORADO CULTURAL RESOURCE SURVEY

Architectural Inventory Form

- 1. Resource number: **5PE.5658** Parcel number(s):
- 2. Temporary resource number: **525311002**
- 3. County: **Pueblo**
- 4. City: **Pueblo**
- 5. Historic building name: **Langdon, John J., House**
- 6. Current building name: **714 West 13th Street**
- 7. Building address: **714 W 13th Street**
- 8. Owner name: **Neighborhood Services, Inc.**
- Owner organization:
- Owner address: **3937 Ivywood Lane**
Pueblo, CO 81005

47. Photograph numbers): **CD-ROM Photo Disc: North Side Photos
File Name(s): 13thstw714**
- Negatives filed at: **Special Collections
Robert Hoag Rawlings Public Library
100 East Abriendo Avenue
Pueblo, CO 81004-4290**
48. Report title: **Pueblo North Side Neighborhood Survey**
49. Date(s): **06/27/05**
50. Recorder(s): **Adam Thomas**
51. Organization: **Historitecture, L.L.C.**
52. Address: **PO Box 419
Estes Park, CO 80517-0419**
53. Phone number(s): **(970) 586-1165**

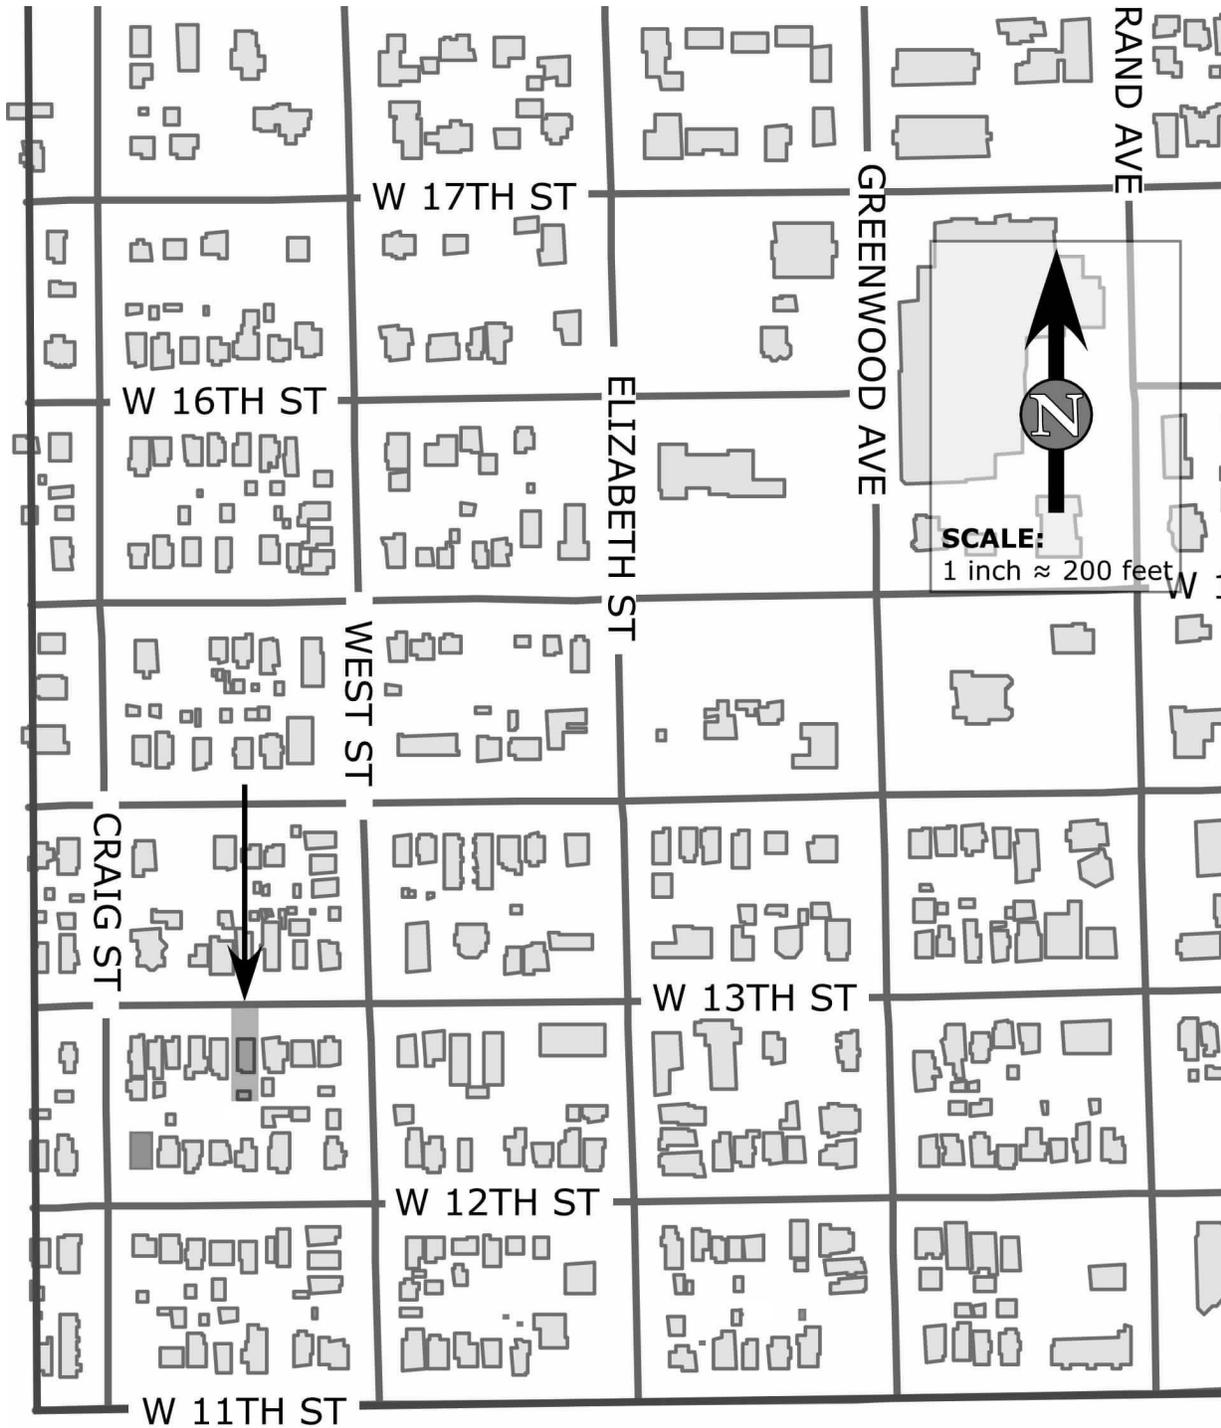
SITE SKETCH MAP

This property is located on terrain sloping downward from north to south, with an elevation of around 4,700 feet above mean sea level. The neighborhood features modest, one- and two-story houses and commercial buildings. Setbacks from West 13th Street, the busy, principal east-west thoroughfare through this area, are generally the same on this block. This property is situated on the south side of West 13th Street, between 712 West 13th Street to the east and 716 West 13th Street to the west. Gravel covers the strip separating the sidewalk from the street. A planted-grass yard, with mature landscaping, covers the lot, and large juniper dominates the front of the house. A gravel driveway runs along the east side of the property and a gravel parking area is located on the southern edge of the property. Surrounding the backyard is a chain-link fence.
