COLORADO CULTURAL RESOURCE SURVEY

Architectural Inventory Form

- 1. Resource number: **5PE.5659** Parcel number(s):
- 2. Temporary resource number: **525310007**
- 3. County: **Pueblo**
- 4. City: **Pueblo**
- 5. Historic building name: **Bannister, Charles, Building**
- 6. Current building name: **Manzanares Tax Service and Private Residence**
- 7. Building address: **715 W 13th Street**
- 8. Owner name: **Jose L. and Clara H. Manzanares**
- Owner organization:
- Owner address: **715 W 13th St.
Pueblo, CO 81003**

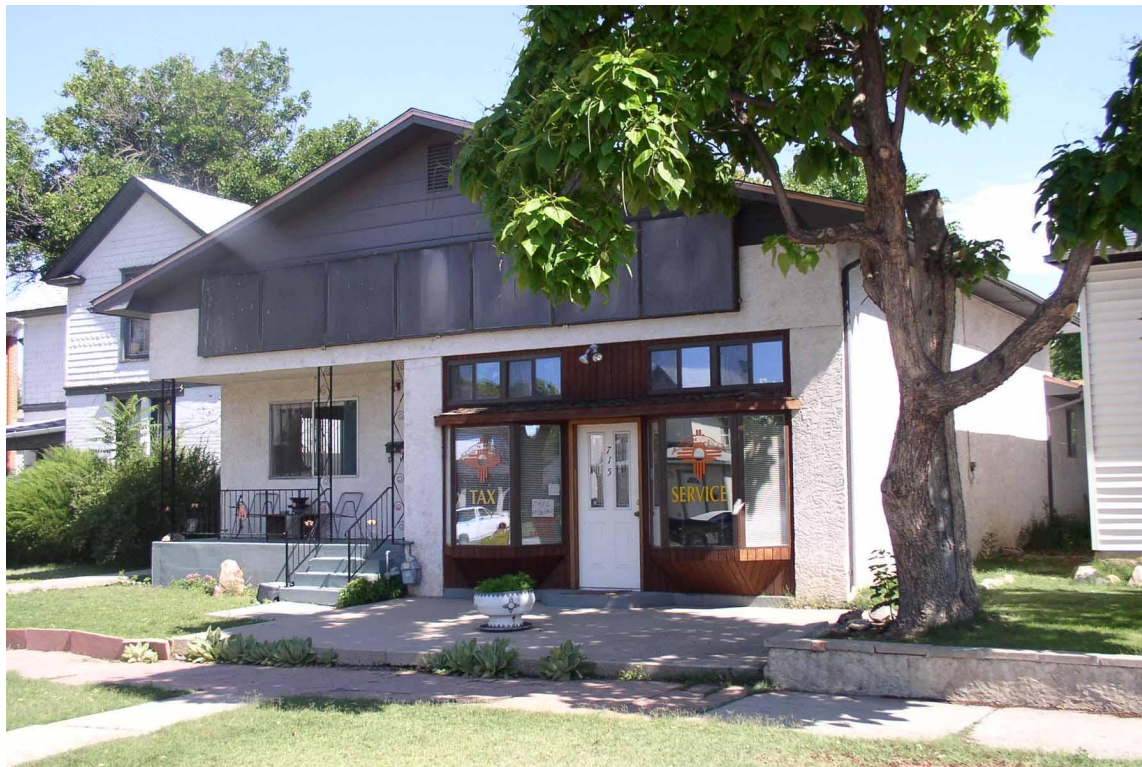
19. Primary external roof material: **Asphalt Roof/Composition Roof**
Other roof materials:
20. Special features: **Fence**
Porch
21. General architectural description:
Oriented to the south, the building rests on a concrete foundation. Buff-tinted stucco clads the exterior walls. Brown, aluminum siding covers the gables. Windows are generally 1-beside-1-light, sliding sash, with aluminum frames. The front (south) facade hosts two different bays. The east bay is actually a storefront, with vertical wood siding as exterior wall cladding. Flanking either side of a doorway at the center of the storefront are 3-sided, canted bow window. Above them is a wood-shake-covered pent roof, which also shelters the doorway. Above the window and pent roof are clerestory windows comprised of 2 bands of sliding-sash windows. The doorway hosts a 2-light, 2-panel, white, metal door, with decorative leaded glass, in a prairie-style pattern. A single, concrete step approaches the doorway. Dominating the west bay is an integral porch. It has a concrete floor and black-painted, decorative wrought-iron railings and supports. Small leaf ornaments and the monogram "M" have been painted a salmon color. Three concrete steps approach the porch on its east side, corresponding to a doorway opening beneath the porch. It hosts a two-panel, white metal door, with two rectangular lights beneath a fanlight. These lights have frosted glass in a brass-coated leading. A long solar panel spans the entire façade between the top of the bays and bottom of the gable. Another doorway opens north of center in the west elevation. A small, front-gabled structure protrudes from the west end of the rear (north) elevation. Opening in this structure's east elevation is another doorway, providing access to a concrete patio. Gray, interlocking asphalt shingles cover the front-gabled main roof. Brown-painted wood fascia and soffit box the eaves.
